# Dropped Object Incidents on Chevron operated assets

**January 2010**

There were three RIDDOR-reportable Dropped Objects on Chevron operated assets in January 2010:

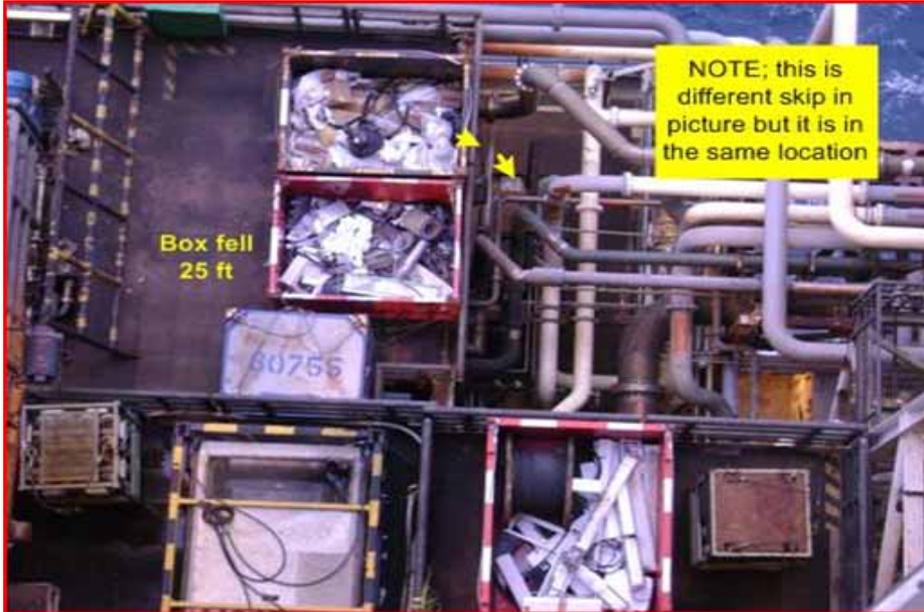
Aerial view of skip location showing where object dropped to

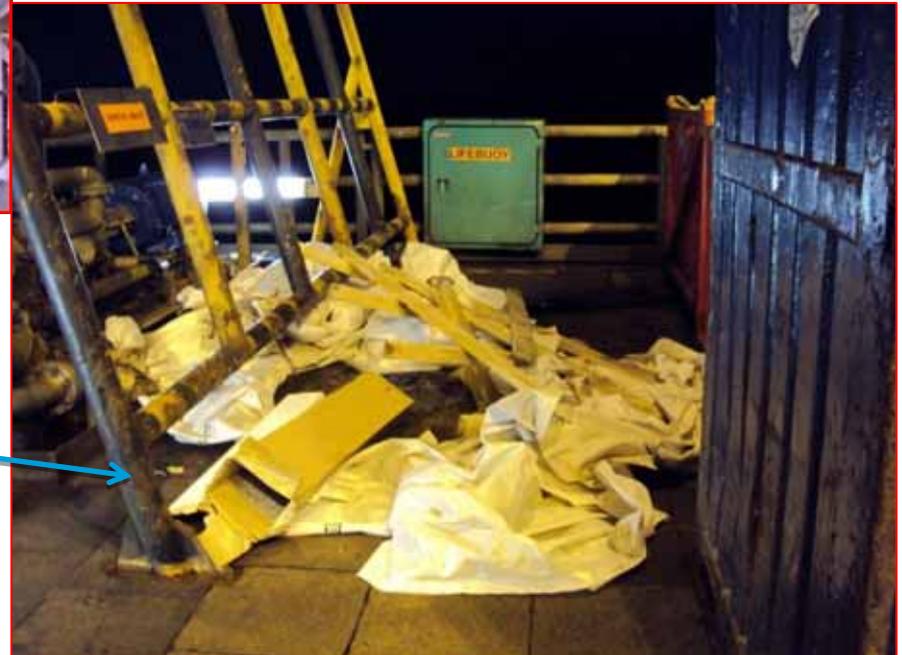
Other material dislodged from skip during lift

- The design of the lay down area did not allow for clear and safe access to monitor lifting legs while skip was being used (location of the skip was too close to the edge of the deck).
- Failure to comply with requirements of procedure which requires the load to be checked to ensure there is no potential for parts of the load to fall prior to undertaking the lifting operation (accepted practice was to use a controlled lift to extricate legs of lifting assembly from debris).
- All personnel involved in this lift should have been sufficiently trained and competent to recognise the hazards that were present and to control them according to procedure. The Banks man was not positioned such that he had an unobstructed view of all edges of the skip once debris began to rise when lifting assembly was tensioned.
- Stop Work Authority was not used by any member of the deck crew.

- Reminder to all platform deck crew to ensure they are in full view at all times of all skips when trying to clear lifting assembly leg obstructions. Also deck crew to ensure skip openings are left completely clear of lifting leg assemblies when landed, and periodic monitoring program of skips during use.
- Skip location to be reviewed to allow better access to view contents and also to provide a catchment area if items are dislodged
- Increased awareness of all platform personnel about the use of skips and hazards around segregation, lifting assembly legs, netting use and overfilling (through TBT and OIM Forums).
- Wire mesh to be installed to bumper bar areas to provide improved dropped object protection.

- All members of deck crew to be asked to sign acknowledgement that they have read and understood requirements of the procedure and that they are aware of the requirements placed on them by this procedure.
- Review Lifting Plan for lifts of waste skips to ensure it adequately identifies and addresses specific hazards associated with loose items contained within skip.
- Increase the awareness of Stop Work Authority, as this opportunity presented itself but was not taken.

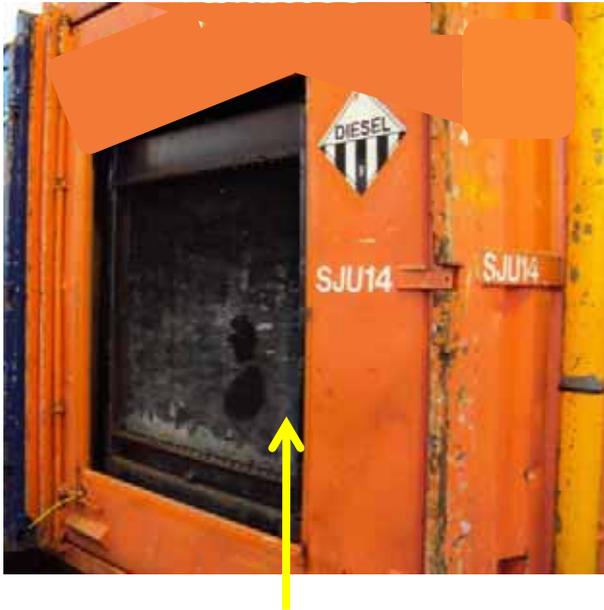
Unit on platform, following detachment of louver end plate

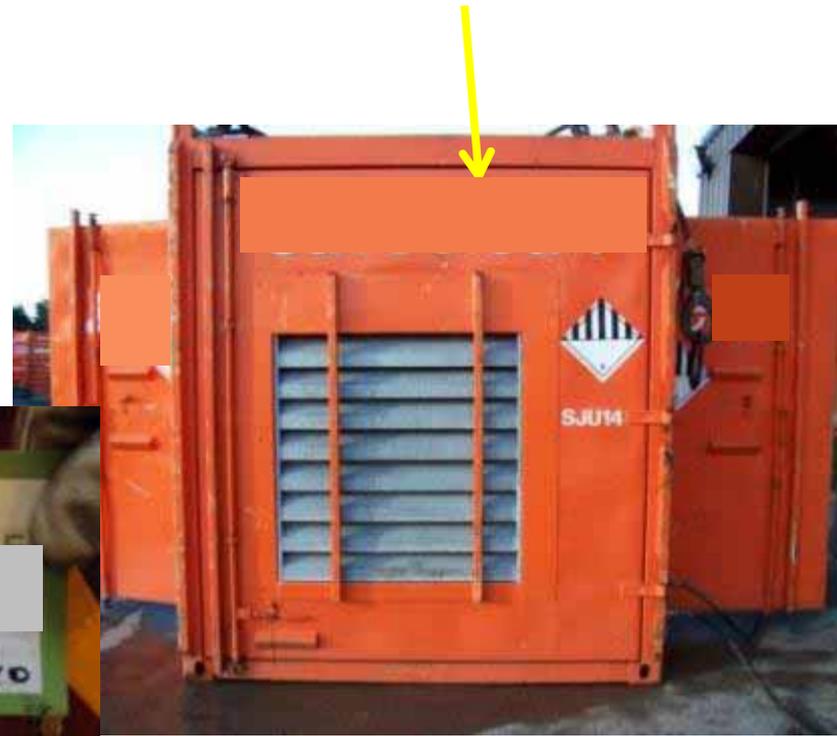
Unit in yard showing example of louver end plate that fell to sea

- Incident occurred as a result of retaining bolts shearing and the fact that there was no secondary securing device in place. Possible contributing factors include incomplete QA inspection prior to shipping and inadequate access to unit offshore to allow for pre lift checks. Highly likely that unit contacted other unit on vessel (blue paint observed on unit upon inspection).

- Deck co-ordinator to communicate to all crews that if any anomaly/damage is observed during lift that the load is to be landed as safely and quickly as possible with damaged area facing inboard to allow for inspection.
- Integrity team leader to communicate with contract owner of Jetting unit that equipment mobilised to Chevron installations must have secondary retaining device fitted to externally mounted parts of temporary equipment.
- Note: As a result of this incident the unit provider has changed the design of these units. the louver is flush fitted.

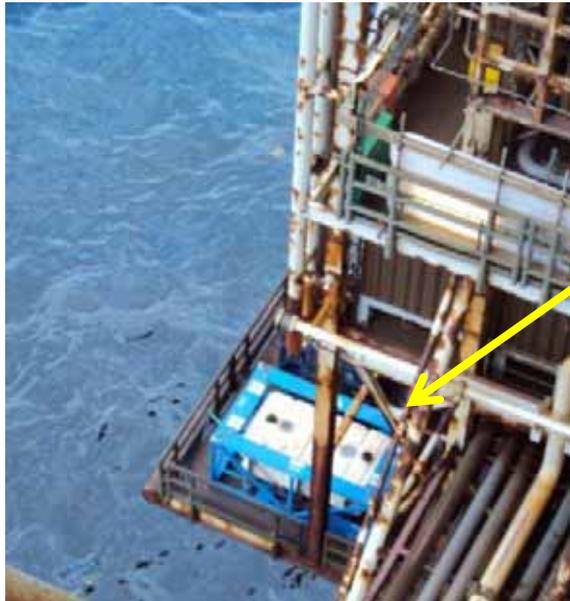
View of lay down area where unit was being placed following lift from pipe deck  
N.B. This is a blind lift

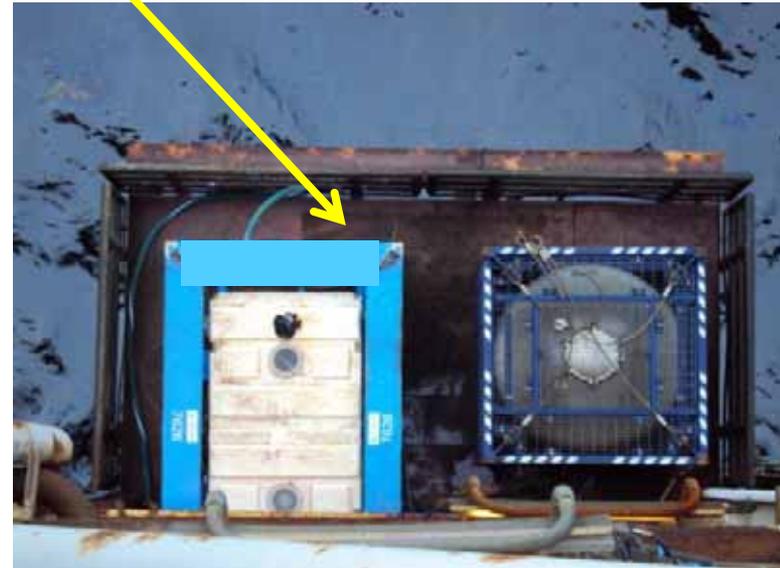
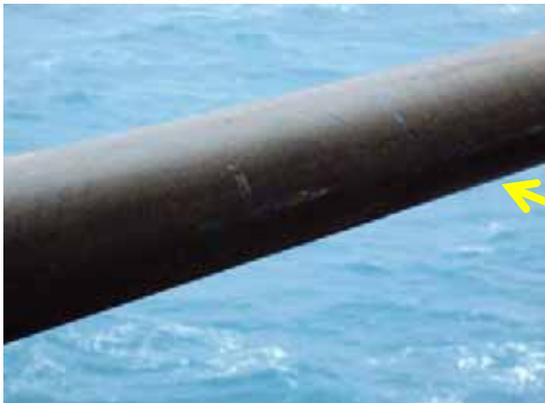
Close up view of handrail where container was landed (no sign of marking)

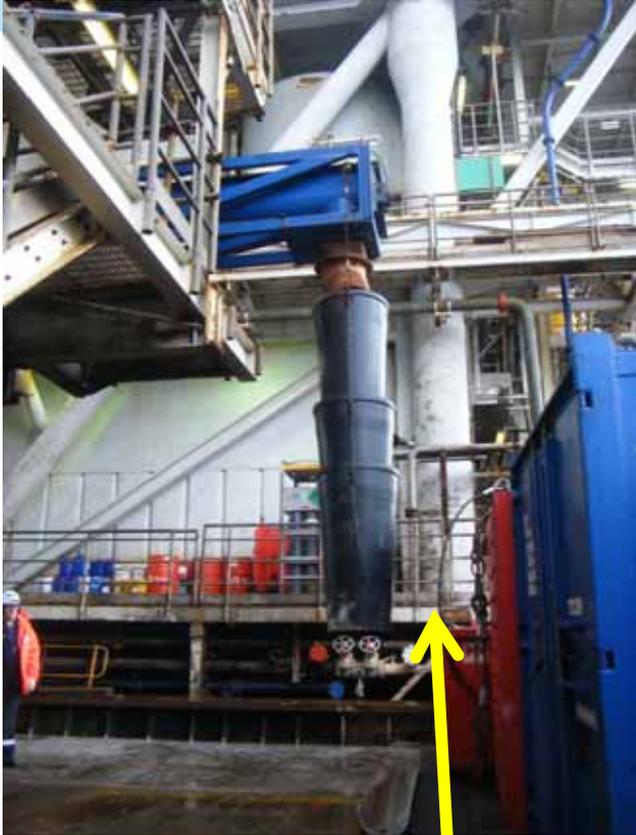
Cuttings chute in place  
(Dropped object removed)

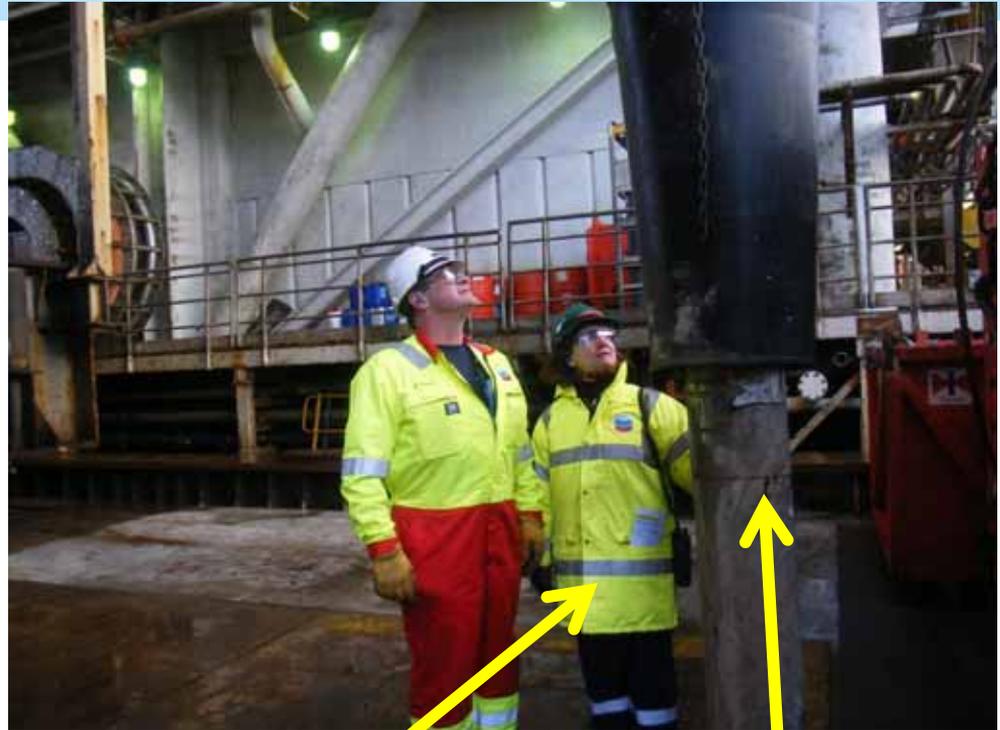
Position of  
witness when  
incident  
occurred

Position of  
dropped  
object held  
within chute

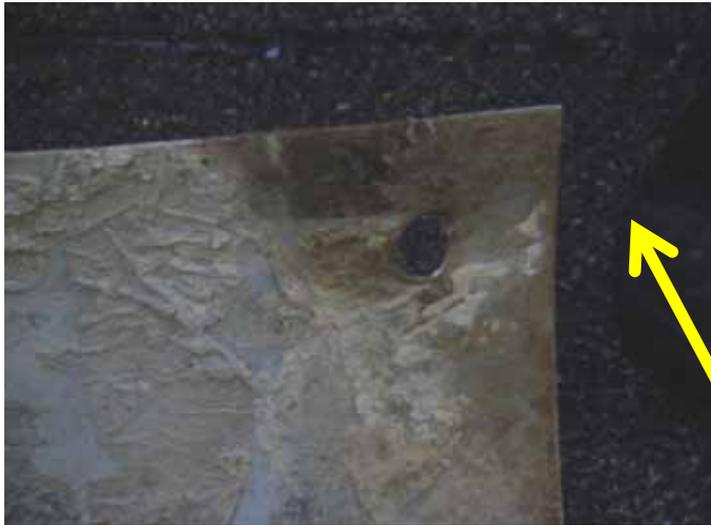
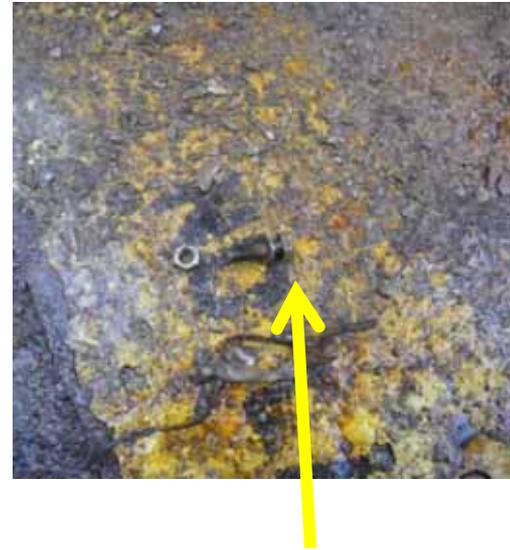
# Securing mechanism of deflector plate

Deflector  
plate secured  
by 2 bolts

- MOC and temporary equipment procedures not followed when equipment installed initially so no inspection schedule set up for equipment. Following that, there was a modification made to the chute that did not have a securing device that was fit for purpose. The securing device of this additional modification failed and resulted in the dropped object.
- Equipment was not in use and there was no requirement for the chute to be in place.

- Remove rest of cuttings chute.
- Drilling superintendent to ensure service partner reviews method of transferring cutting to skips when blower is unavailable and informs OIM of changes and ensure new design is captured in an inspection schedule.

- Drilling superintendent to share dropped object from drilling chute incident with chute provider and ensure the vendor reviews their procedures to incorporate lessons learned from this incident.
- Senior Tool Pusher to reiterate to all crews that home made devices are unacceptable and that all procedures relating to temporary equipment and or Management of Change (MOC) should be followed. This ensures that equipment will be included in an inspection regime.
- Drill site Manager to ensure that rig down procedures include instructions for all temporary drilling equipment to be rigged down at end of drilling campaign.
