Preventing Dropped Objects – Introduction of the KCAD Maintenance to Operations Handover Certificate

**KEVIN POPE**

5th December 2019

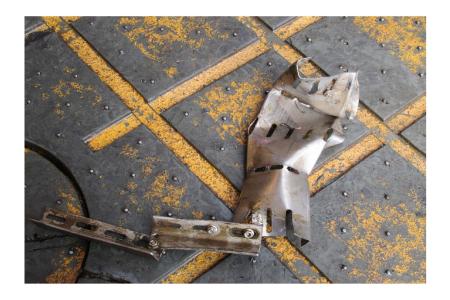
Weight of parted cable tray = 1.1kg

Height = 27 metres

The dropped piece of cable tray weighting approximately 1.1 kg.

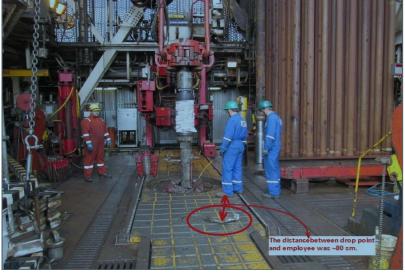
This photograph shows the position of personnel on the drill floor at the time of the incident, highlighting the dropped object potential.

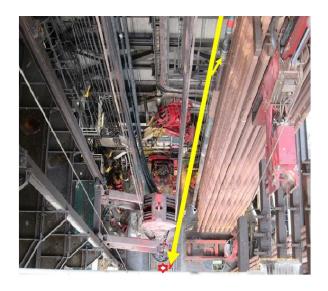
View from derrick giving approximate path cable tray fell to the rig floor.

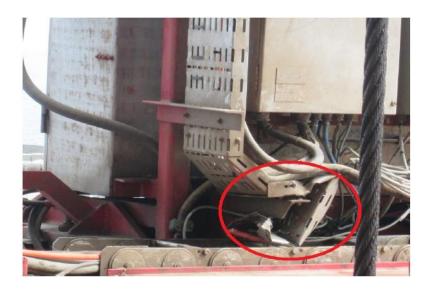
The damaged East West cable tray above the Drag Chain.

Parting of the camera cable pulled the cable tray down, leaving insufficient clearance in between the cable tray and the hydraulic pipe work on West side of the Bridge Racking Crane (BRC) travel path resulting in the BRC cable tray making contact with the hydraulic piping support bracket causing damage to cable tray

- 2. Review all OEM BRC cable tray installation and supports against as built drawings. The cable tray is required to have a minimum of 2 supports with one being at the end of the cable tray run.

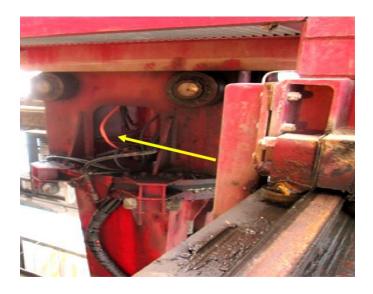
The routing of this rig's camera cable is on the outside of the hydraulic swivel head.

- Cable tray was not repaired correctly after the camera cable was damaged on the 2<sup>nd</sup> July
- The camera cable which was installed previously was too short. No camera cable
  installation work scope assessment was carried out. The position of the BRC at the
  time of installing the camera cable was facing east requiring the cable to turn/travel
  180 degrees when going west.

- 11. Complete review of BRC drop object protection.
- 12. Contact SKN and establish procedure and policy on the use of steel cable ties
- 13. Obtain wiring diagrams if available for the cable routing of the BRC camera cable

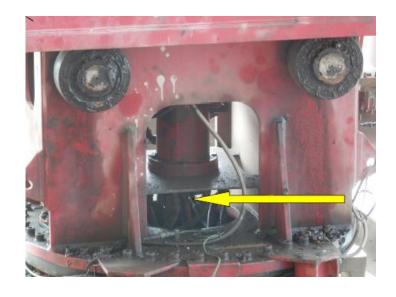
A N other Rig - Camera cable is routed through the centre of the hydraulic swivel head (correct method).

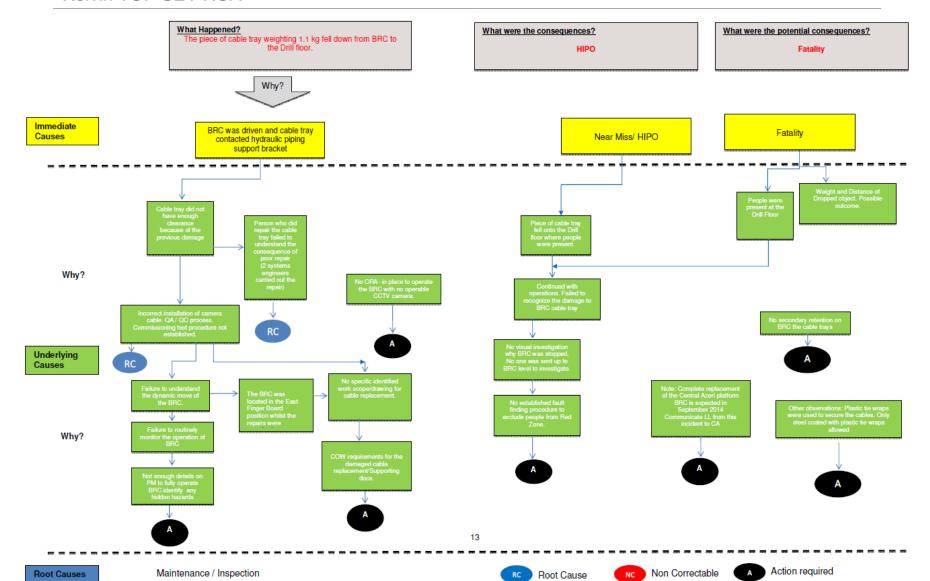
#### Kelvin TOP SET RCA

#### **Maintenance / Inspection:**

When the camera cable parted on 2<sup>nd</sup> July and attempts to repair the cable tray were made there was a failure to:

- Understand the consequence of the poor repair 2<sup>nd</sup> July. Equipment put back in service with no clearance of the cable tray and hydraulic pipe clamps on West side of the BRC travel path
- 2. Commissioning back to service procedure not established resulting in BRC returned to operation with incorrectly routed cable.
