# Dynamic Dropped Objects

and Offshore Helicopter Operations

# The scenario

## Helicopter approach to support vessel helideck

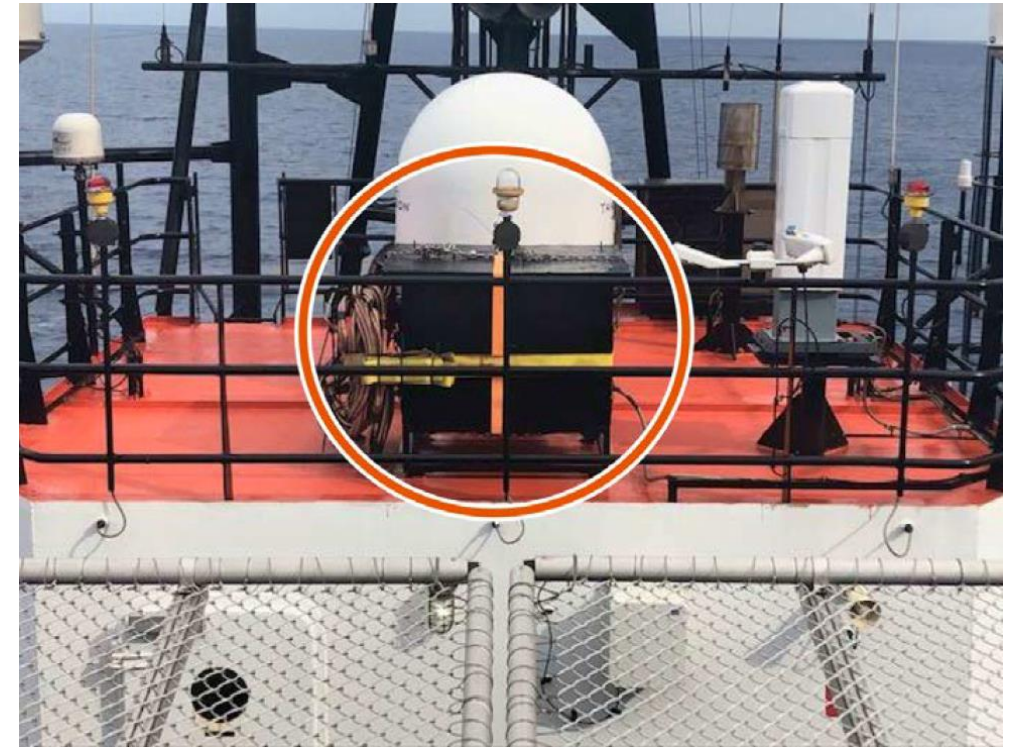
Helicopter restarter kit located in a box positioned on the monkey island, located aft of the helideck and not part of the helideck structure.

Lid of the restarter kit normally secured by a ratchet strap and four bolts. The strap had not been re-attached after routine maintenance conducted. Furthermore one of the four bolts sheared as a result of galvanic corrosion.

The downdraft of the arriving S92 dislodged the 10kg lid which was blown overboard and 75 feet below into the water.

*Figure 1: Circle indicates lid on restarter kit*

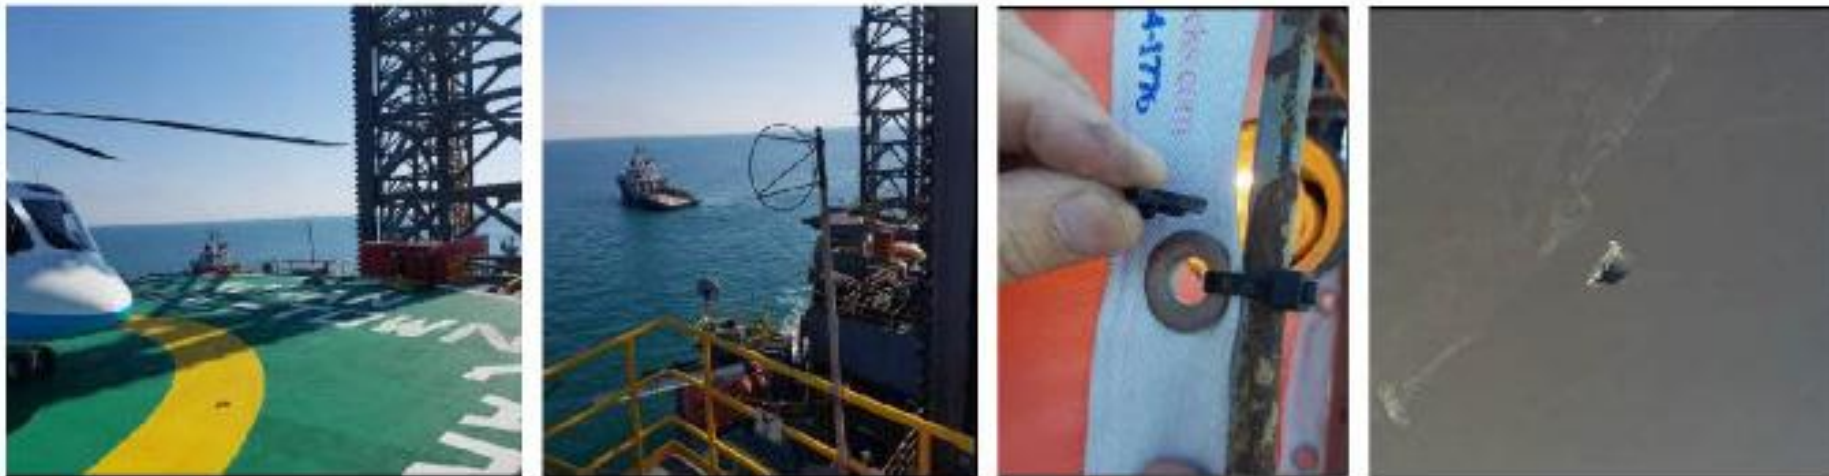
A crew change chopper landed and the windsock located to the STBD side of the helideck became dislodged from its mounting ring and was sucked into the main rotor blades of the helicopter. The pilot shut the helicopter down and inspected the blades and found one blade had suffered damages.

- The windsock was attached to the windsock pole by small black zip-ties (quantity unknown)
- The proximity of the windsock and pole may be within the Limited Obstruction Sector and not in compliance with CAP437 (requires further investigation with RM-22).
- A 'D' shaped hole was found on one of the main rotor blades. A new blade was shipped from Tanajib to the Drilling Rig by boat.
- Maintenance removed the damaged blade and installed the new blade overnight. A ground balance test was completed and found within specification.
- Aircraft flown back to Tanajib last night and arrived at 00:25am.
- Maintenance performed a track and balance on the aircraft. The aircraft was returned to service at 9:48am on November 24<sup>th</sup>.

- Send request to Drilling, Marine, and Offshore Producing Department:
  - Inspection of all windsock poles and windsocks for condition and security.
  - Replace all windsock showing any sign of wear around the attachment points.
  - Replace all windsock fasteners and all ensure that all attachment points are being utilized.

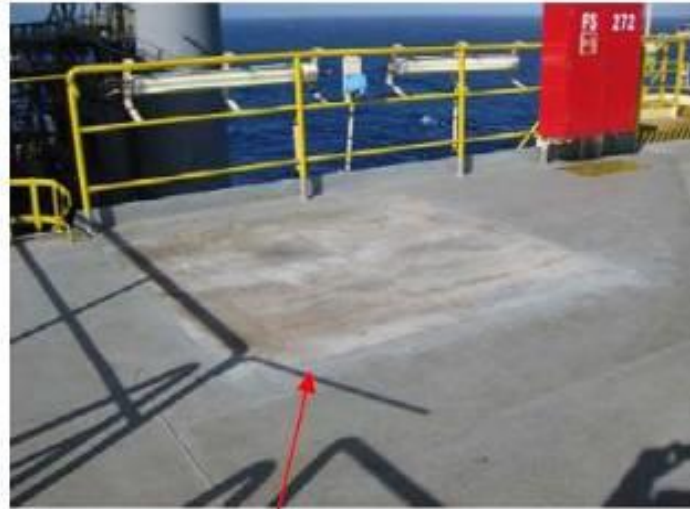
**Facts:** A Billy Pugh personnel transfer basket and fibre glass box were blown from the emergency generator roof to the main deck below. The incident occurred when a crew-change helicopter was landing on the helideck. The box and the Billy Pugh, of an estimated combined weight of 200kg fell a distance of 10.6m, with a potential of 20797 joules. The box struck the corner of a container before reaching the deck. The corner of the box was damaged, but the Billy Pugh was not. No injuries were sustained. The area on the main deck that the box landed on was not a designated walkway and the area was clear for helo ops.

The box containing the Billy Pugh had been deliberately located in position (for approx 5 months) to limit boom movement & for ease of access for previous operations prior to the rigs arrival in Australia. The box was positioned on 2" dunnage (which provided an air gap). The lid had been secured to the box, however the box was not secured to the deck. The design of the box (i.e. large surface area) contributed to it being lifted by rotor wash from the (EC225 aircraft). Significant critique had been placed on helicopter operations, in the lead-up to the first aircraft arrival. Planned inspections had been conducted by competent personnel, where the box had not been identified as a hazard.

Outline of where box was situated & final position where it came to rest

even heavy objects (more than 200 kg), or objects seemingly unlikely to be moved by helicopter downwash should be assessed as potential hazards. Re-inspect helidecks with this scope.
