HSEQ ALERT- DROPPED OBJECT

| Description of Incident | | Metal plate detached itself from the container and fell to the ground. The metal plate was 5kg in weight and approximately 350mm x 300mm | |
| Location | Quayside | Classification | Near Miss |

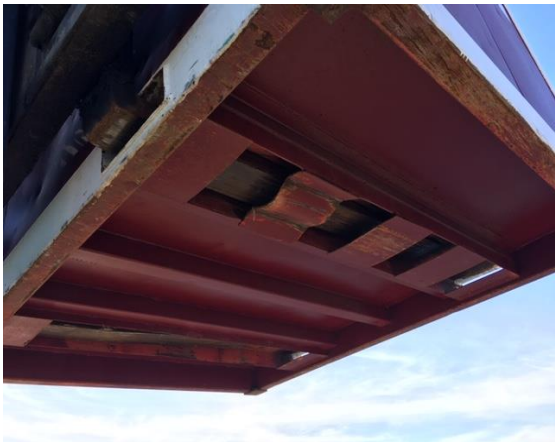
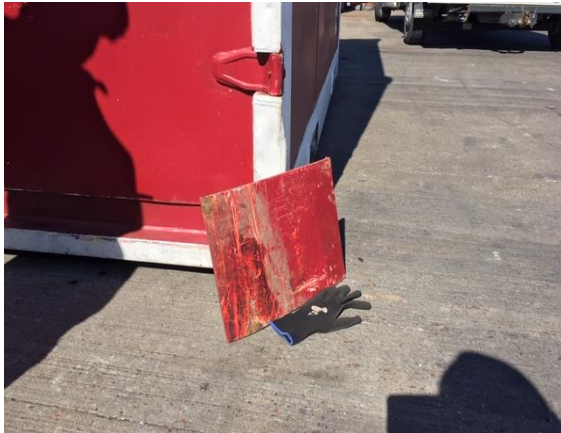
| <p>Container was mobilised to quayside on Monday 13th May 2019 for the vessel sailing to an off-shore installation.</p> <p>On loading the vessel on Tuesday the 14th of May, the Loading Team had noticed that the bottom of the container had loose debris (rust) falling to the ground and then a metal plate detached itself from the container.</p> <p>The metal plate was 5kg in weight and approximately 350mm x 300mm – a sizeable steel plate to fall from height. No persons were injured.</p> | | | |
| <ul style="list-style-type: none"> • The design of the forklift pockets in question are liable for the forks to catch, damaging them • The visual check of the underside of the container was not completed as part of the pre delivery inspection • Current 3rd party inspections do not cover the underside of containers • It was established that the metal plates were only stitch welded, which has meant over time, these will have degraded. For DNV certified containers, the plates must have full penetration seam welds | | | |

| <ul style="list-style-type: none"> • Inspect all existing forklift pockets on assets to identify designs of this kind. Those showing signs of damage or having stitch welds should be quarantined until rectified • The underside of containers should be inspected prior to dispatch. Regular inspection and maintenance programs should be implemented | | | |
