# DROPS Forum

04/09/2014

GULFMARK  
OFFSHORE

# DROPPED OBJECTS

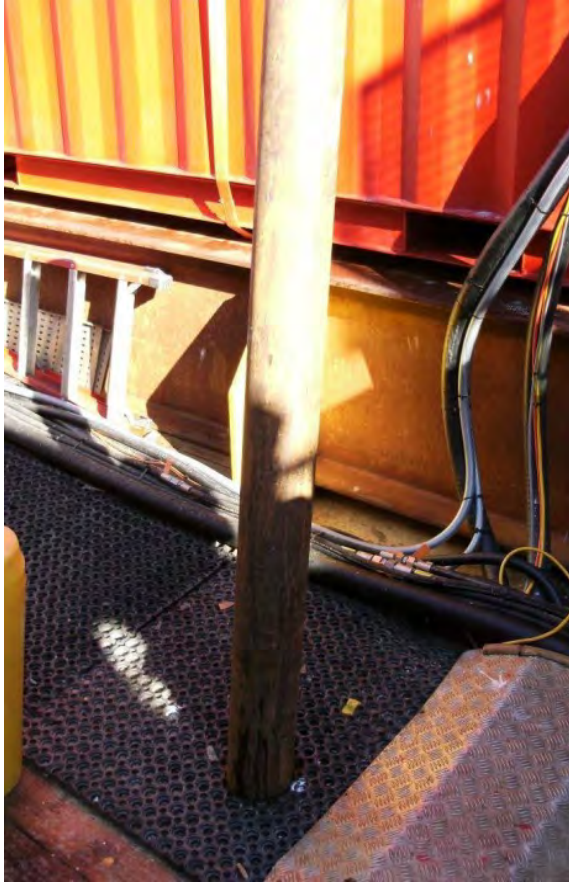
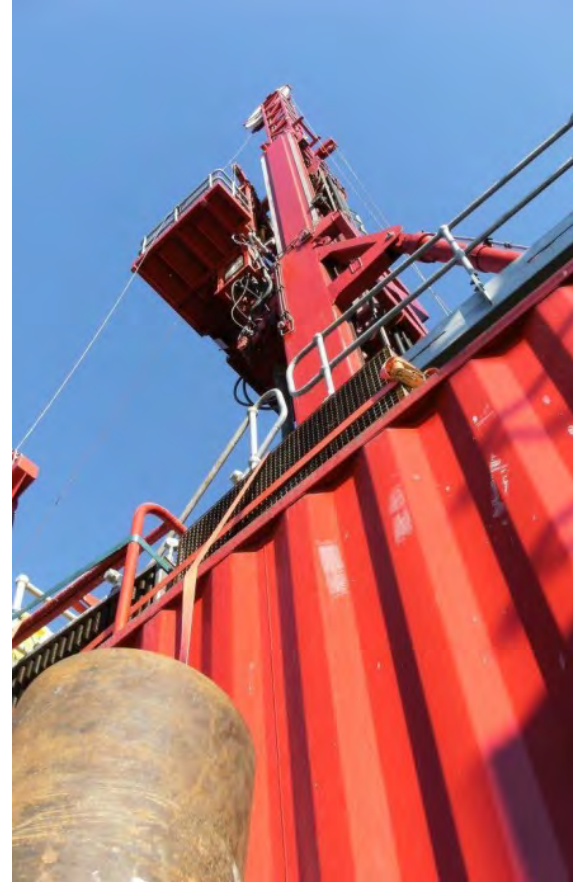
**Drill pipe dropped from Drill Mast Rooster Box impaling ship's deck**

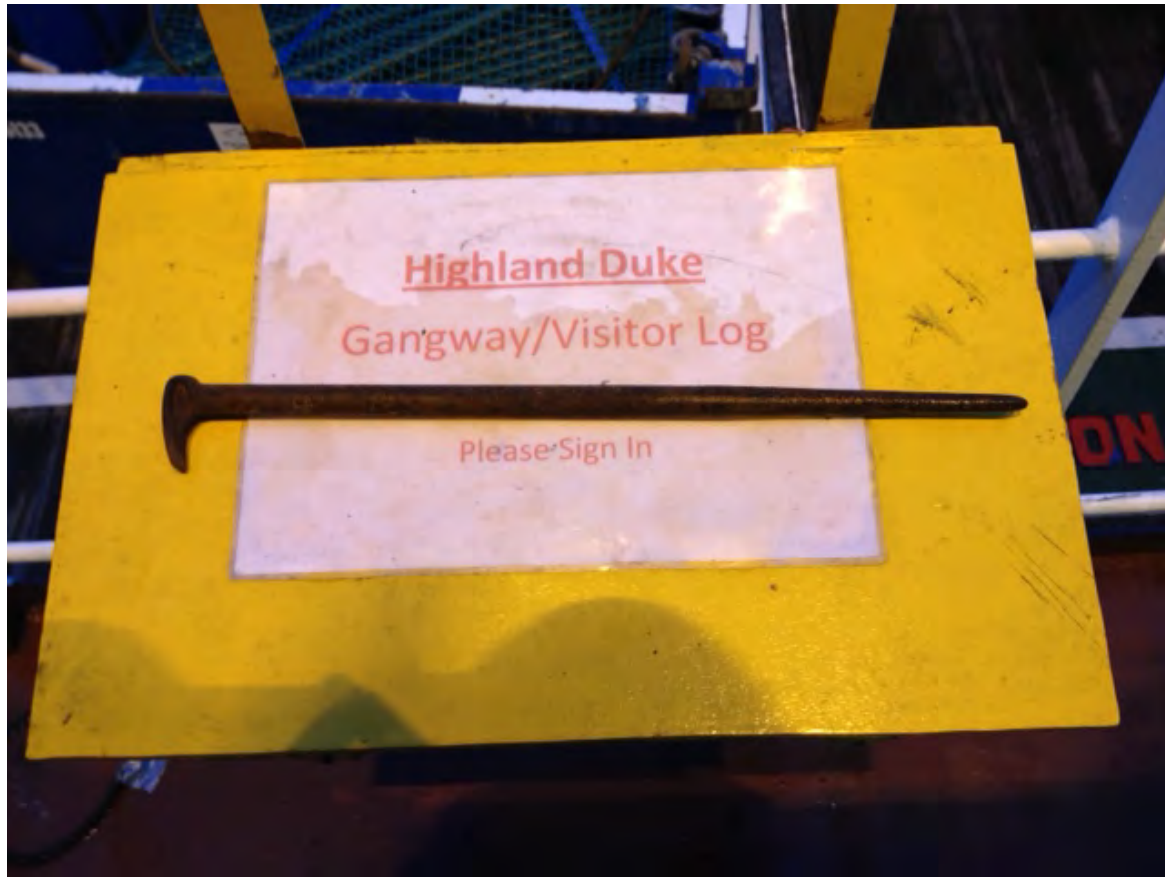
**Podger bar was recovered from top of Mud Skip**

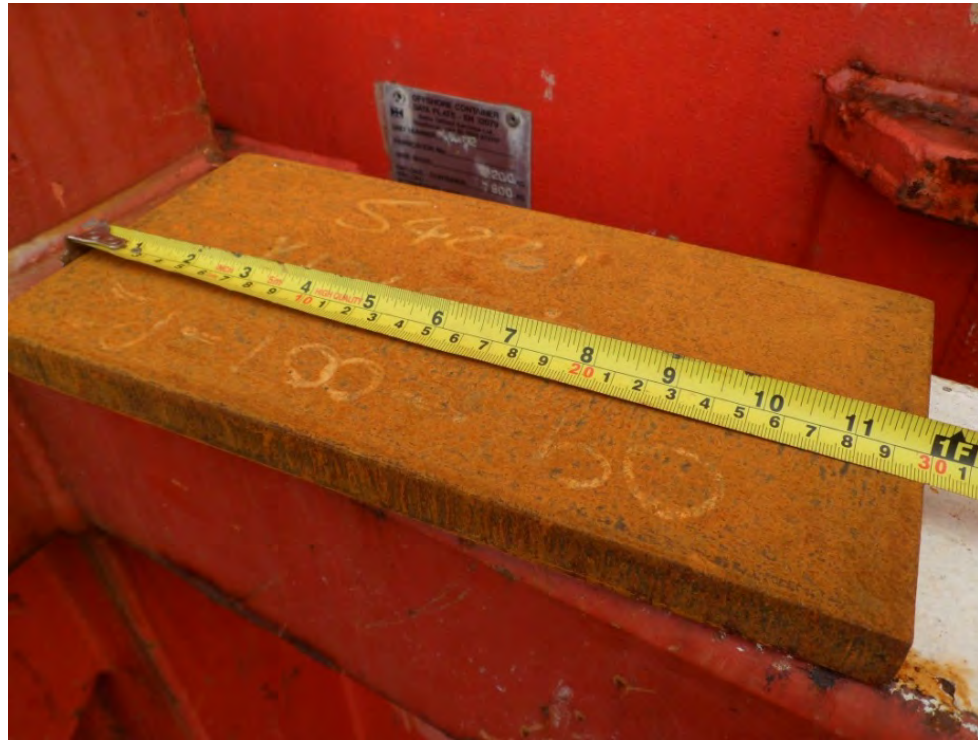
**Piece of plate steel on the top edge of a unit**

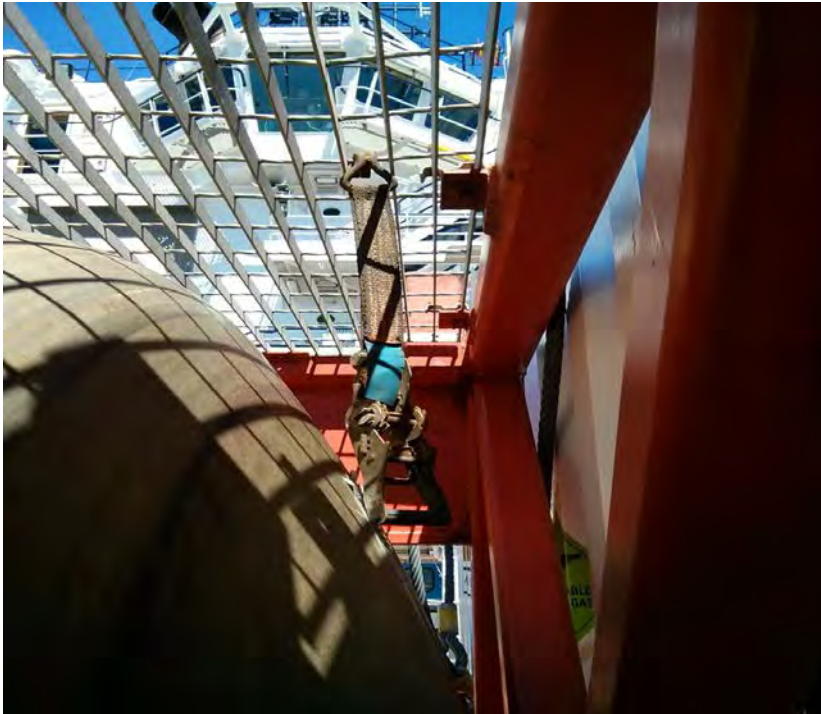
**Ratchet and strap hanging inside container from the top grating**

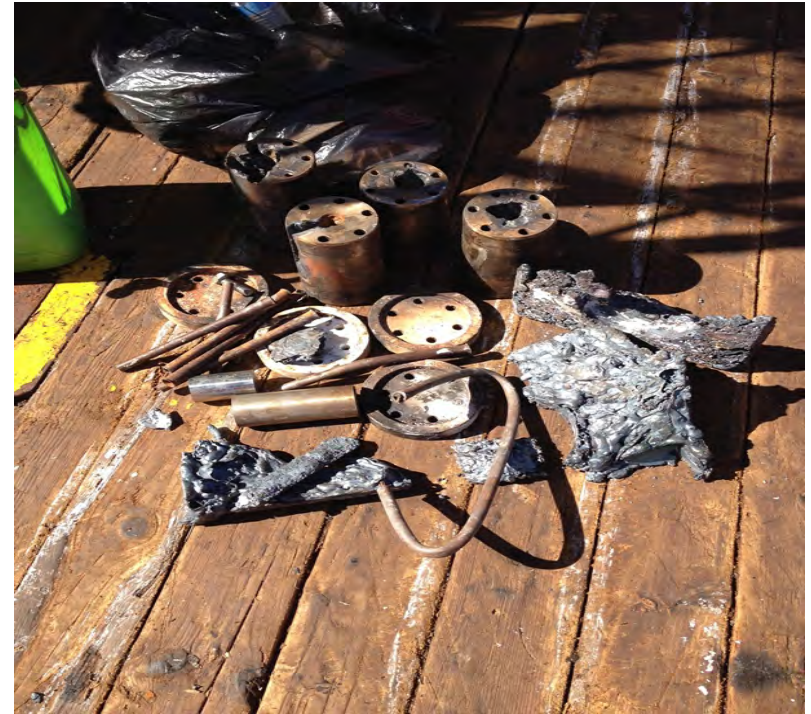
**Debris left lying atop crane after maintenance**

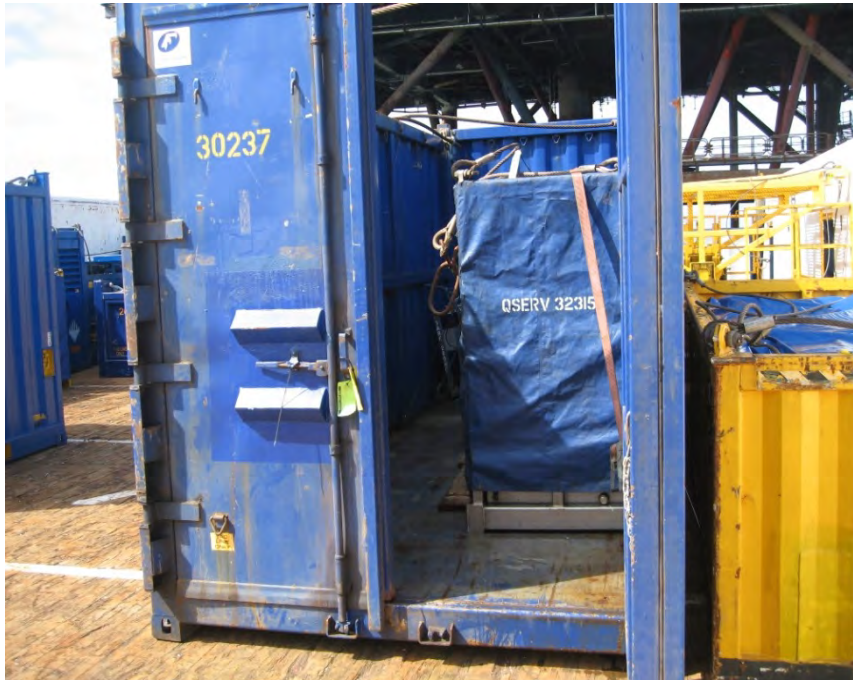
Container back loaded with doors unlocked

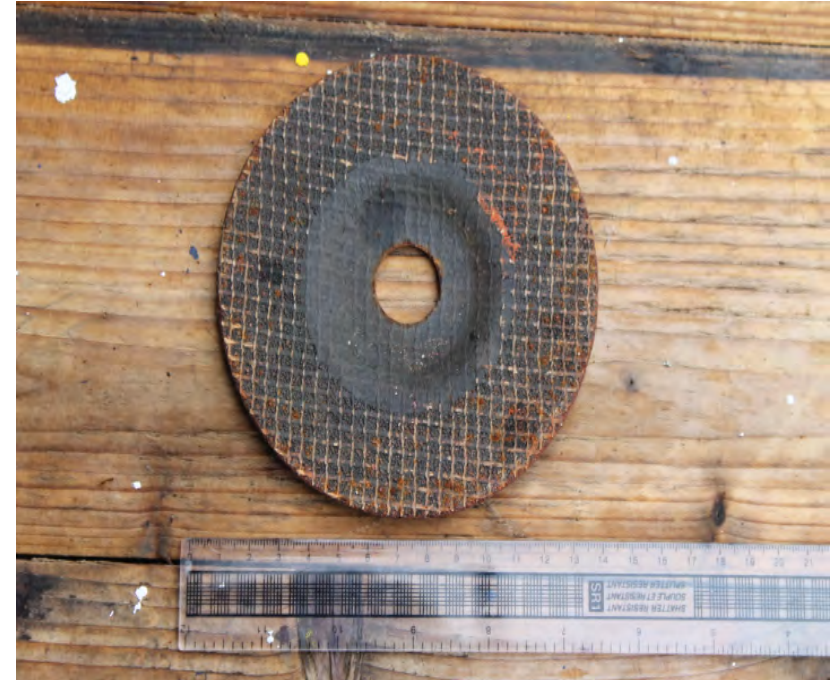
Cutting disk protruding from under the door of a 10ft half height basket
