TUBULAR HANDLING RECENT FINDINGS

PRESENTED BY:
Stewart Gillies

TUBULAR HANDLING

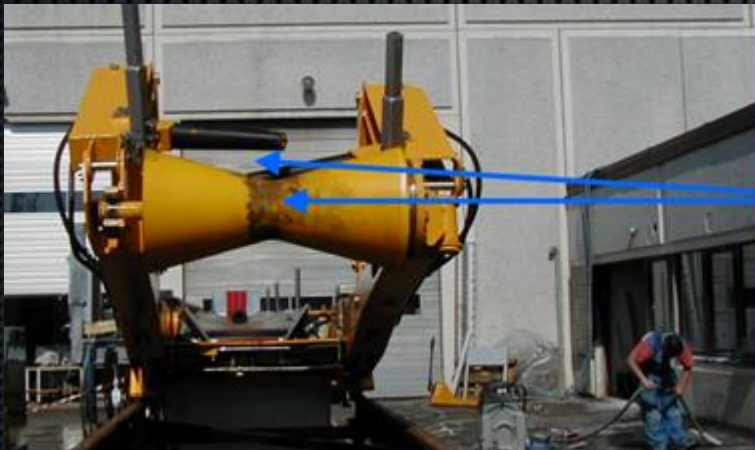
Missing parts

As Fitted on Rig
Clamp missing

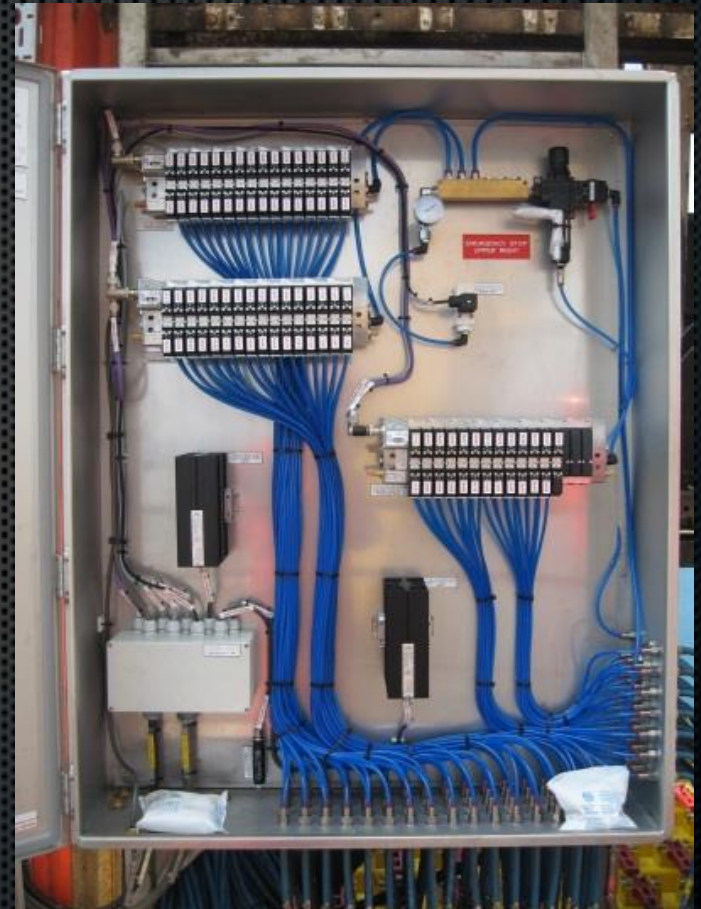
These I/O s provide feedback information to the driller that the solenoid is activated and on the drillers screen the finger appears as open. **However, this does not mean that the finger is actually open.**

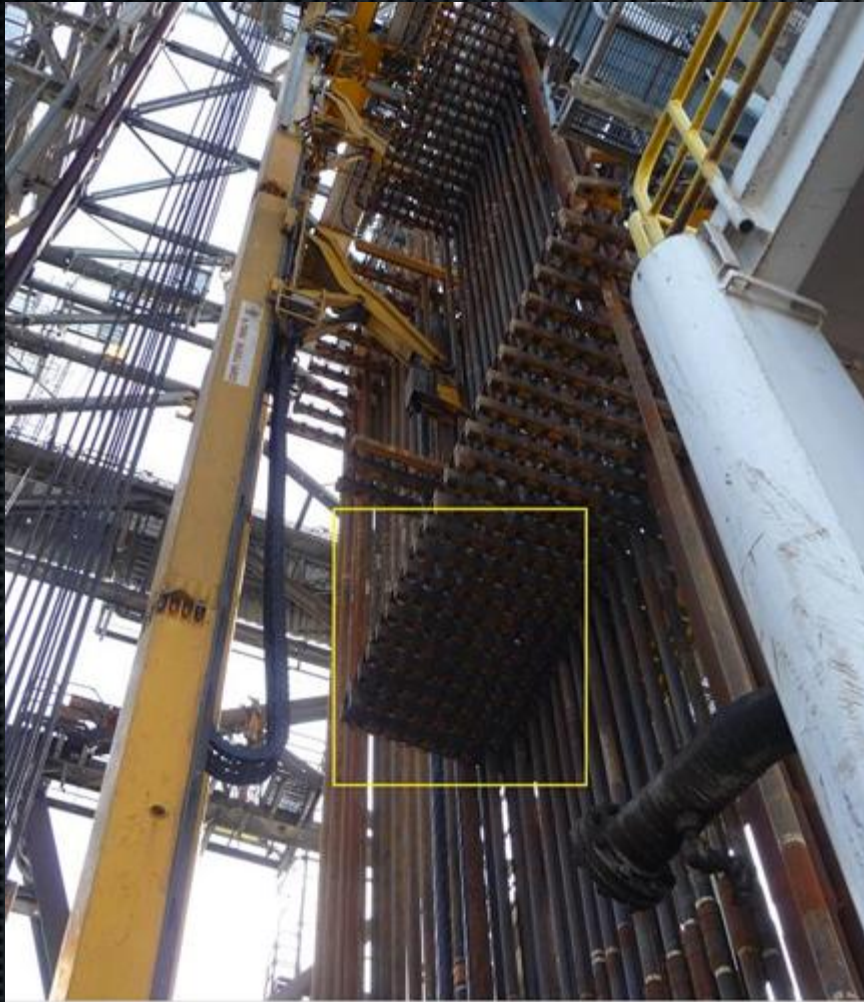
From the roughneck position outside of the Red zone, it was not possible to see the position of the fingers on areas of the fingerboards. **More than one occasion.**

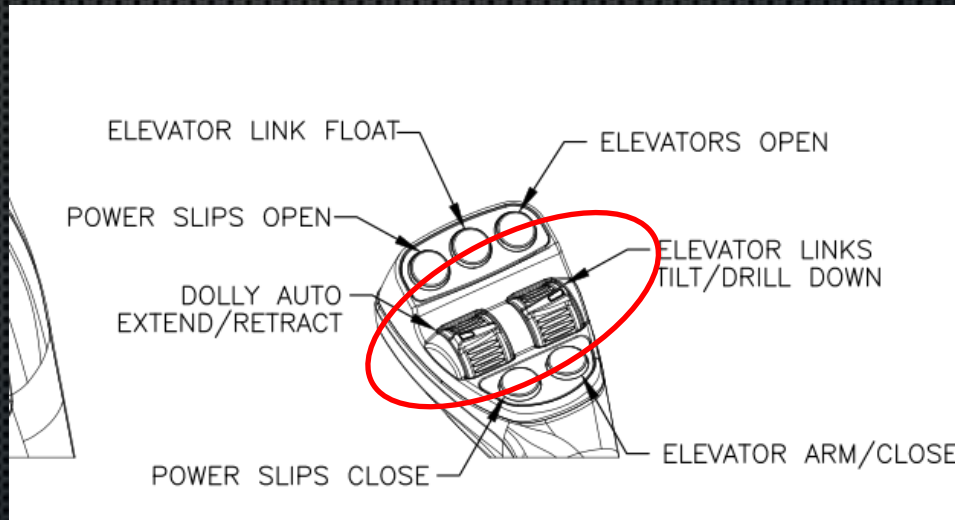
The Drillers chair Dolly Retract (Left switch) and Elevator links tilt (Right switch) were virtually identical tactile buttons placed next to each other on the right joystick.

It was considered to be very easy to inadvertently press the left switch whilst intending to press the right. Regardless of whether the Dolly was selected in Auto or Manual Mode, the Stick top switch was always active.

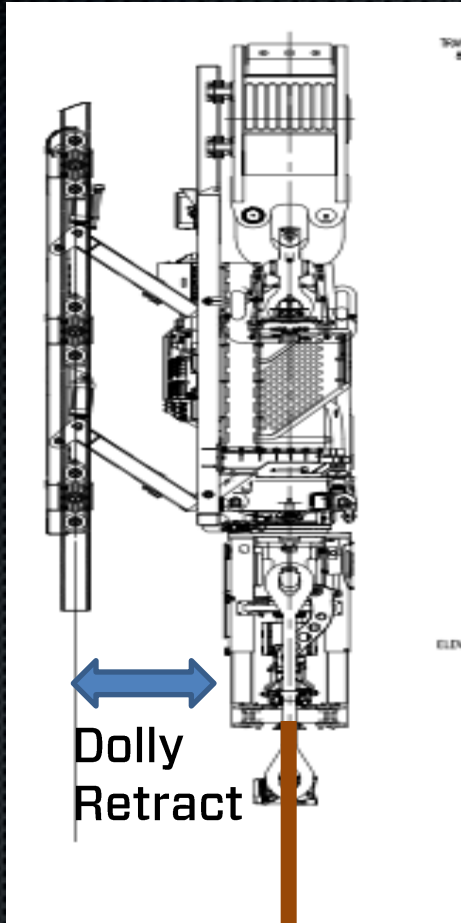
- In Auto mode the Dolly fully retracted upon activation of the switch.
- In Manual Mode the Dolly retracted only as long as the button was activated.

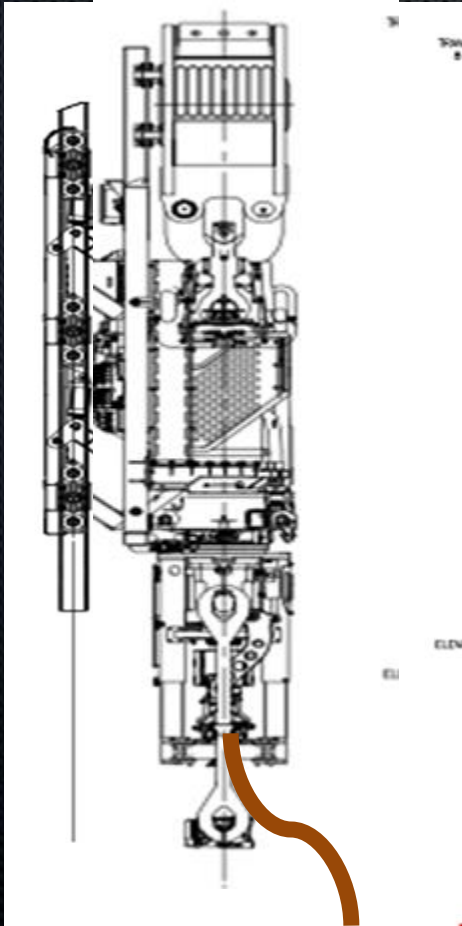
- Inadvertent dolly retraction could result in a bent drill pipe, damage to the rotary table and damage to the top drive.

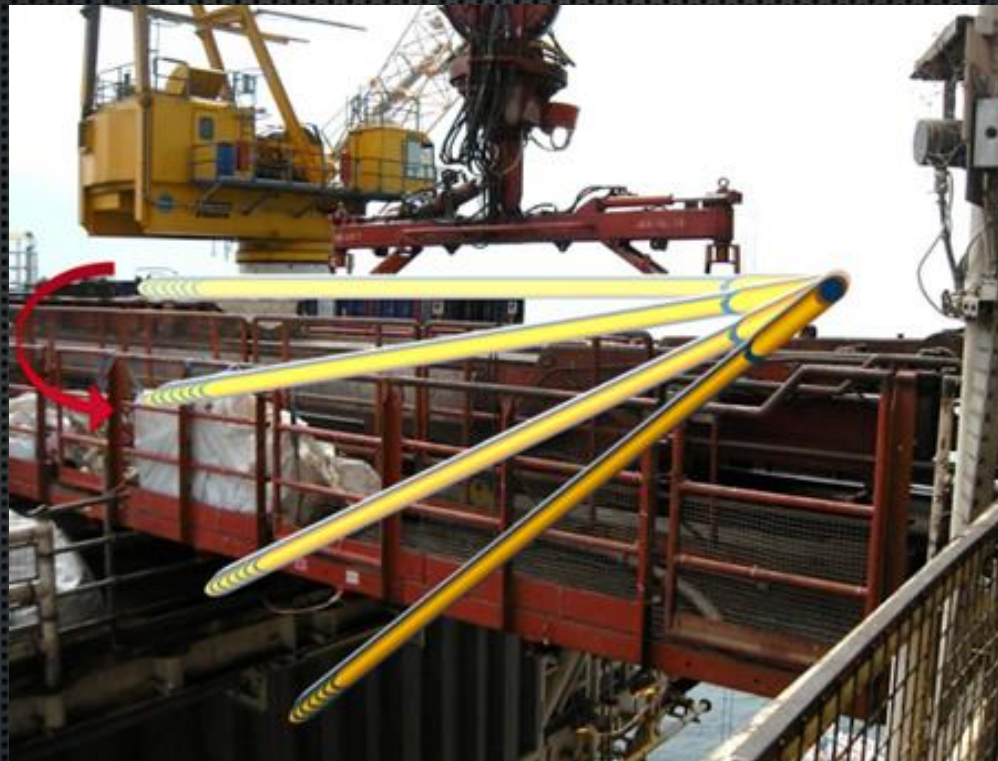
Previous incident - 5" drill pipe (HWDP) slid out of a NOV standard 20" gripper yoke.

The crane operator was using the gripper yoke with the pipe support de-activated.

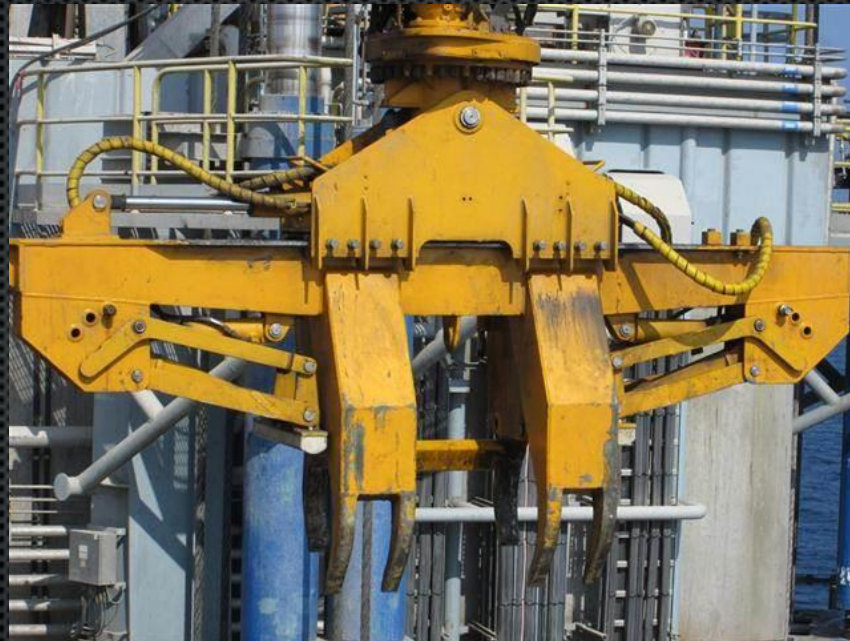
Software Update was not embodied

NOV recommended a small change in the software program for the pipe support function on the gripper yoke.

This software change would automatically activate the pipe support when the gripper claw is closed.

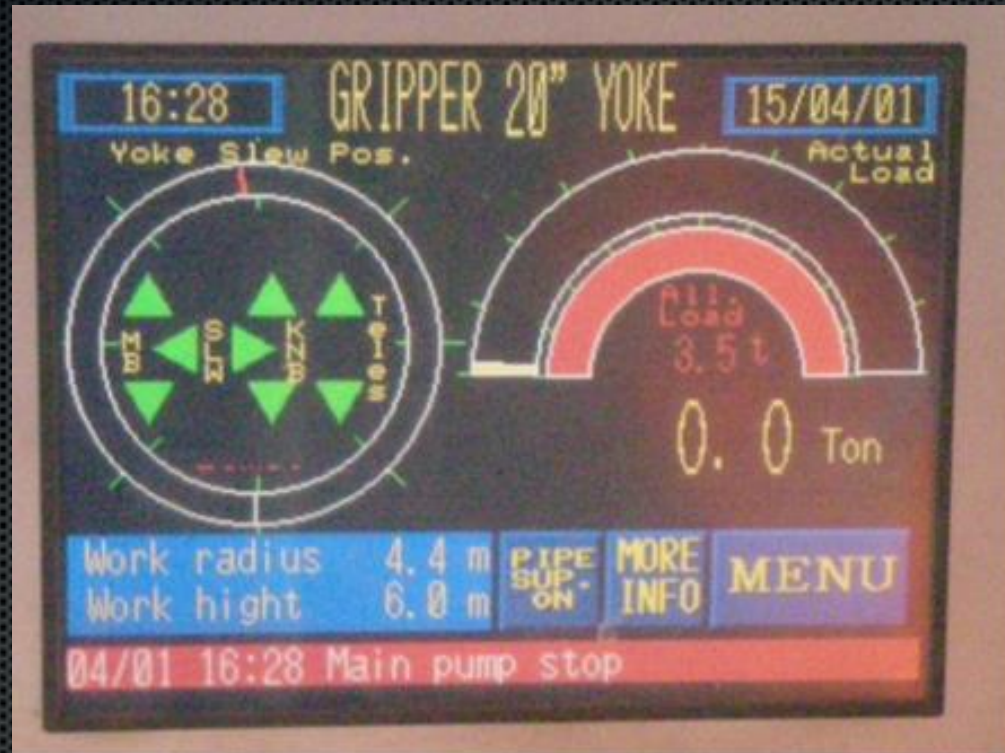
Other findings - Confusing Indications

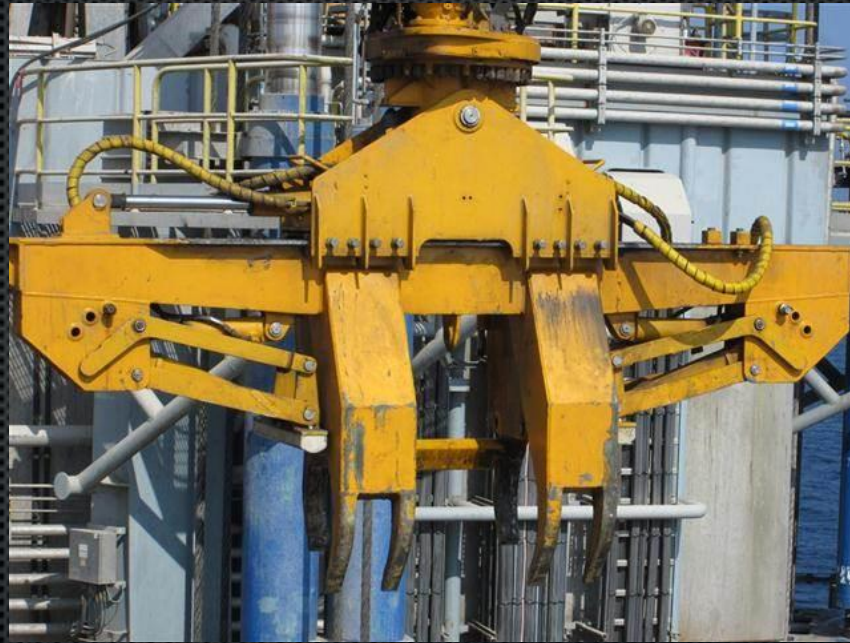
Another finding with this yoke was incorrect setting of the mechanical stop. This can cause the pipe support to be too far away for the size or number of tubulars being lifted and result in them being unsupported.
