Brent Bravo Dropped Barrel

**Incident:** Oil drum dropped during lifting operation.

**Location:** Brent Bravo

**Date:** 17/05/2010

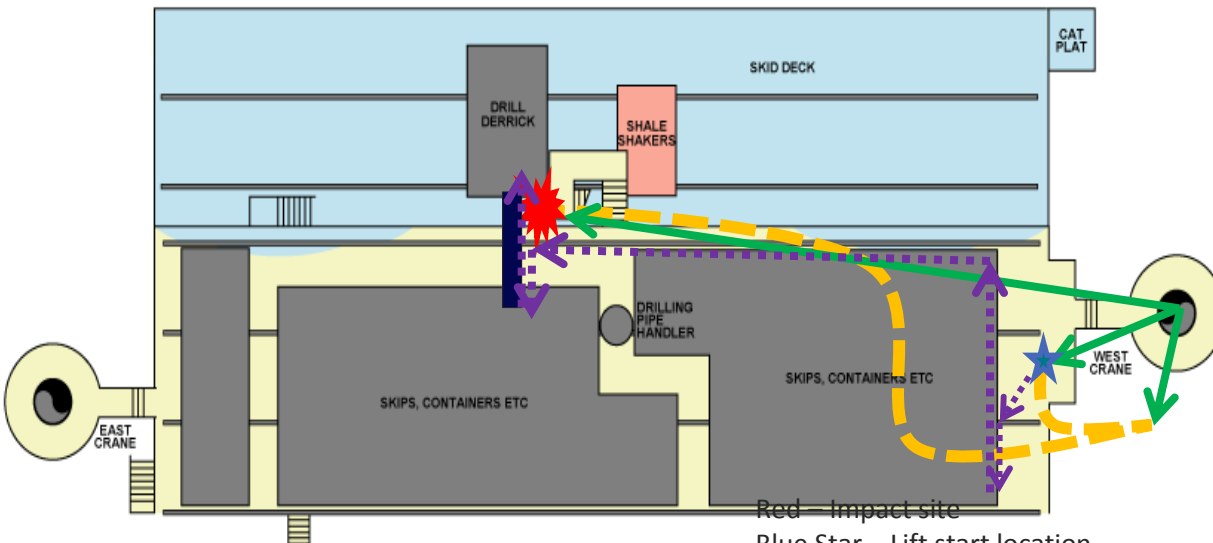
The drum was lifted on the route as shown so as the load would not pass behind the pipe handler creating a blind lift.

Red – Impact site  
Blue Star – Lift start location  
Green Line – Crane Positions  
Purple Dotted line – Route  
Personnel walked  
Orange dotted line – Projected  
crane movement path

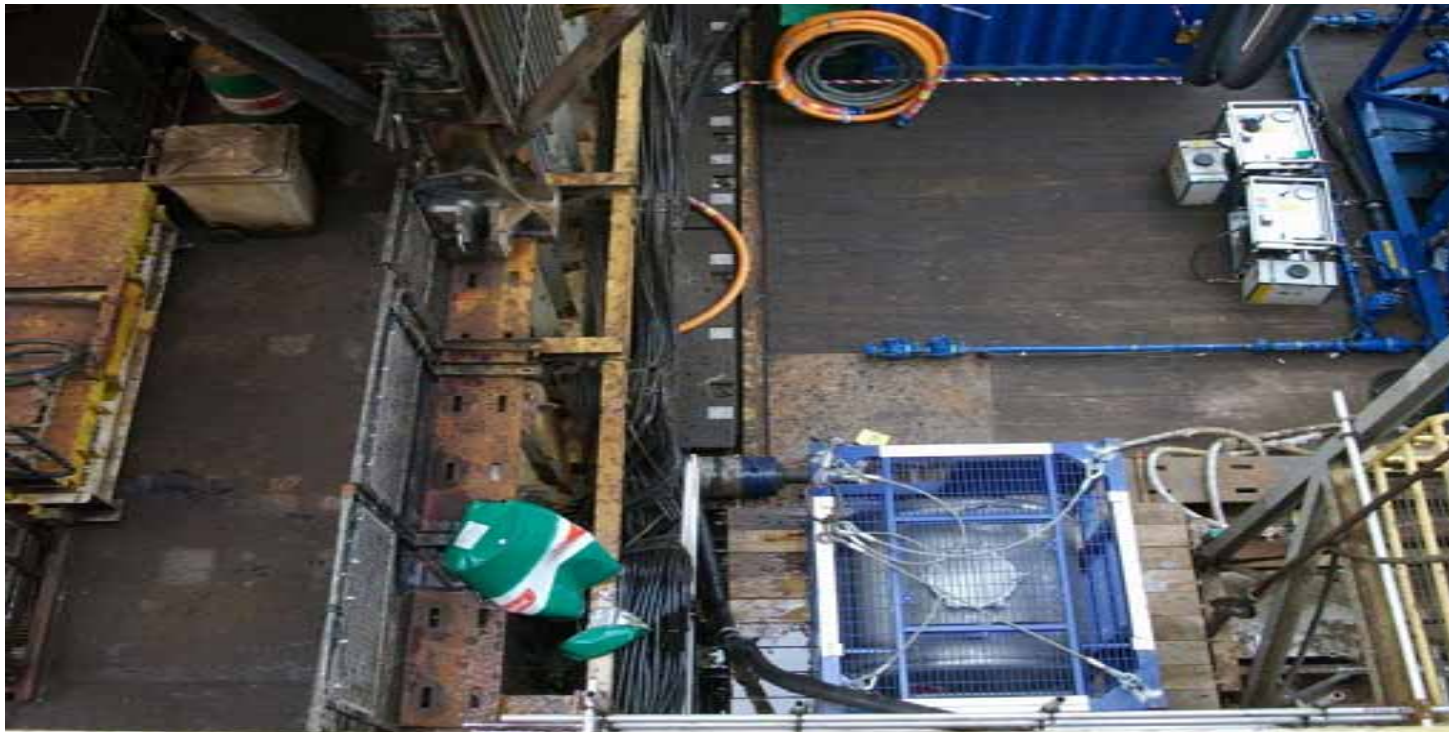
The drum fell out of the VBC as it was being boomed down to the Drill Derrick catwalk

The drum impacted on the west side skid beam of the drill rig sub-structure

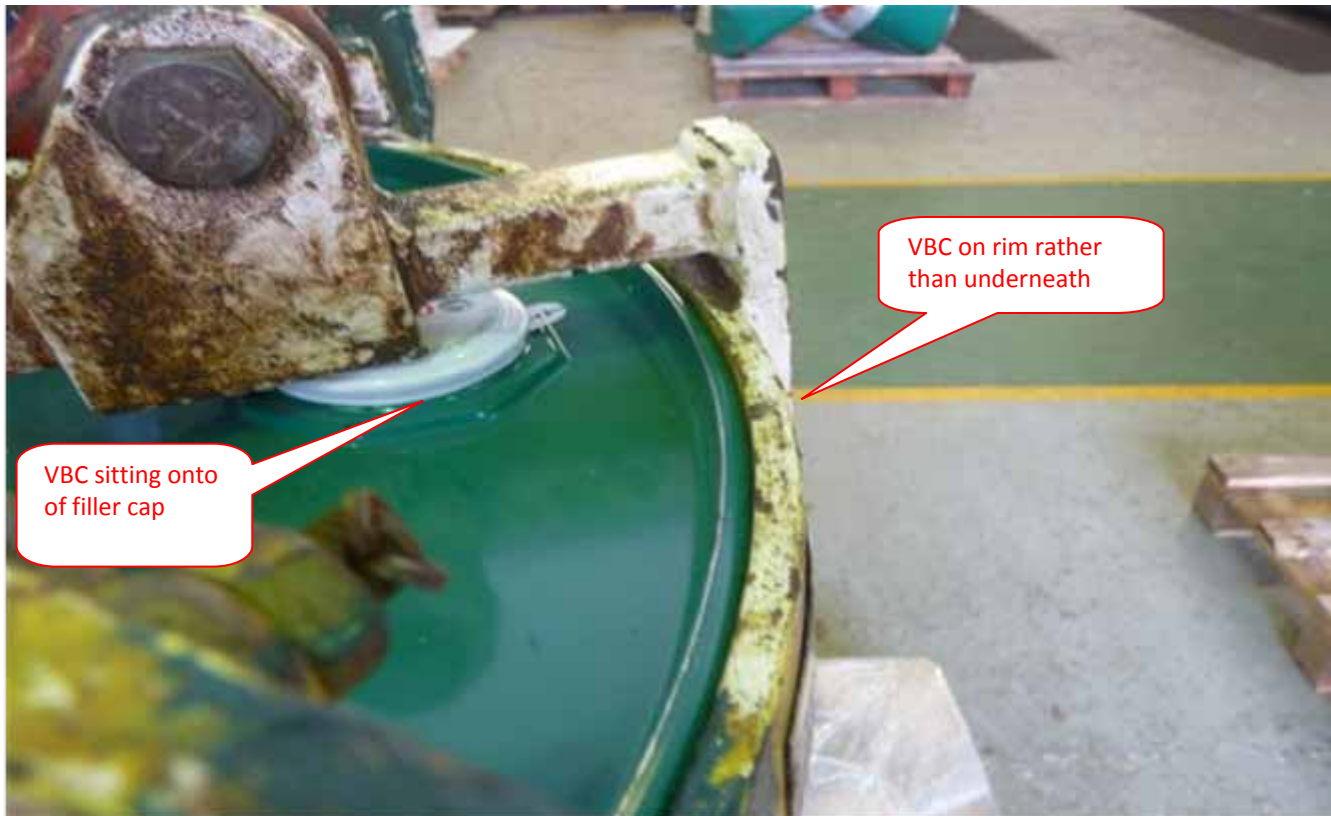
There was no mechanical failure of the VBC

The VBC was incorrectly fitted to the drum. The VBC was fitted over the top of the filler caps on the lid of the drum. This meant that both clamps could not be installed under the rims of the drum as required by the operating instructions

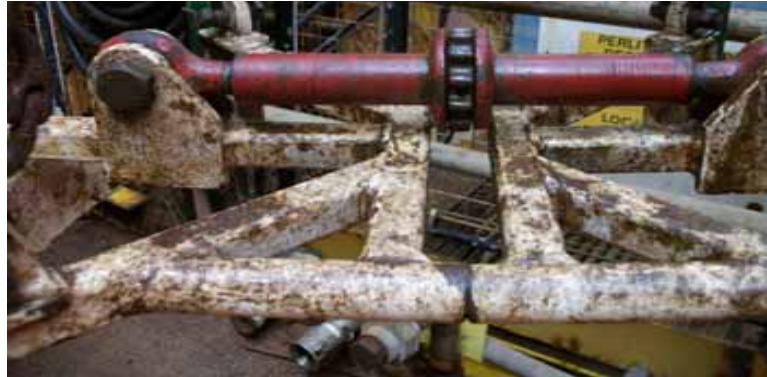
- The VBC was also found to be in the fully closed position after the VBC was removed from the crane. This showed the VBC had been over tightened.

When the fully closed position was re-created with the VBC orientated over the filler cap at the onshore test facility the drum was deformed. With the distortion of the drum, the clamps not being under the rim, the weight of the drum and the motion of the lift meant the drum worked its way free of the clamp.
