**Norway:**  
**We have a problem**

**In the Norwegian oil and gas industry;  
more than  
60 %  
of all serious  
Incidents and Accidents  
are related to DOs.**

# Examples:

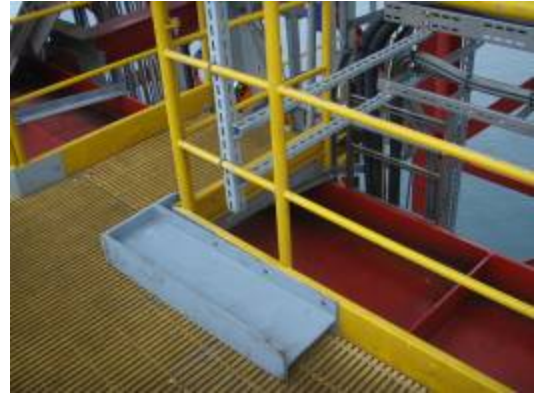
## Main/Aux Derrick Level 12

Aft walkway.

Two H-beams are left unsecured on the walkway. Approximately 1.0 m further ahead there is no toe board or swing gate. In rough sea these beam can slide and fall down to lower levels with serious consequences.

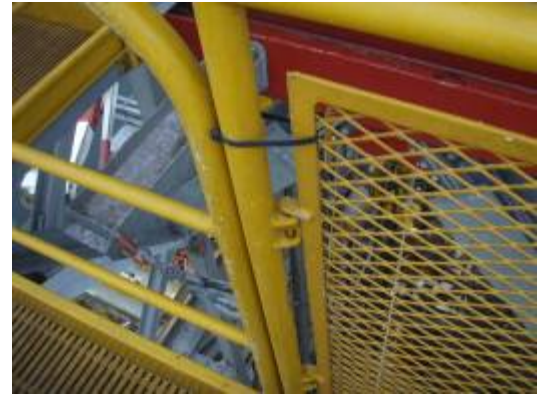
## Main/Aux Derrick Level 10

Railing by the fast line guides.

Gates for accessing the fast line guide can easily be detached as they are only secured by a wire string and a plastic tie wrap.

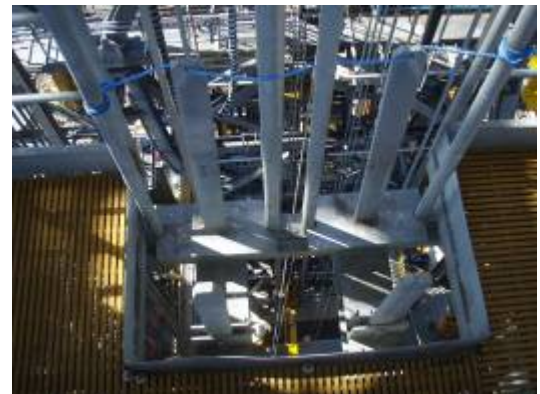
## Main/Aux Derrick Level 8

Forward walkway.

Proper barriers/railing is missing around the area where the counter weights for the rig tong shall be installed. The brackets for the weights are only secured by rope. If the brackets are tilted they can be taken right out from the support.

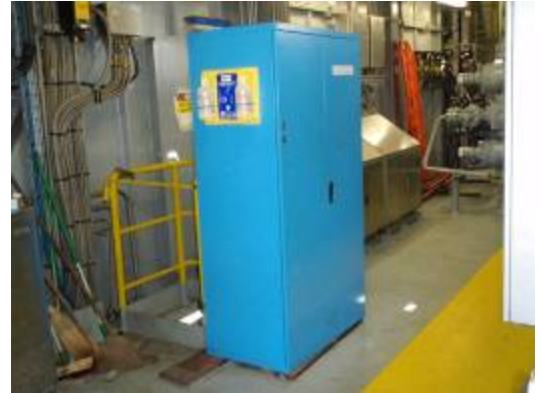
## Mail/Aux Derrick Drillfloor

4 Cabinets on the rig floor are standing loose and not sea fastened.

If in heavy sea, the cabinets can fall over.

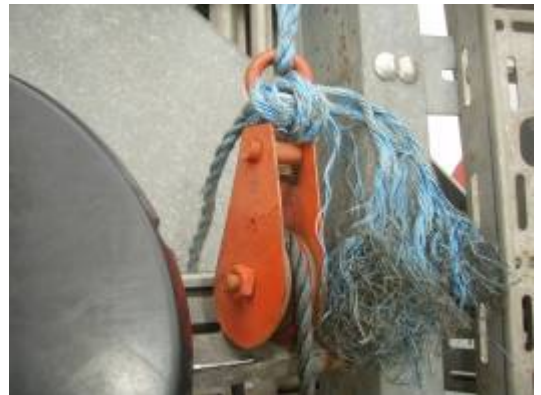
## Main/Aux Derrick General

Anti fall system in ladders.

Some places temporary system is installed and some places are left without. On the port side fwd pulley for breech block is tied up with a rope and a poor knot. If the knot comes loose the block will fall down.

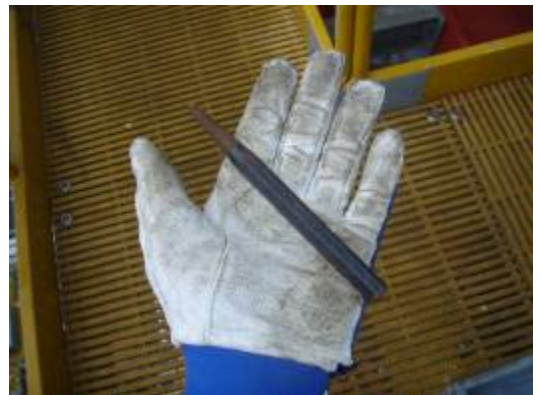
## Main Derrick Level 12

Aft side cable tray.

A centre punch tool is left lying on the top of the cable tray. If the tool drops it will fall directly to the drillfloor.

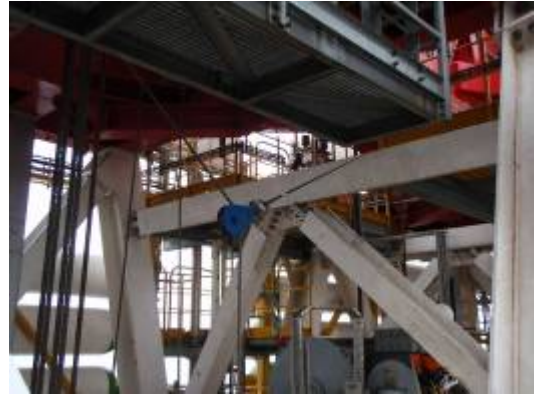
## Aux Derrick Level 14

Fwd-starboard side.

The wire holding the snatch block is damage. If the wire snaps the snatch block with the wire will fall approx. 64 meters with potentially serious consequence.

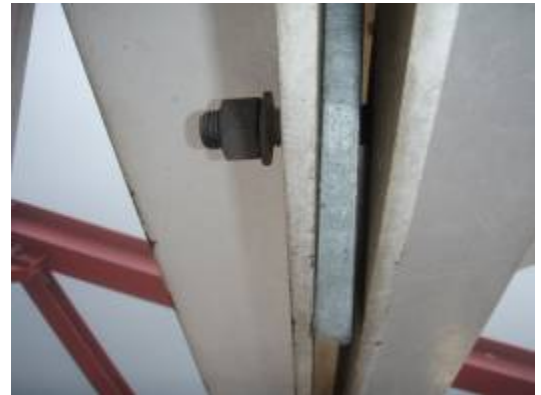
## Aux Derrick Level 12/13

Main structure, short diagonal brace starboard side aft, between level 12 and 13. Bolt and steel sheet are loose.

There is gap between the structure beams.

Bolts is now hand tightened.

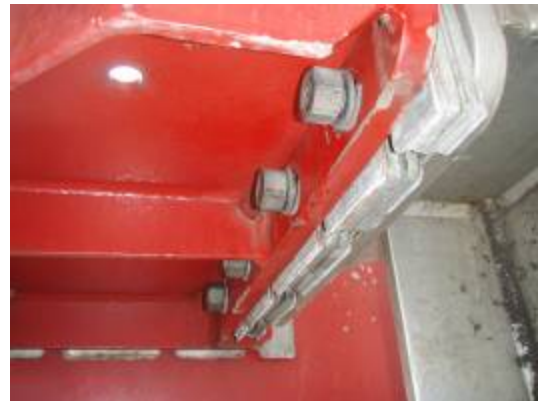
## Main Derrick Level 12, Dolly guide

Dolly Guide support structure, port side rail.

One the bottom side all 4 bolts are loose and the nuts have started backing out.

On the top side one of the bolts are missing double securing (Pal nut).
