DROPS Seminar
November 3 2011, Perth

Dropped Objects – The Regulators Perspective

Damien Cronin
Investigation Manager

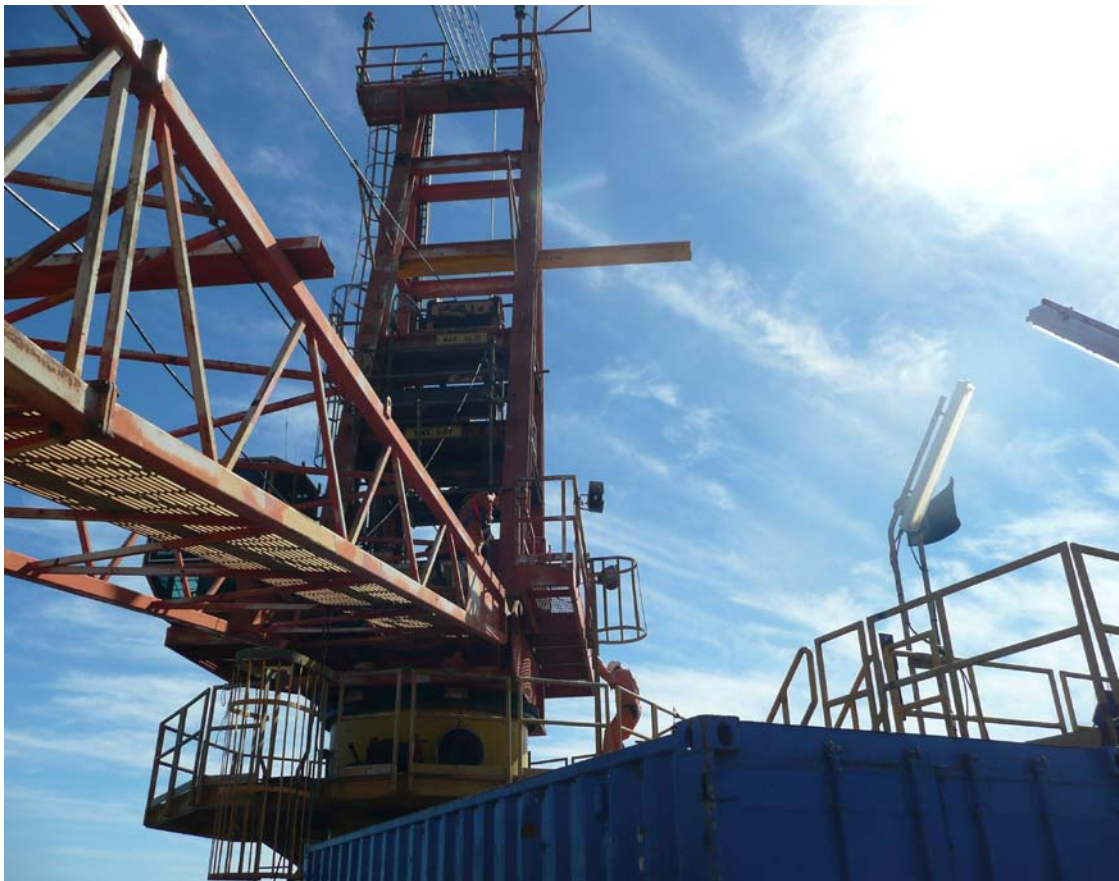
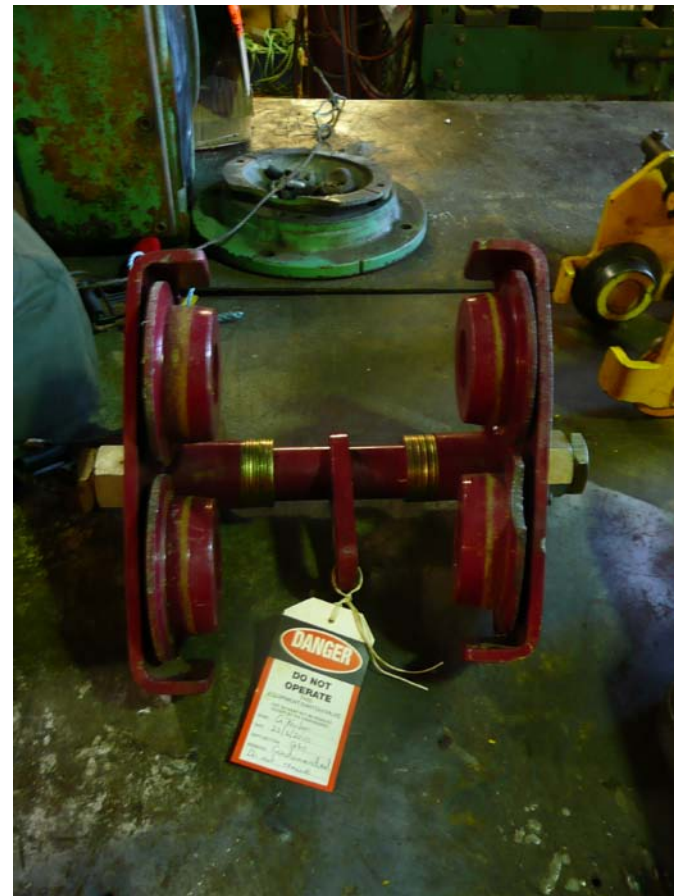
- Equipment – Wheeled Beam Trolley
- Weight – Approx. 12kg
- Height – 13 Metres to the deck
- Injury – No
- Potential - Death or Serious Injury
- Equipment Damage – Trolley Destroyed
- Production Stoppage – N/a
- Root Cause Analysis – Design Specs (problem not anticipated)

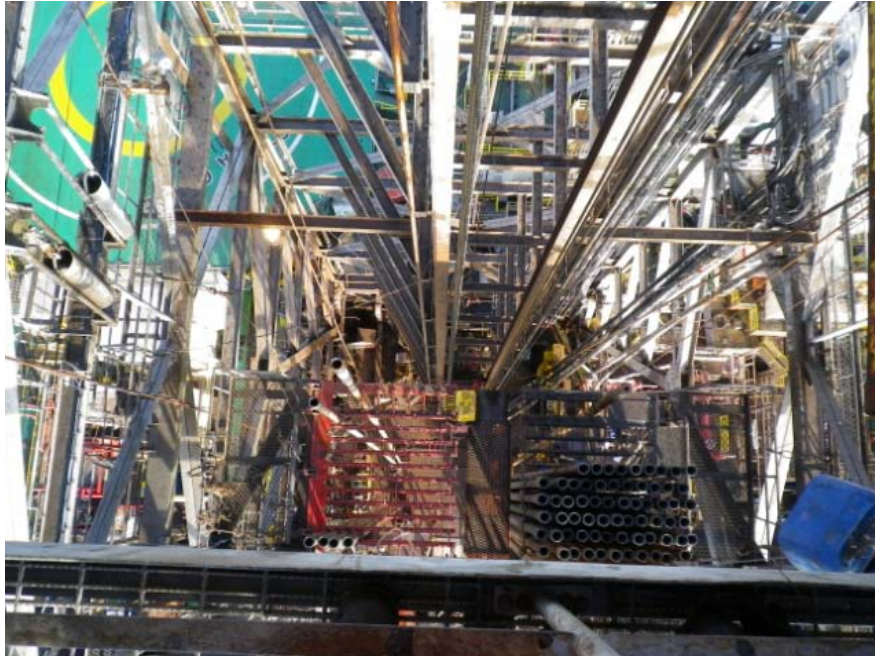
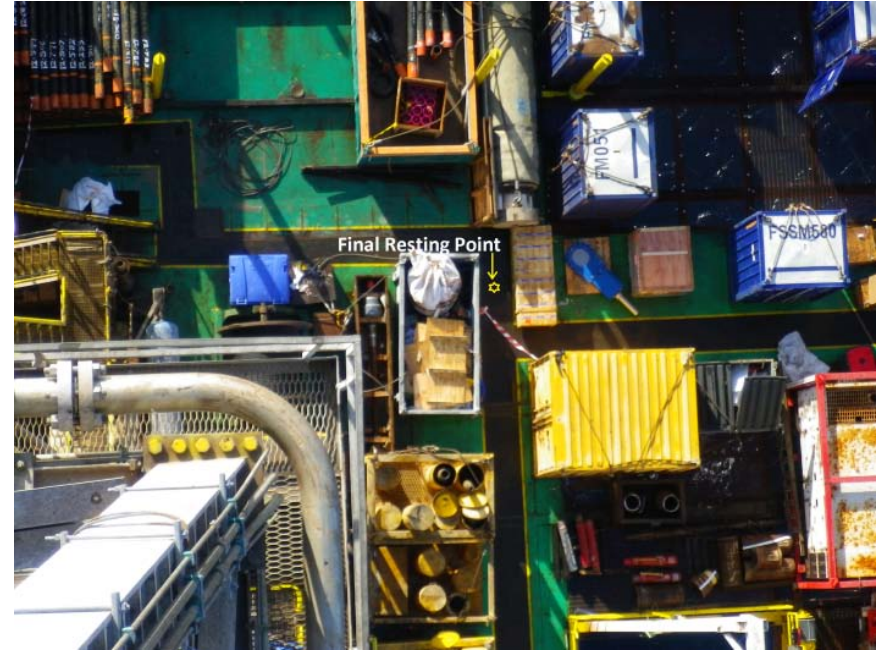
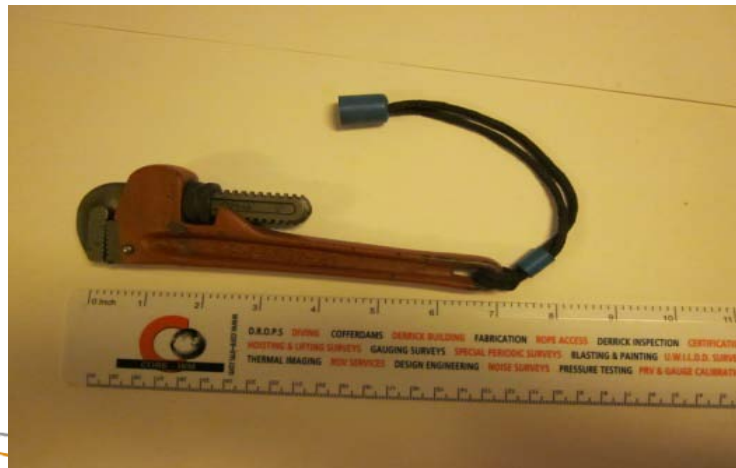
- Equipment – 8” Pipe Wrench
- Weight – 330g
- Height – 30 metres to the drill floor
- Injury - No
- Potential – Death or Serious Injury
- Equipment Damage – N/a
- Production Stoppage – N/a
- Root Cause Analysis – Preparation & Lack of Supervision during work

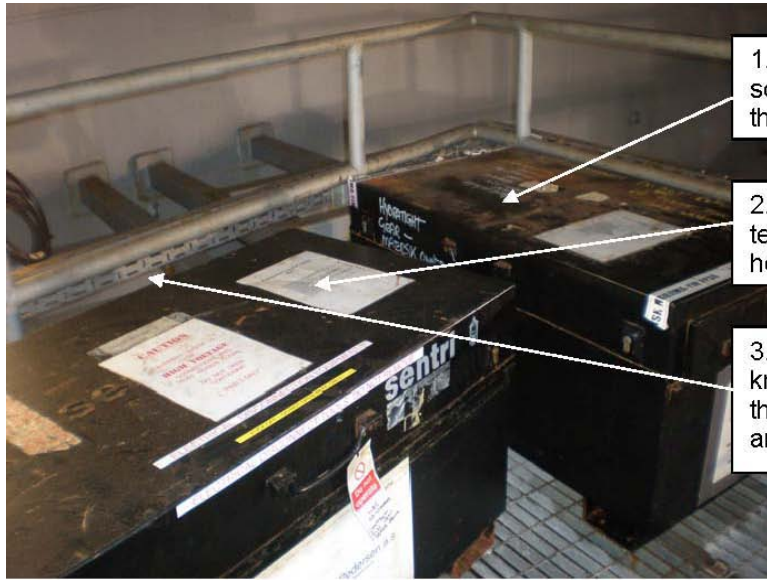
- Equipment – Pneumatic ‘rattle gun’
 - Weight – 1 kg
 - Height – 26 Metres to the bottom level of the turret space
 - Injury - No
 - Potential – Death or Serious Injury
 - Equipment Damage – Gun destroyed
 - Production Stoppage – N/a
 - Root Cause Analysis – Work Direction – lack of supervision
-

1. Rattle gun sourced from this toolbox.

2. Rattle gun temporarily placed here.

3. Rattle gun knocked through this rail opening, and fell 26m.

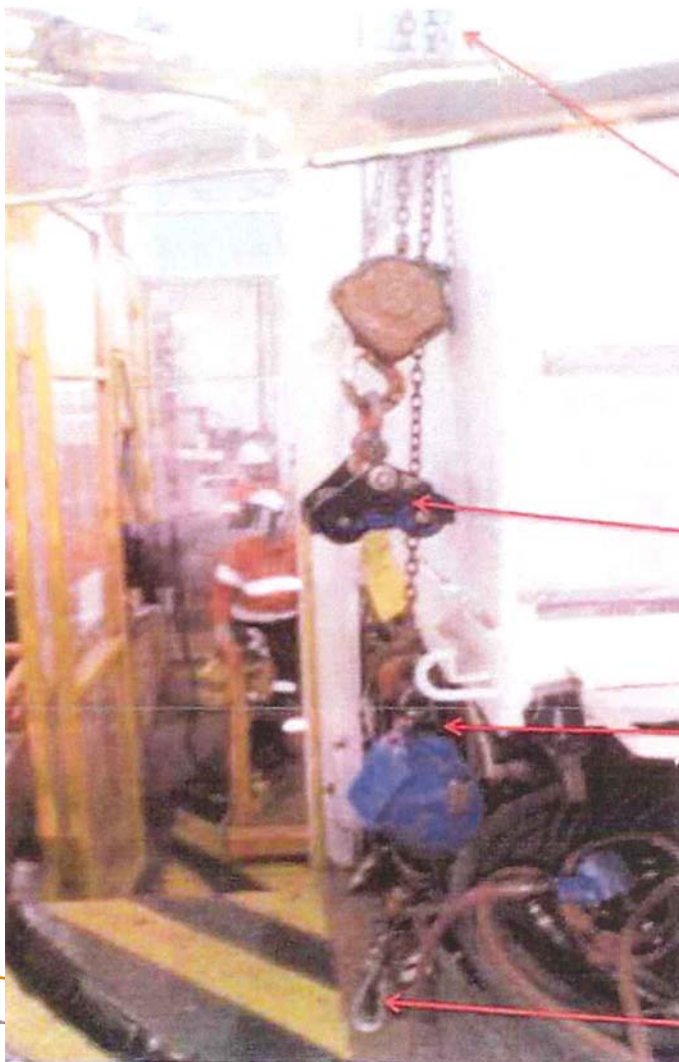
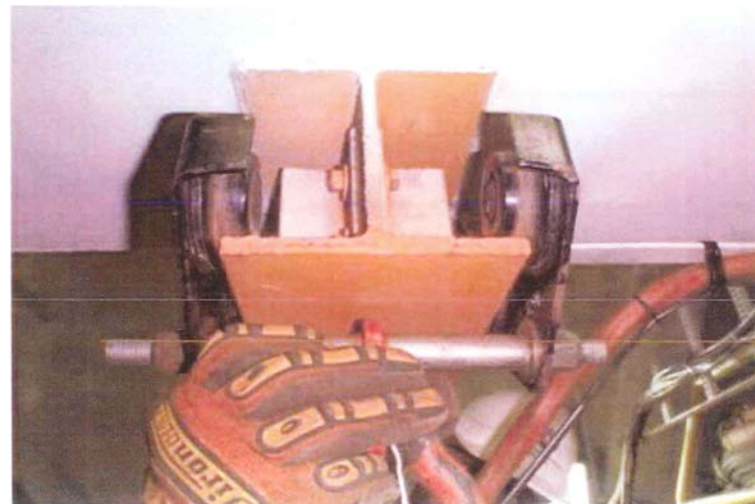
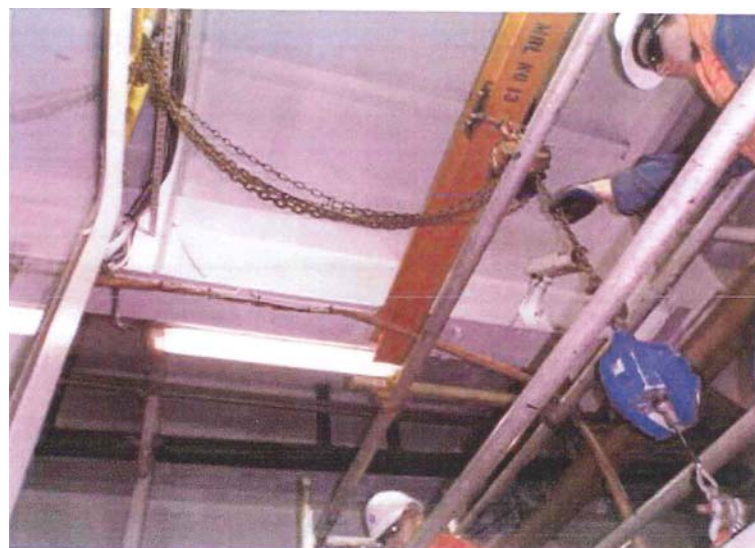
- Equipment – Wheeled Trolley Beam
 - Weight – 37 kg
 - Height – 2.2 Metres to the deck
 - Injury – Yes (Bruised shoulder)
 - Potential – Incapacitation > 3 days
 - Equipment Damage – Minor Damage
 - Production Stoppage – N/a
 - Root Cause Analysis – Design of Equipment & Procedures (no specific procedures for the task)
-
