Maersk Completer

DROPS – Incident sharing and
Awareness

Location: Maersk Completer Time: 13:25hrs 04/09/10 Title: Dropped Object

Incident: Dropped object – Metal sign dropped to Drill Floor
Synergi Case: 451625
Location: MAERSK COMPLETER, FADP-03, Brunei Darussalam
Date: 17th May 2010

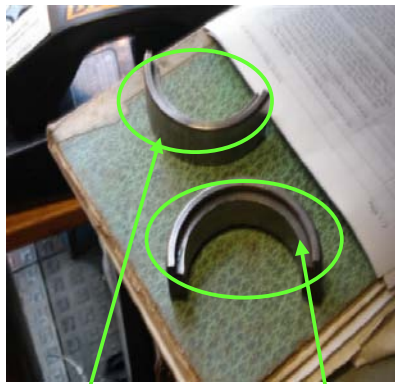
The piece of dropped bearing

After racking back a stand of drill pipes in the aft setback area a Floorhand heard something land on the Drill Floor. When investigated one half of a roller bearing from the X/Y-Racker main arm was found on deck between the X/Y-Racker and the drill pipe stands. The landing area was inside the 'Red Zone'. There were 3 people on the Rig Floor, 1 was inside the 'Step Back Safety Area', 1 was moving towards that same area after setting the manual slips, 1 had been monitoring the fingerboard and about to head for the 'Step Back Safety Area'.

Unknown at this time.
Possible mechanical stress or metal fatigue in the bearing.

Called out for TOFS immediately.
Maintenance Supervisor carried out a thorough visual inspection of the X/Y-Racker. During the inspection the other half of the bearing was found and removed from its position.

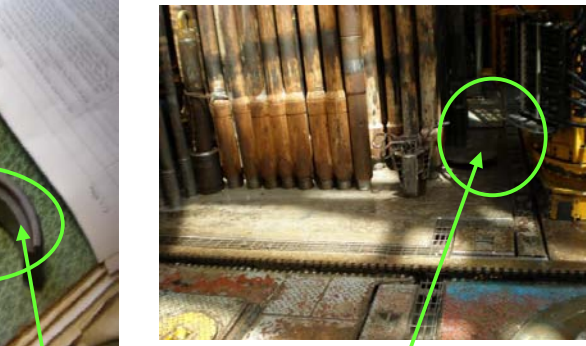
Area where bearing landed.

The piece removed from arm.

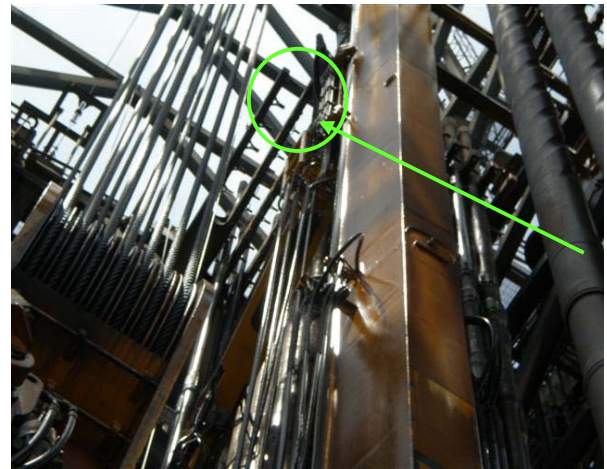
Location where bearing dropped from.

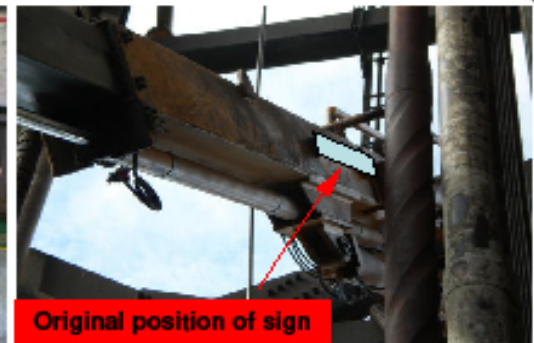
1. The energy created from the drops was 59.6 Joule.
2. The DROPS calculator classifies this as a "recordable case" – 2c
3. Sign sitting in a exposed position and likely to hit stands in aft setback area.
4. Sign had not been identified in Maersk Completer DROPS register as a potential dropped object
5. It has no functionality

Original position of sign

1. Check other Drill Floor equipment for similar signs and remove them.
2. Re-visit the need for 3rd Party review of DROPS manual on the Maersk Completer

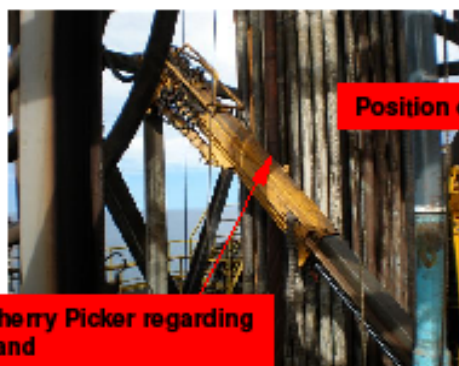
At approximately 3:20 pm, while using Cherry Picker for making up casing spear, the Cherry Picker hit a stand of 6 ¾" drill collars in the aft setback area. This caused a metal NOV sign to brake off and fall about 8 mtr to the Drill Floor inside the Red Zone. No personnel are allowed in the red zone while cherry picker is moving.

Position of Cherry Picker regarding Drill collar stand

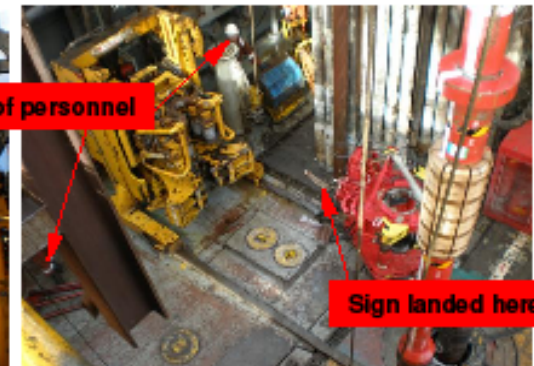
Sign landed here

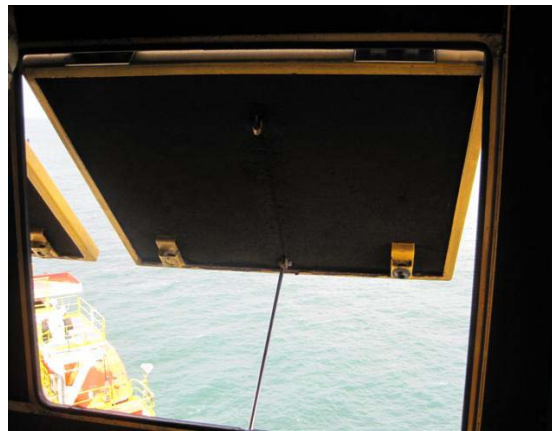
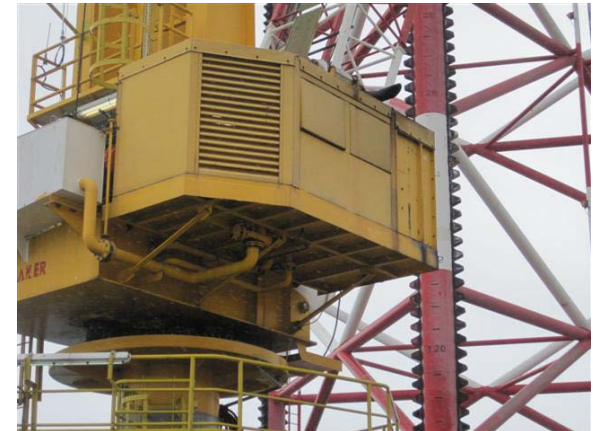
Jalil Sajai, Crane Operator noticed this after finding corrosion beginning around the hinges during an inspection. Which could, in time, lead to them become dropped objects.

The engine house ventilation flaps on the deck cranes have been fitted with secondary fall prevention after it was reported that they did not have any method.

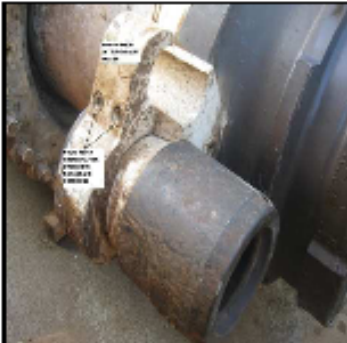
Drill Crew were in the process of recovering riser. When they came to split the Upper Flexible Joint from the spacer joint the dummy finger and box detached and dropped into the sea via the Moon Pool.

There were no personnel in the Moon Pool area at the time. On examination it would appear that at some time prior to pulling the UFJ the finger and box situated on the spacer received damage shearing the 2 Allen headed bolts.

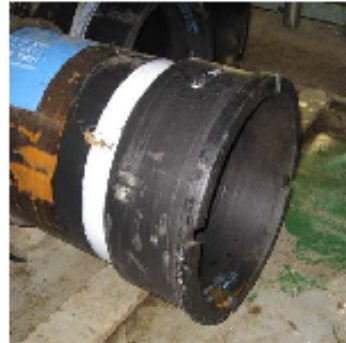
Protector fell off 24" conductor when lifted off boat deck, and a second one fell off as conductor was landed in cantilever pipe bay. Protectors weighed 9,6 kgs, one fell from 0.5 metre and other from 1.0 metre.

Protectors may not have been fully secured inside conductor box ends when loaded on to boat in town. Request better inspection from client suppliers to ensure potential dropped objects are eliminated.

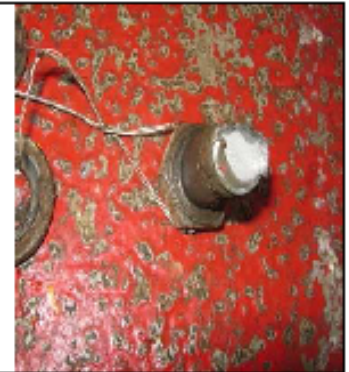
Main PTA, main arm roller foundation bolts sheared during operation and the job was stopped. PTA was supporting 20" cgs jnt. Hanging vertical in TDS elevators, when the 6 foundation bolts sheared causing the main arm to drop down 1½ ft. and hang in actuator piston.

Handling capacity of the PTA according to the manual is 36". After checking the Auxillary side bolts they also showed signs of fatigue.

Investigation showed that the bolts already had fatigue caused by constant impact / shearing force by tubular handling to and from the VPC/RPS tripping in and out as well as single jet handling.
