# Experience Transfer

<b>Subject:</b>	Dropped Objects from CTLF	<b>Date:</b>	23/01/2019
<b>Region:</b>	UKAF	<b>Revision:</b>	2
<b>Product Line:</b>	<b>Coiled Tubing and Pumping</b>	<b>Case ref:</b>	<b>14214</b>
		<b>E.T. number:</b>	<b>939</b>

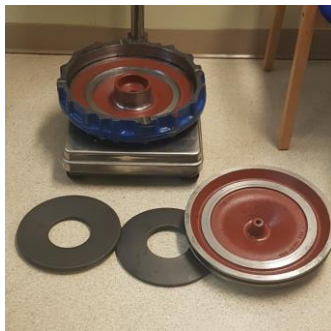
Items which fell from CTLF

- Brake housing - 27kg
- Brake piston – 17kg
- Bevelled washers – 4kg, 4kg

- The main winch brake housing failed due to hydraulic overpressure.
- In 2012 a secondary brake was installed as part of an improvement to the hydraulic winches. This secondary brake required to have a separate case drain line fitted. The 2 case drain lines were connected at the winch control panel. When connected this gave the full circuit 2 methods of overprotection.
- Each brake had its own pressure reducing valve which reduced the pressure to the brake housing by diverting flow from the valve down the case drain line
- There was no secondary overpressure protection device on the hydraulic supply to the secondary brake when the case drain hose was blocked or disconnected

- When the case drain was blocked or disconnected the full control pressure was able to build up across the reducing valve and pressure up in the brake housing
- The system design had previously been signed off by a 3<sup>rd</sup> Party company but by drawings only and not physically checked on the equipment
- The drawings did not clearly show quick connect couplings
- There was no method to confirm that the entire system had been installed correctly other than function test
- Function testing of the CTLF did not flag that the case drain line was blocked or not connected correctly due to time taken to build pressure
- There was no obvious method of alerting the operational crew that the main winch brake was experiencing overpressure
- Two of the four dropped objects were confirmed to hit the drill floor outside of the red zone in the dynamic yellow zone

- Undertake full overview and design review of hydraulic system
- Implement upgraded design complete with over pressure protection to all parts of system
- Any maintenance checklists and associated paperwork to be updated to show enhanced systems and required checks
- 3<sup>rd</sup> Party Company to undertake physical verification of new system implemented as per design
- CTLF Documentation to be updated to show enhanced protection
- Create and roll out documented verification process for checking system hook up offshore
- Drilling contractor to review Red Zone procedures with reference to the control of personnel in the dynamic Yellow Zone
- Safety alert with finding and actions to be created and circulated to Industry bodies and relevant stakeholders
