Gulf Offshore N.S. Ltd

DROPS Forum 28th Feb 2013

Potential Dropped Objects Summary

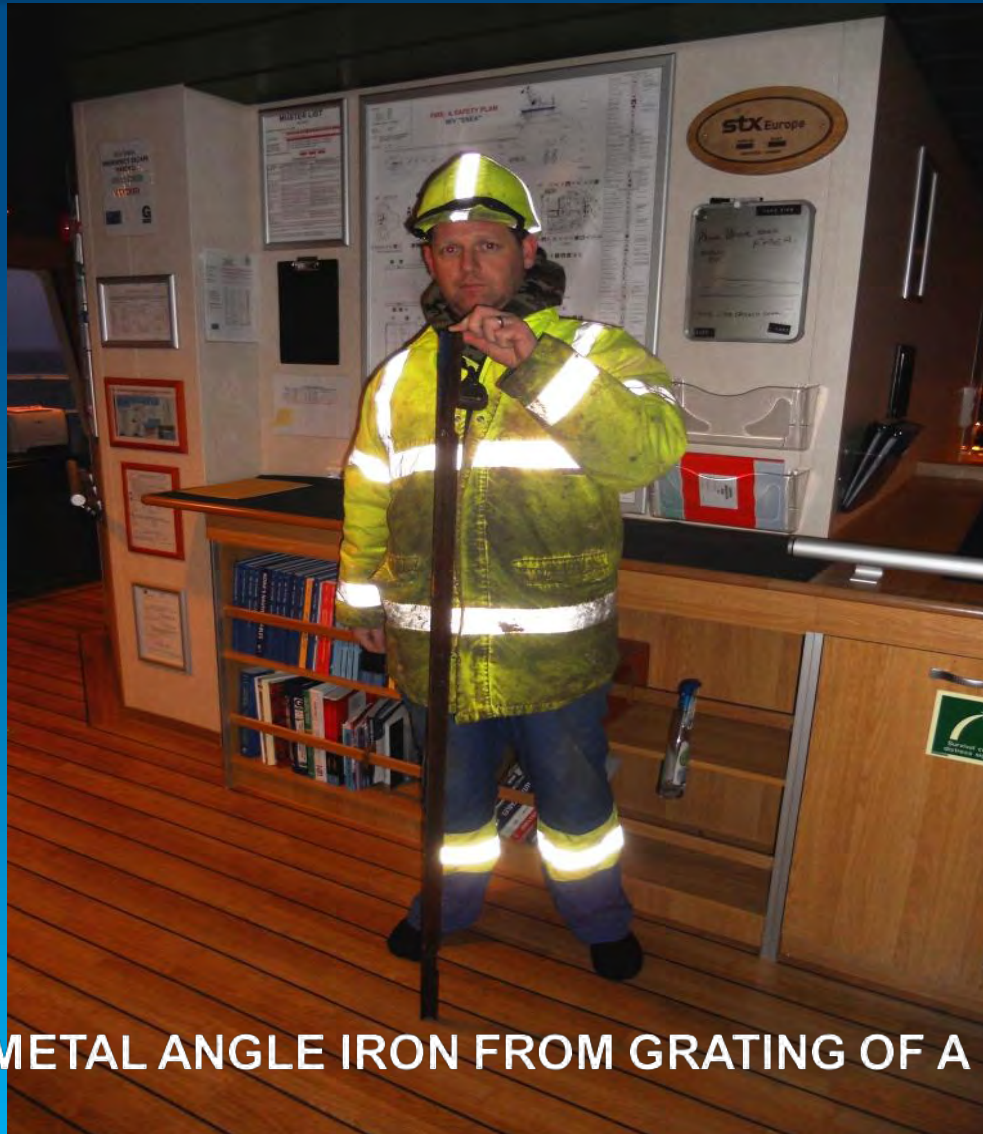
1.5m/5 foot METAL ANGLE IRON FROM GRATING OF A TANK UNIT

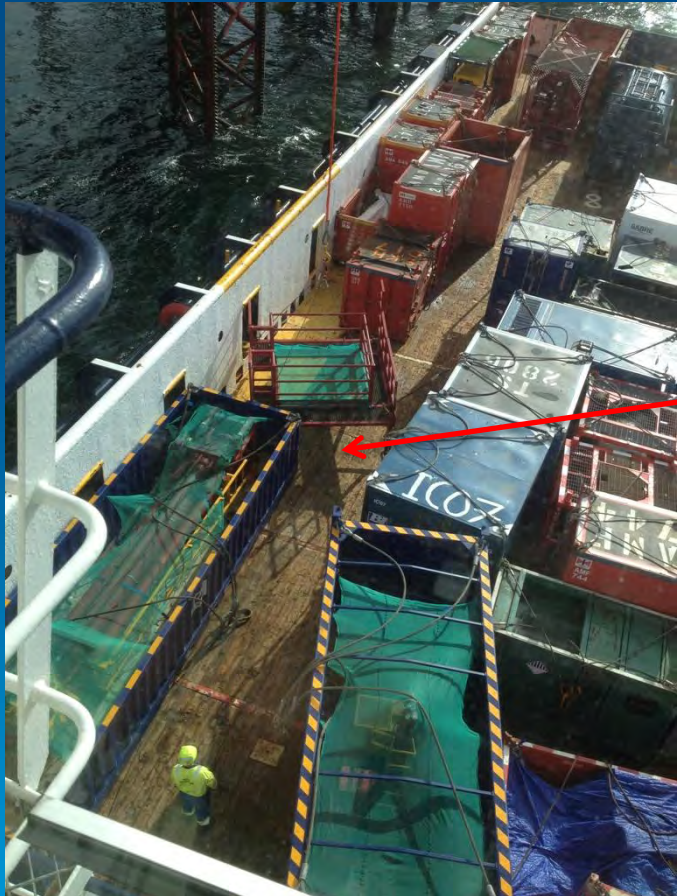
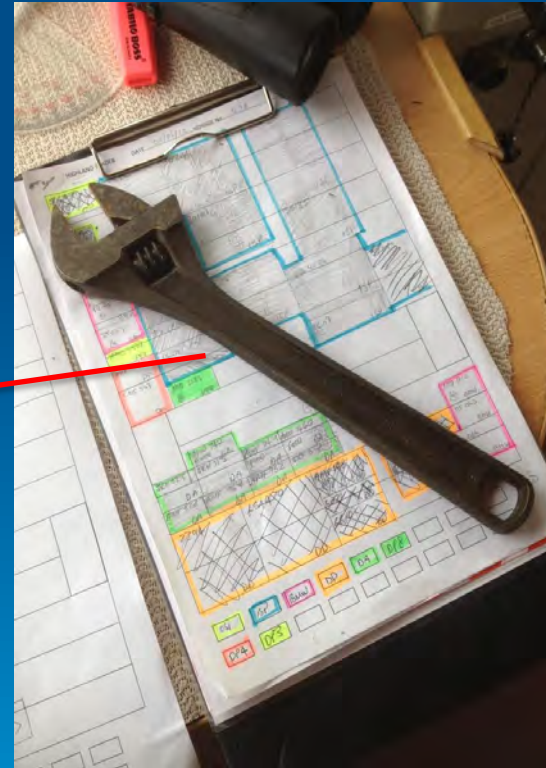
Adjustable spanner (665g) dislodged and fell approximately 5 feet from lift as it contacted the supply boat's crash barrier whilst being backloaded and just before landing on the deck

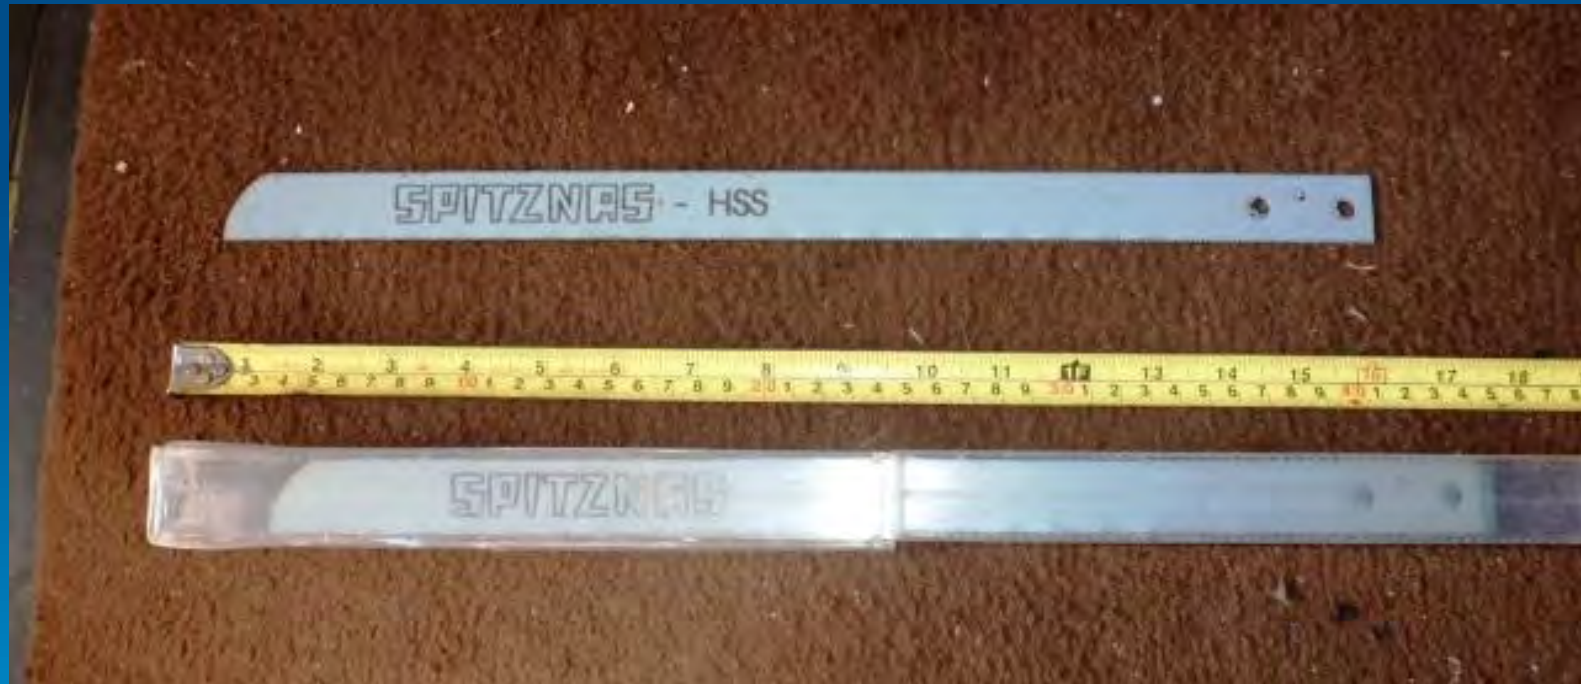
Plastic rectangular box of hack saw blades 41cm x 4cm

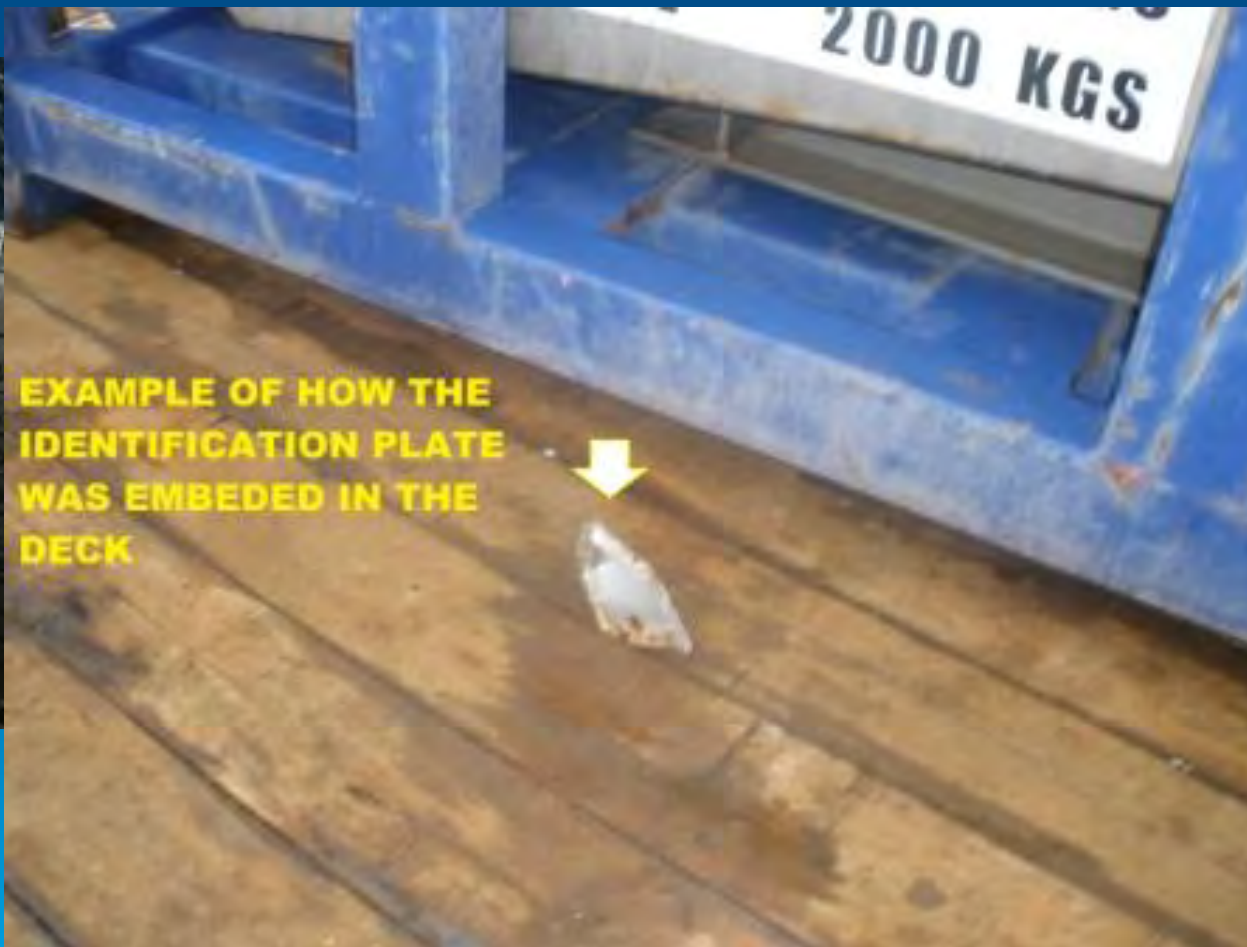
Metal identification plate

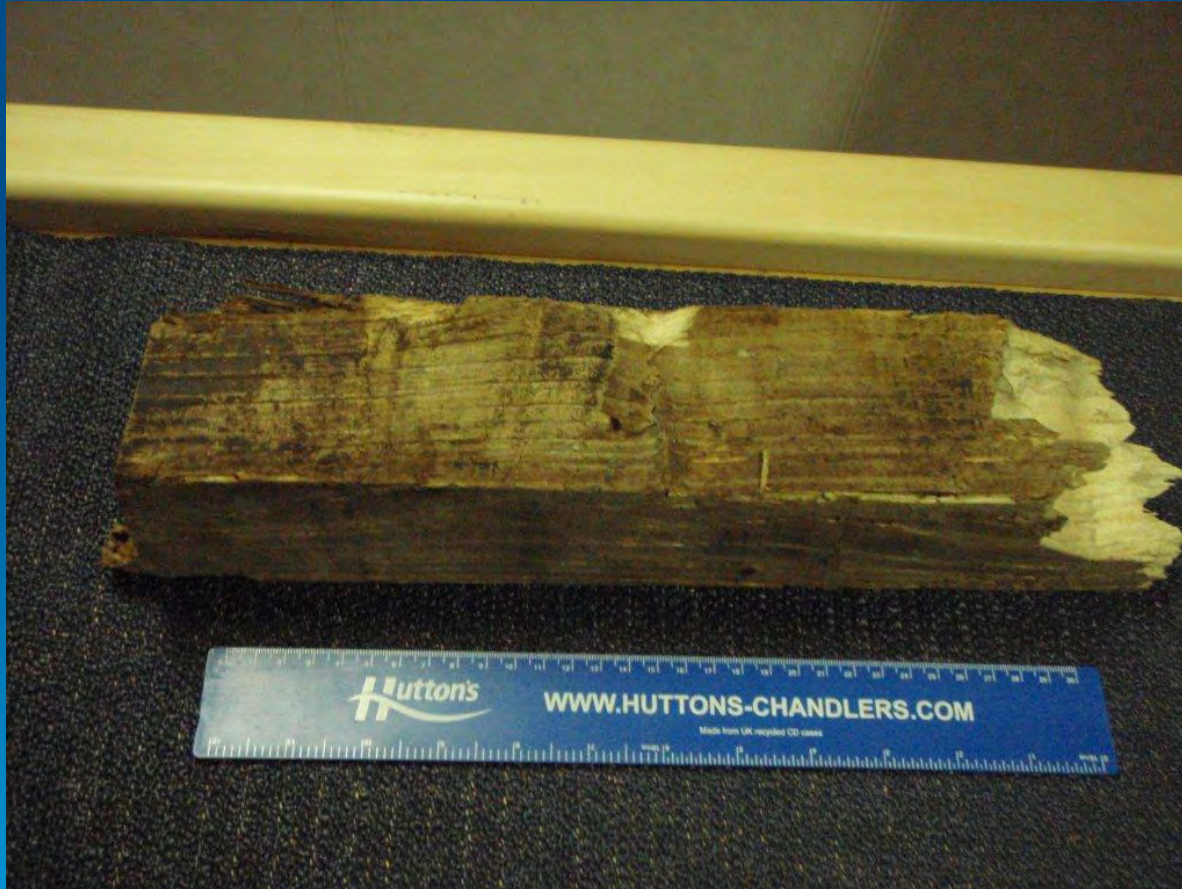
Piece of timber damp around 0.7kg weight
35cm x 8cm x 7cm

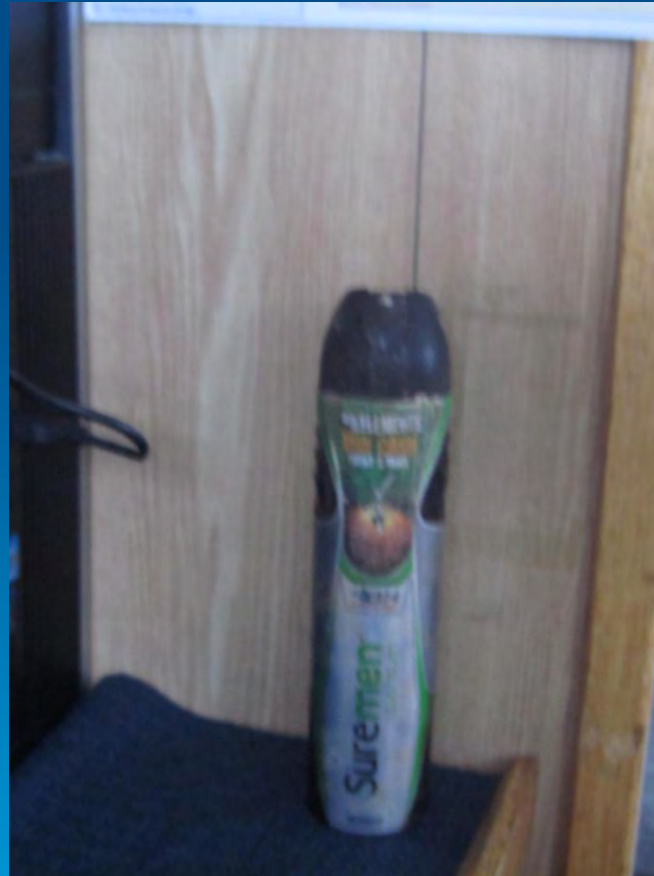
Gas rack was being back loaded when the lift was approx 3mtrs from the deck, an object was seen to fall from the lift

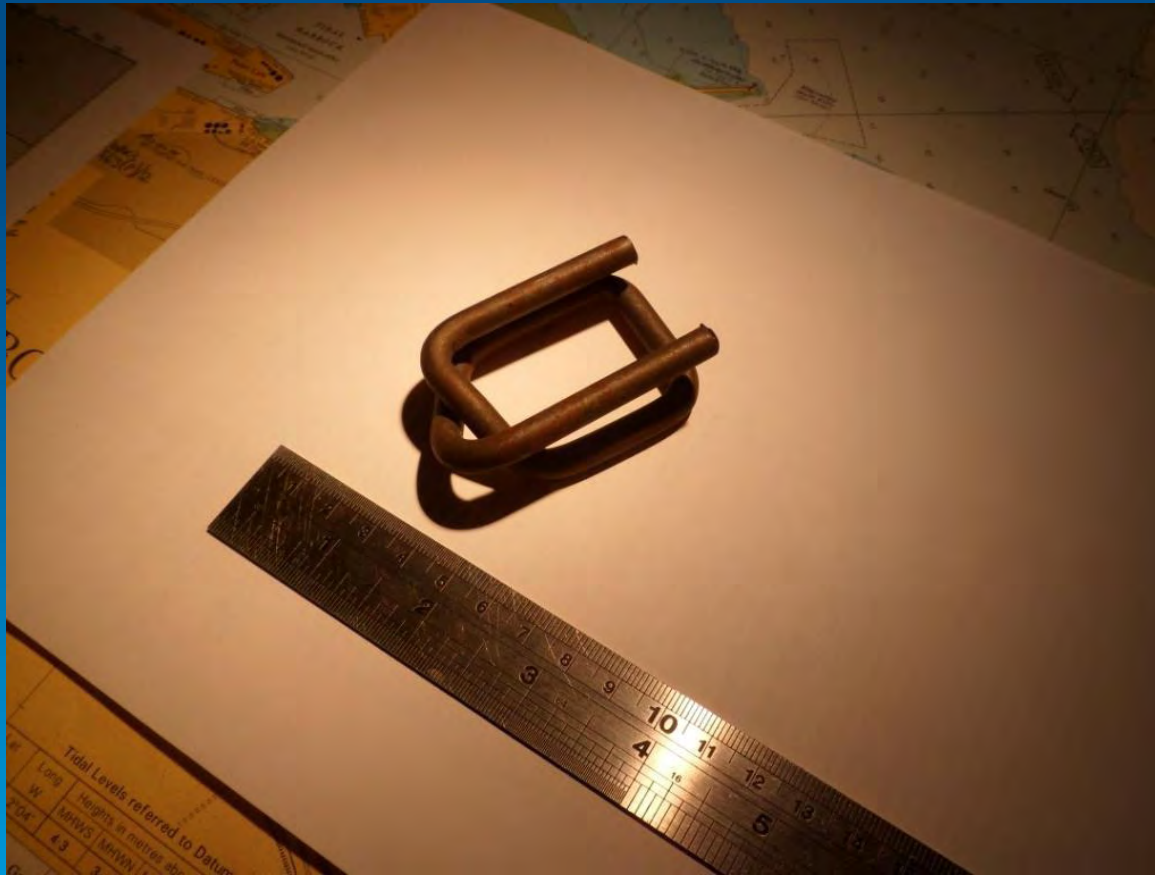
Buckle about 10cm inside the forklift holes

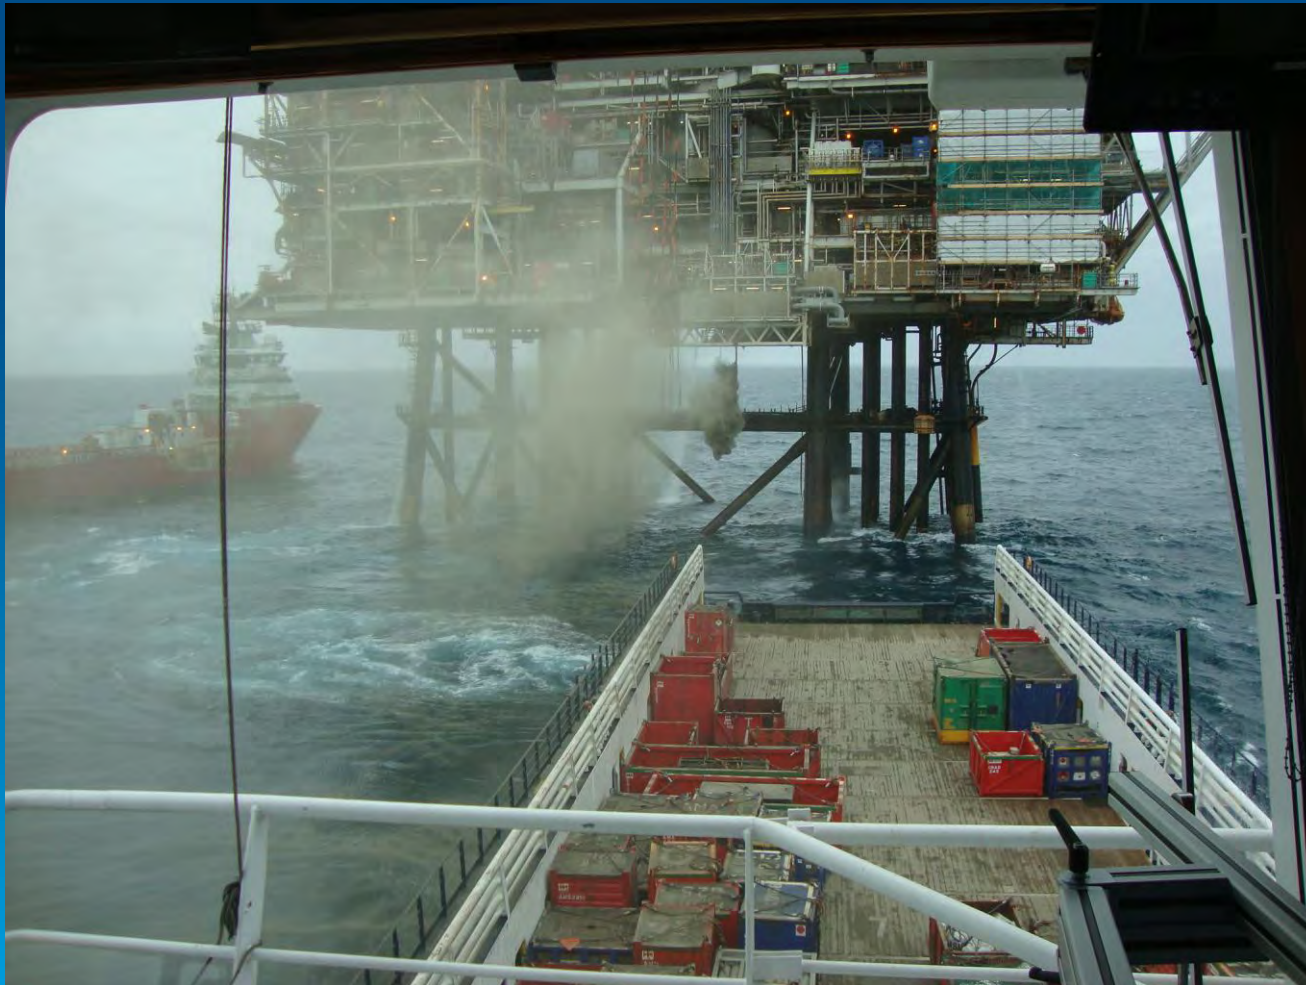
While backing into the Platform to backload 1 lift the platform started to vent off cement, thus covering the deck and most of the accommodation block in the product

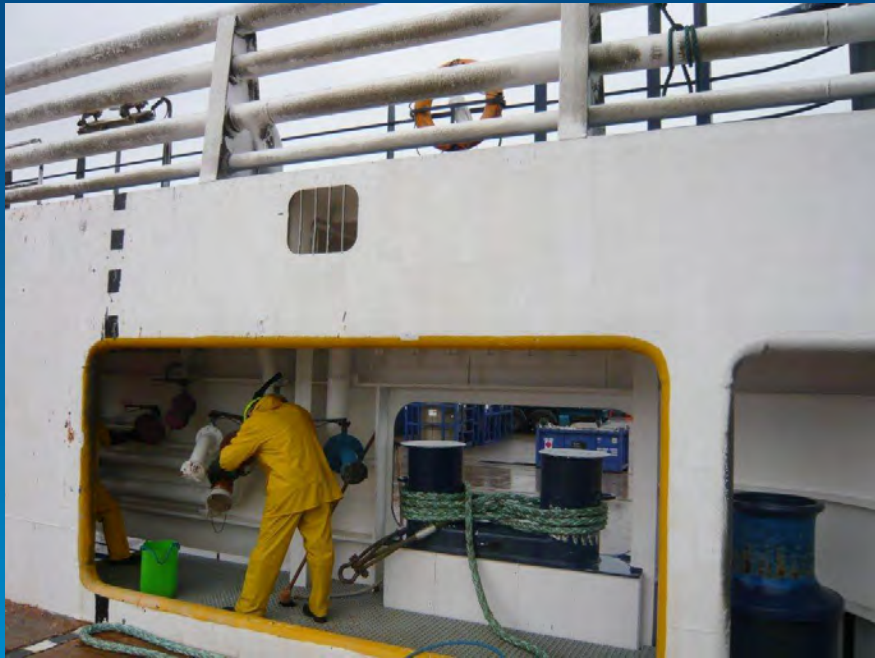
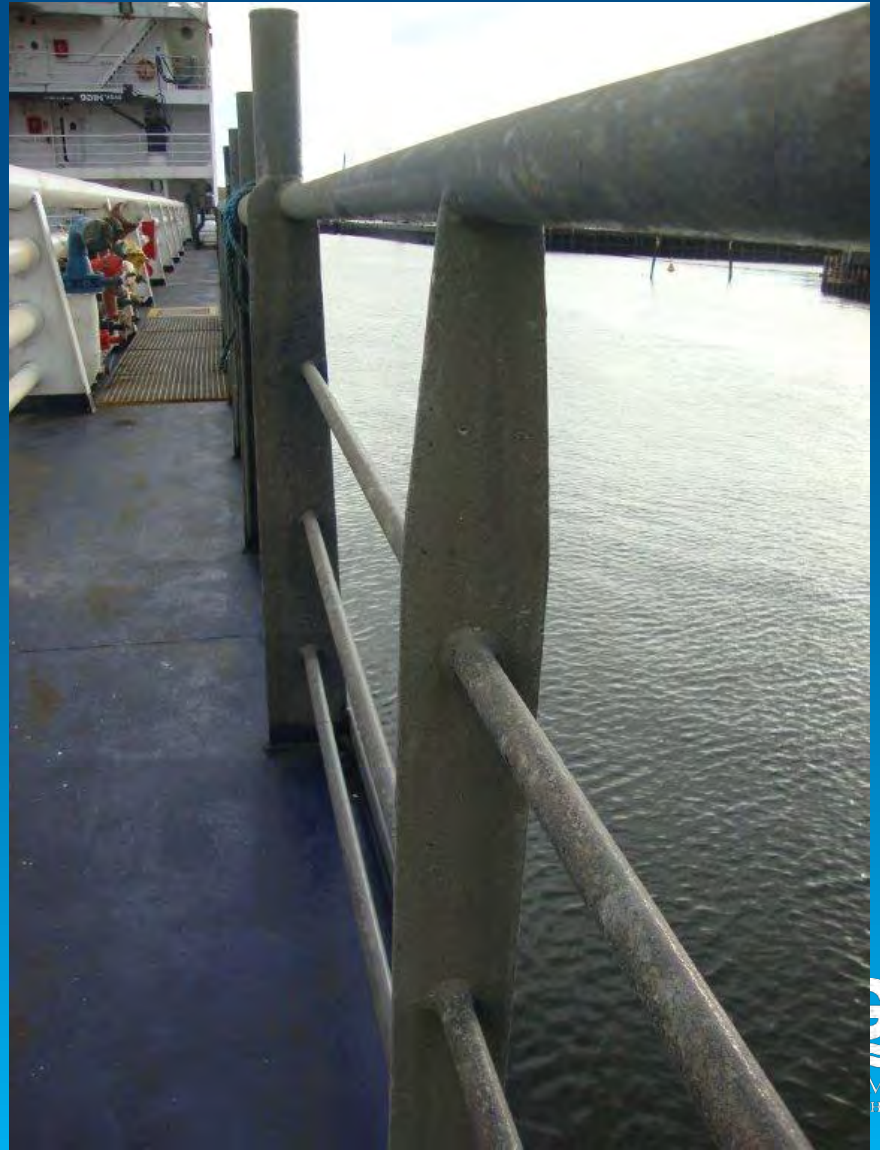
The Latest Overboard Discharge!

- Platform vented off one of its dry bulk tanks engulfing the vessel in a large cloud of barite and greatly reducing visibility
- Control Room Unaware of any dry bulk ops
- Vessel preparing to take pot water hose down
- Deck crew would have been directly downwind from discharge.
- Significant hazard to vessel and crew resulting from communication breakdown
