# DROPs Lessons Learned: Cable Ladder Rungs from Derrick Cable Tray

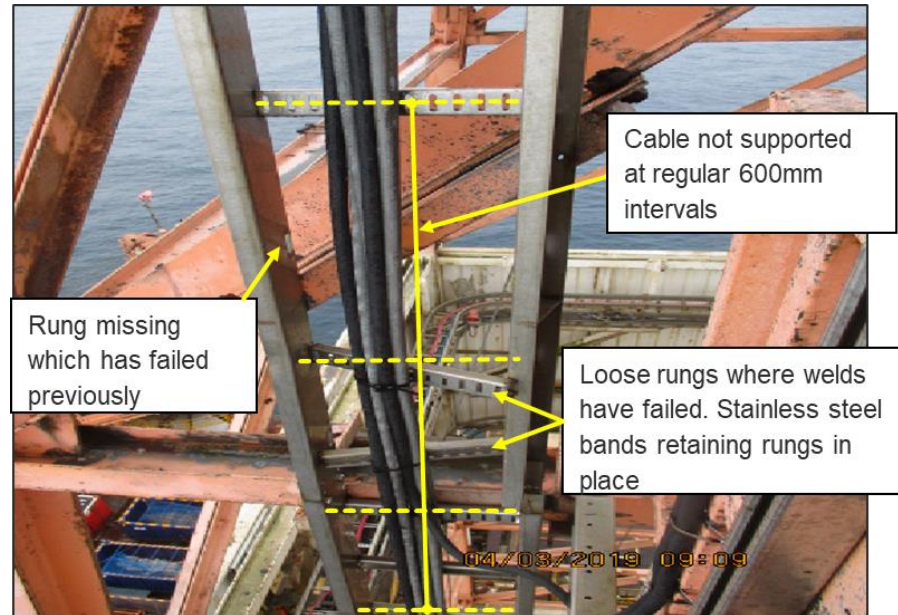
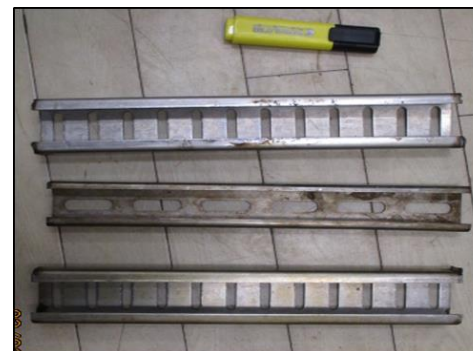
- Upon inspection, the objects were identified as rungs from a cable ladder rack located within the drilling derrick. The heaviest rung weighed 0.45kg and fell from a height of 48.4m. Based on the calculated impact energy, this had the potential to cause a fatality.
- The pre-fabricated, cable racks with welded rungs were in place from original build (>30 years).
- Plastic cable fasteners were used instead of the required metal cable fasteners.
- Cables were not adequately secured to the ladder rack with the bundle spanning multiple rungs instead of the minimum of every second rung required for Low Voltage cable.

- Inspection surveys failed to identify:
  - the fatigue caused to the welded ladder rungs by movement in the exposed location, or
  - the cable fasteners were the incorrect specification and used at incorrect spacing.

- A full DROPS sweep was conducted by rope access personnel to ensure there were no other areas of loose cable rack within the derrick that could pose a dropped object risk.
