# MSF - Drops Forum

30/04/2019

Actively promoting safety within the marine sector of the oil and gas industry

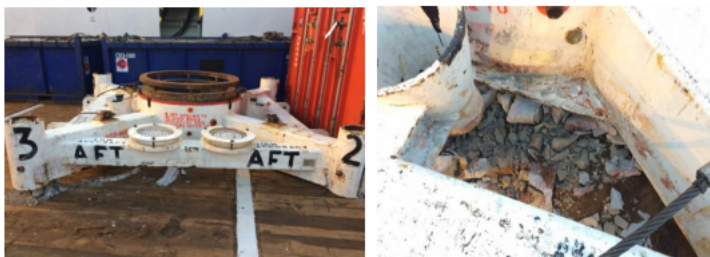
A guide-base unit was back loaded from the installation with significant amounts of hardened cement attached to its underside. When the guide-base landed on the vessels deck the contact dislodged some of the cement. The AB's 'stopped the job' and unhooked the lift however they didn't raise any particular concern.

It was only when the guide-base was about to be offloaded in port that the shore side stevedores noted the hardened cement was a potential dropped object and again 'stopped the job' until the hardened cement was removed using pinch bar's and hammers prior to the guide-base being lifted from the vessel.

Although the vessels crew did notice the cement falling from the guide-base when it was backloaded they didn't consider the follow-on potential dropped object scenario during discharge.

- During cargo transfers, when and where possible, remain within safe haven areas avoiding the risk of 'potential dropped objects
- If anything falls from the cargo assess your own safety and if / when safe to do so recover / report the object
- DO NOT return the offending cargo to the installation
- Report the incident to the installation
- Discuss the incident and identify the concern to the stevedores at the pre-discharge TBT once back on shore

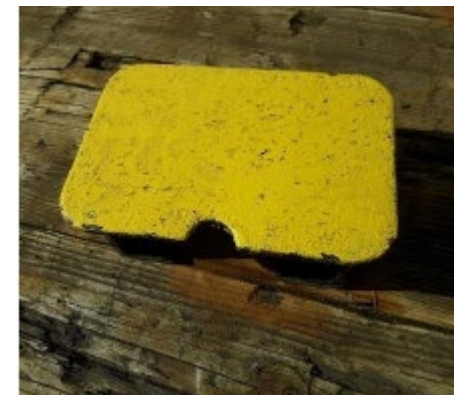
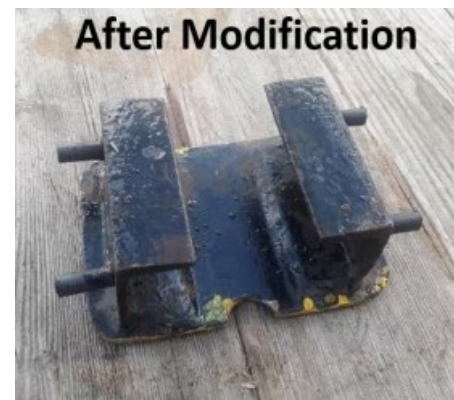
During cargo operations at an offshore location, a 20ft basket was discharged from aft on the main deck. Shortly afterwards bridge team were informed by the installation crew that a yellow metal plate was found trapped inside the forklift pocket of the basket. Later that day, a picture of the plate was sent to the vessel and ships staff confirmed that the plate originated from the vessel's deck.

The plate in question was used to protect a potential trip hazard (stanchion mounting holes) when not in use.

Note that the control measures listed did not include pre-inspection of the deck. The control measure requiring a pre-inspection of the container alone failed, as it did not identify the potential dropped object. However, it should be noted that the ability to conduct a full inspection of a container prior to lifting from a vessel's deck can be impaired and may not always identify all Potential Dropped Objects, e.g.

A spare cover plate was immediately fitted, and the trip hazard removed. Ship Staff were also able to engineer a solution so that no single motion i.e. wave action on deck could result in the plate being inadvertently shifted. Additional pins have been added which will hold the plate in place unless intentionally removed.

1. Update the risk assessment - add pre-work inspection of the deck as an additional control measure against the hazard of Potential Dropped Objects
2. Update 500m entry checklist to include a requirement for a positive report to the bridge that the pre-work deck inspection has been completed
3. All Safety Officers to conduct inspection of the vessel plate cover arrangements to determine if a similar hazard could occur and take preventative action where necessary
4. Conduct an additional recorded briefing for all deck crew on the lessons learnt – particularly the potential failure of the pre-lift check of the container and the new requirement for a pre-work deck inspection

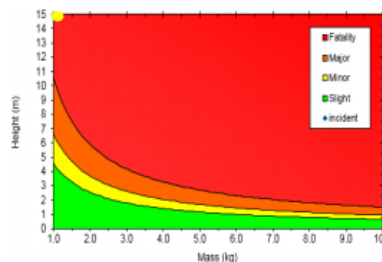
The items were estimated to weigh approximately 1kg and the potential outcome has been highlighted using the drops calculator as shown.

Outcome Calculator	
Height	1.5 m
Mass	1 kg
Outcome	Fatality

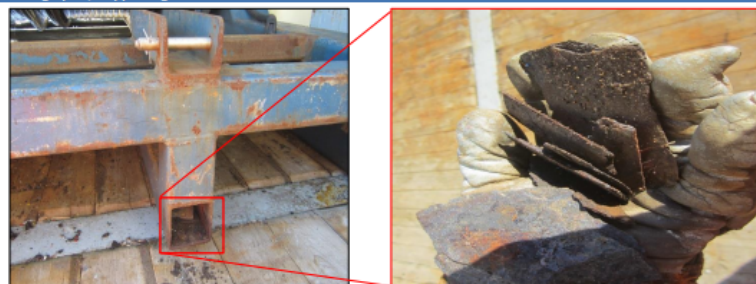
When preparing a heavy lift to be discharged from an offshore supply vessel to an offshore installation the vessel's AB's were carrying out final checks which included checks for any potential dropped objects, during these checks they discovered some debris within the frame pocket.

Cargo checks onshore failed to spot the items before the lift had been loaded onto the PSV. This was apparently due to the lift frame positioning on the trailer which may have hampered the checks at the gantry.

- The potential dropped objects were removed from the pocket and the lift was safely and successfully discharged to the offshore installation.
- This alert highlights the importance of final checks on all lifts prior to discharge offshore even though there had been previous checks onshore.

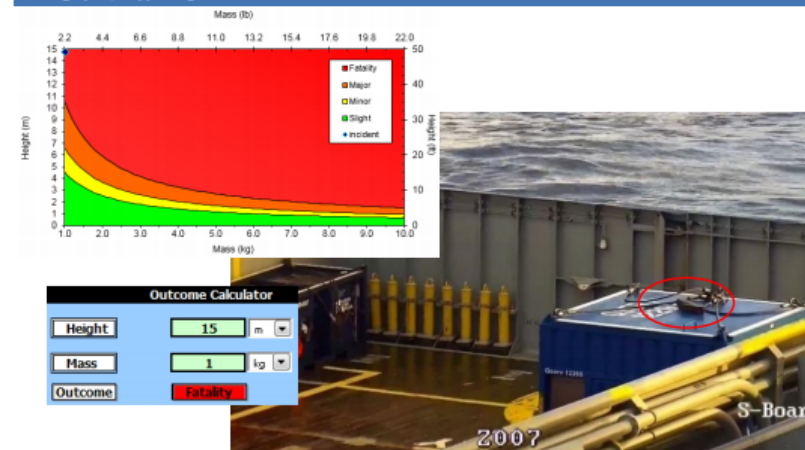
While hose watching during bunkering operations, a Deck Foreman noticed an object on top of a container onboard the Supply Vessel.

The object was later found to be a large piece of wood weighing 1kg. With a possible fall height of 15 – 30 meters during lifting operations. There was the potential for a fatality.

The origin of the wood is not known. CCTV images were captured of the container arriving at port and prior to being lifted onto the vessel – the wood was not seen on top of the container at either of these points.

Vessel Master was contacted, who arranged for the object to be removed.

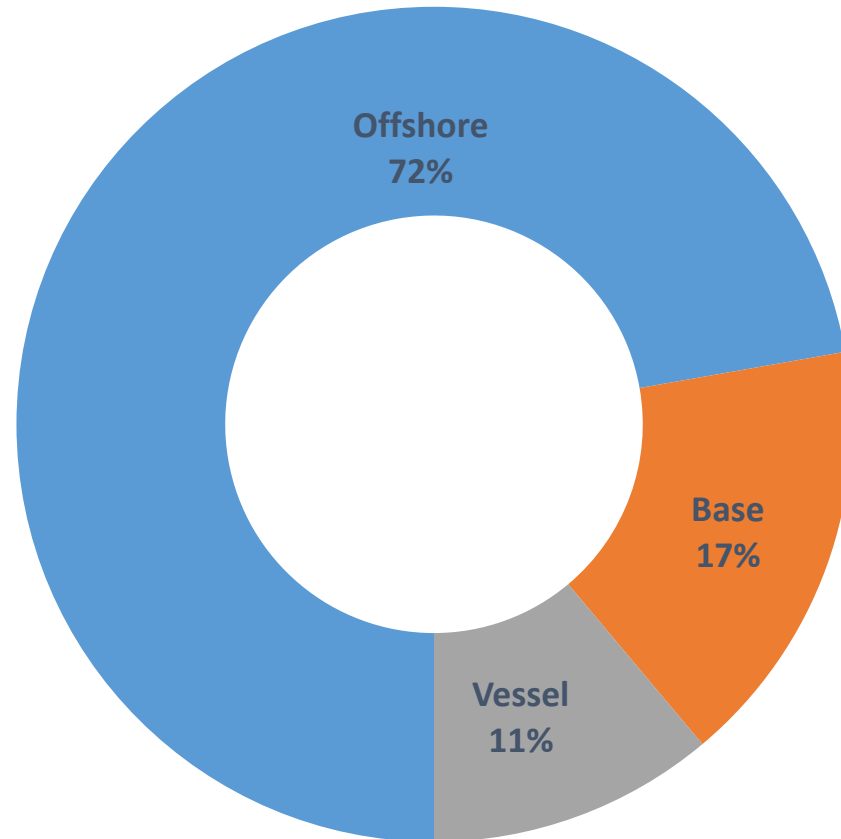
### Potential / Dropped Objects Breakdown

- Checks failed
- Checked several hours prior to backload
- Checks were not stringent enough
- Not ours/didn't come from here
- Inconclusive
- No response
