# IMPORTANCE OF SHARING

# LESSONS FROM INCIDENT

# As a refresher NOV's DROPS mission statement

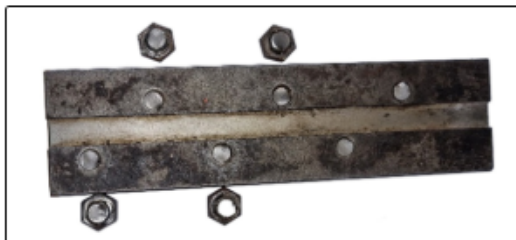
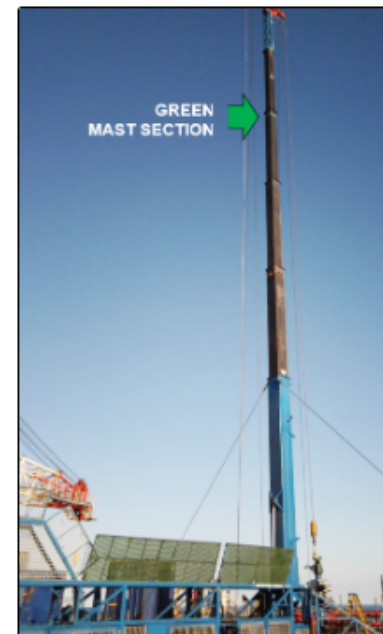
**Dropsonline** (a Global Industry Workgroup with a common goal of dropped object prevention) shared with **NOV** the details of a dropped object incident from a wireline mast column.

The dropped object was caused by the **incorrect orientation of the plate**. The incorrect installation occurred because:

- The installation/maintenance procedure was not clear.
- The plate's bolt pattern design allowed for opposite or erroneous installation.
- The incorrect installation exposed the plate to excessive load and force impact, leading to failure.

- When designing components, prioritize minimizing the possibility of installation errors followed by **ease of installation**,
- Provide **clear, complete, and unambiguous installation and maintenance instructions**.

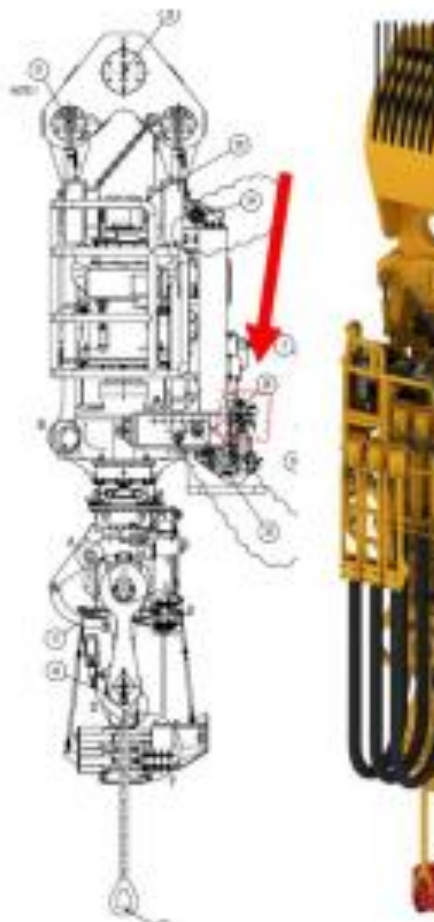
**Subject:** Hydraulic valve handle on HPS Top Drive loosened and dropped to drill floor.

**Issue:** NOV received a report of an event where a hydraulic valve handle loosened from the hydraulic valve and dropped to the drill floor. No equipment was damaged or no personnel injury occurred.

**Recommendation:** Check and make sure that all hydraulic valve handles are removed from the hydraulic valve blocks. These are easily removed by unscrewing the handle. Keep the handles for later use.

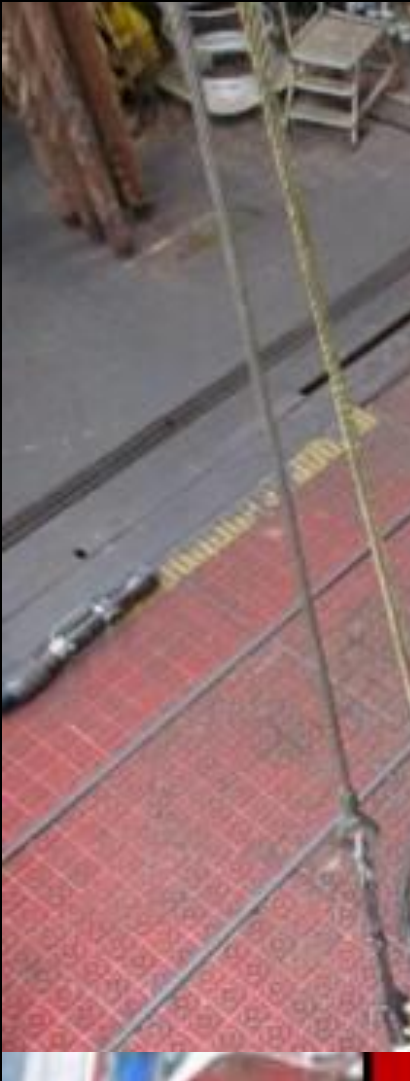
**Subject:** Dropped Object Incident Involving a PH-150 Pipe Handler

**Issue:** In the initial release of this alert (May 8, 2013), NOV reported that a removable **Retaining Pin (P/N 30183615)**, that secures the **Stabbing Guides (P/N 30183613-105)** to the PH-150 Pipe Handler Assembly, sheared and fell to the rig floor. No injuries were reported as a result of the incident.

It was reported that while making a pipe connection, the TDX-1250 Top Drive was positioned at the top of a stand of 6 5/8" drill pipe. When the driller lowered the Top Drive to the connection point, the edge of the Stabbing Guide of the Pipe Handler came into contact with the box end of the drill pipe causing the handle end of the Stabbing Guide Retaining Pin to shear and fall to the rig floor (see Figure 1).

**Solutions:** It is strongly recommended that owners/users immediately and periodically inspect Pipe Handler Assemblies for damage and to ensure that the **Stabbing Guide Retaining Pins (P/N 30183615)** are secured in place and free of cracks, distortion, or wear. Damaged retaining pins should be replaced immediately and secured in place with **Jam Nuts (P/N 50312-C)** and **Lynch Pins (P/N 117496-1)** (see Figure 2). Although this incident occurred with a PH-150 Pipe Handler Assembly, the TDX-1000 uses a PH-203 Pipe Handler Assembly which has a similar design and should be inspected as well.

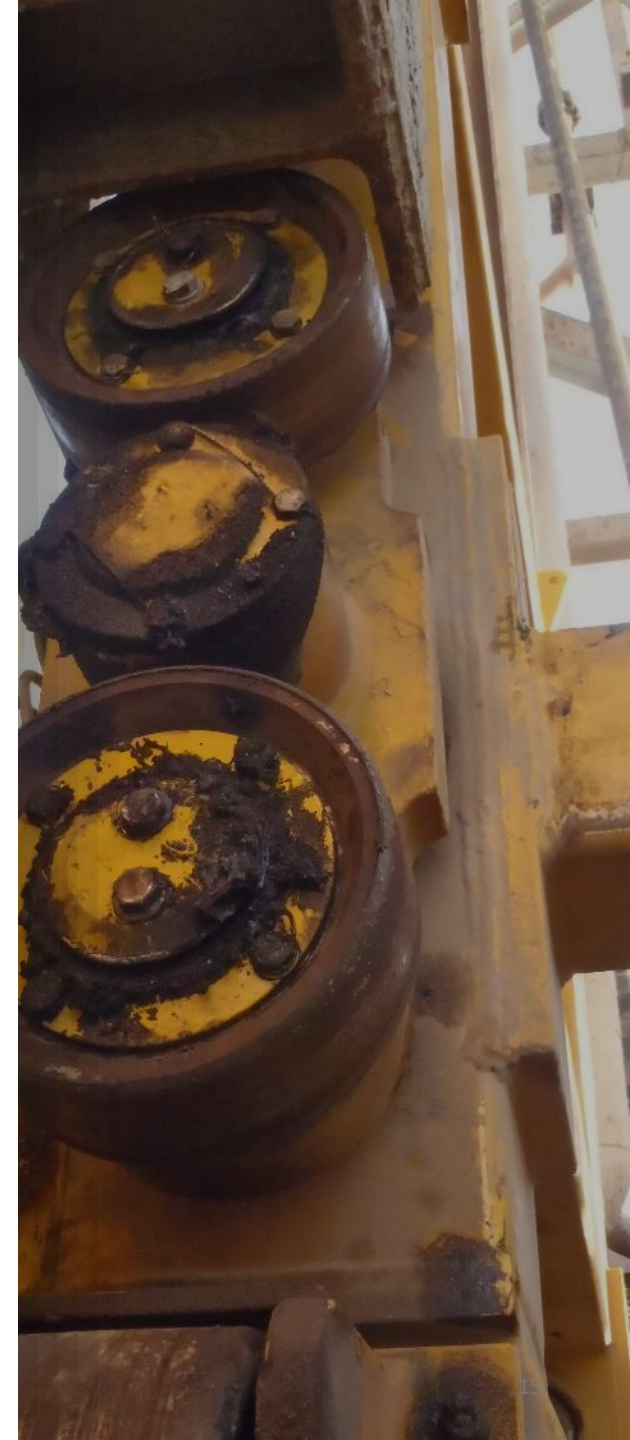
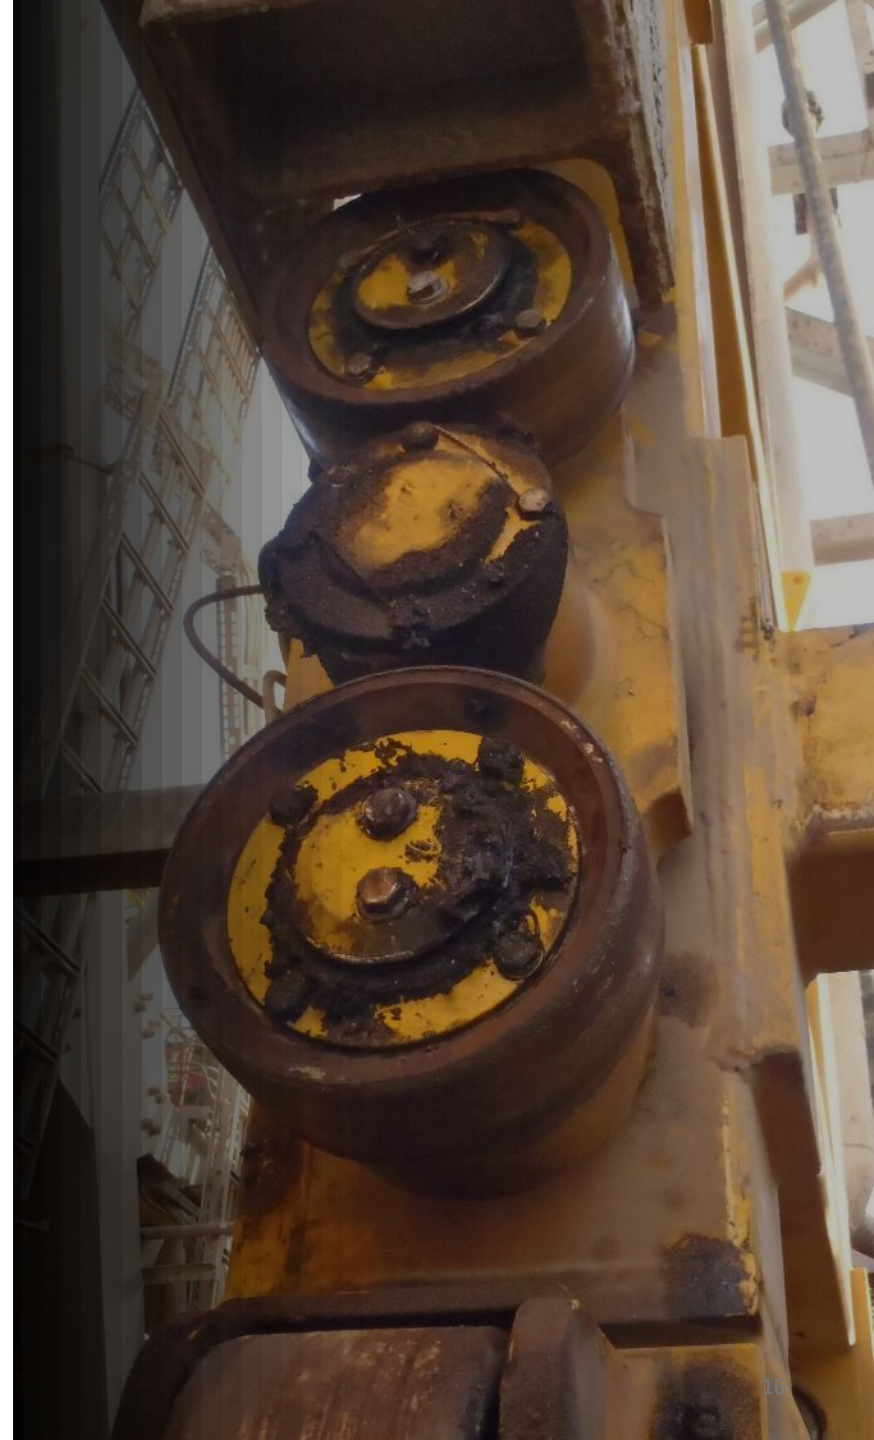
**Subject:** New Improved Dolly Bogie and Dolly Side Roller

**Issue:** NOV have received some reports from customers that the dolly roller bearing in some occasions has failed; resulting in small bearing parts to becoming dropped objects.

**Solution:** NOV has evaluated the entire bearing arrangement on the Dolly bogies and has developed a new improved design that will both prevent the possibility for dropped parts, and also eliminate the need for lubrications. This same bearing design solution has also been implemented on the side rollers. Details are further described in the sections below;
