One Incident Many Lessons

Incident Overview

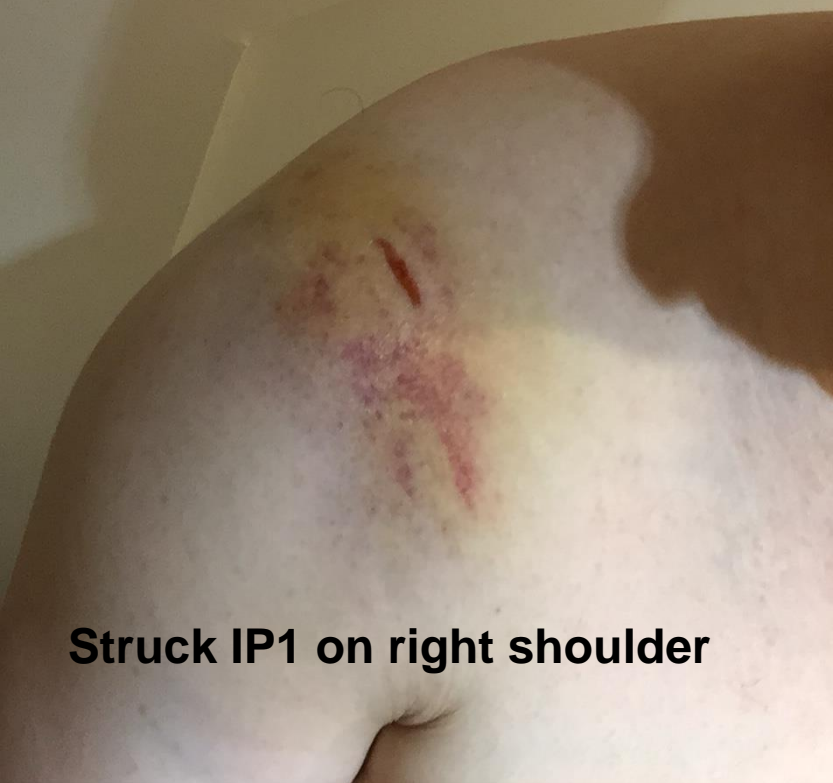
Struck IP1 on right shoulder

- Deflected onto IP2 right calf
- IP1 suffered abrasion / bruising to right shoulder
- IP2 suffered deep gash to right calf requiring four stitches

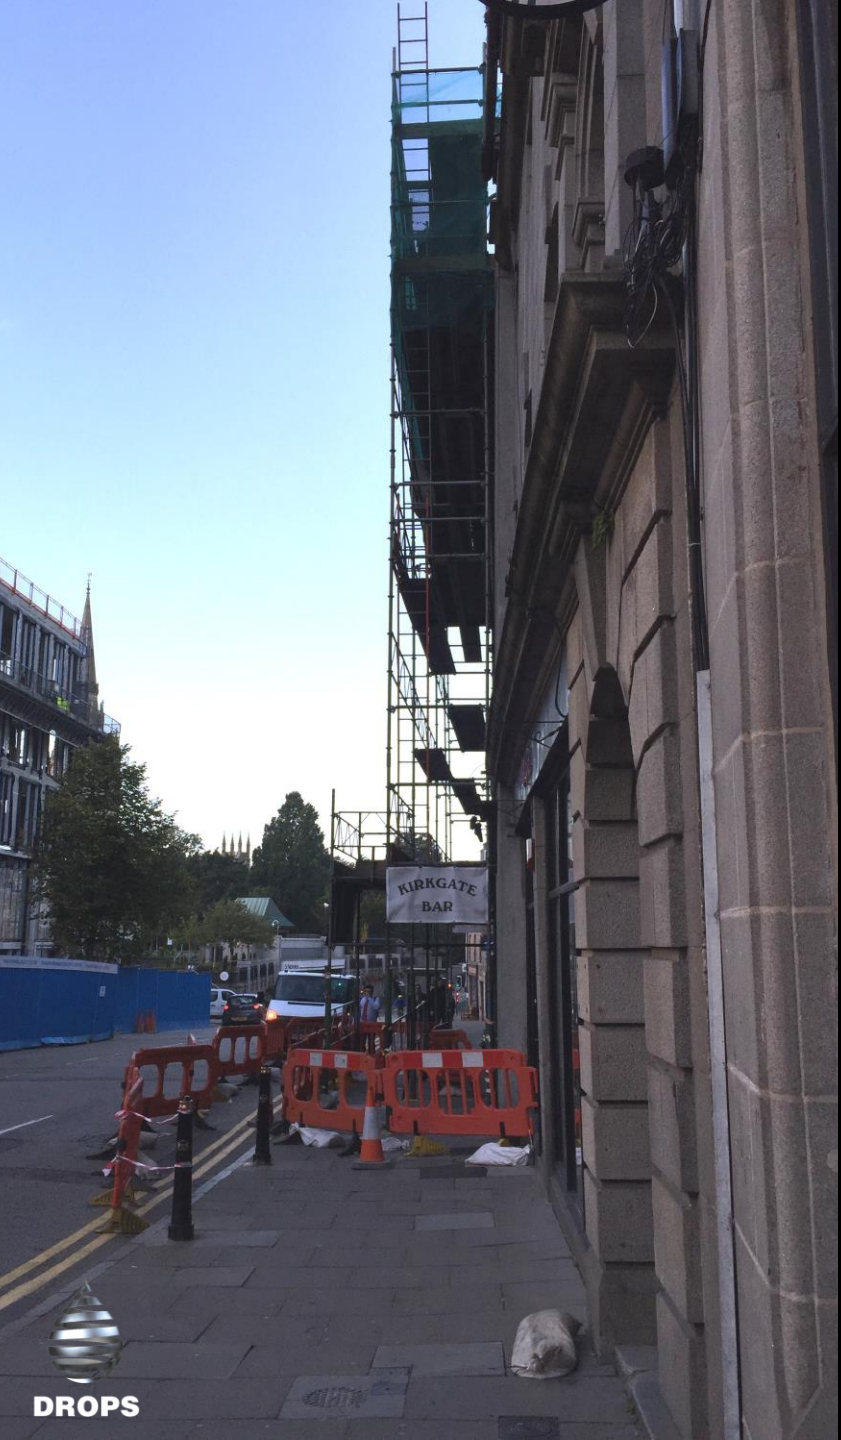
- Incorrect procedure (too many slates on scaffold boards)
- Incorrect layout of ladder hatches (in alignment instead of staggered)
- Inadequate, poorly installed netting around scaffold

- Roofing contractor requested to halt operations
- Police informed
- Incident reported to HSE
- Police cordoned off scaffold and provided pedestrian walkway on road
- HSE suspended all work on site pending investigation
