Maersk Resolve

Incident Summary Flash

Incident Title	Near Miss – PDO Insecure Signage Plate on Gas Rack	
Date / Time	18-02-18	0200hrs
Incident Reference

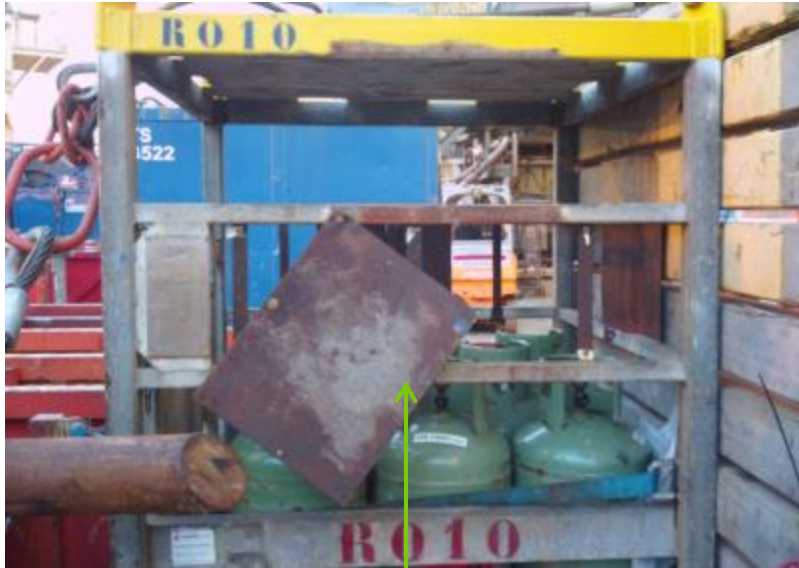
At this time it was noted that a large metal hazard warning display plate was hanging by one self tapping screw to the outside of the rack.

Signage plate as was found when it was landed on the rig

No	Action Description	Responsible Person	Target Date
1	By being secured to the outside of the gas rack and therefore liable to damage or snagging the plates were not adequately or safely secured to the gas racks - It is recommended that these plates are removed prior to being lifted again.	Maersk OIM	25/02/18
2	Similarly the plate design should be reviewed to consider the need for and most importantly the design of the plates such that they are robust and preferably internal to the cage such that they are protected. The rig team would suggest that the previous design be used with a thin metal insert plate affixed instead of plastic.	TBA	
3	Pre use checks both onshore and offshore should be reviewed to ensure that suitable and sufficient securing is in place for the plate, prior to lifting.	Maersk OIM

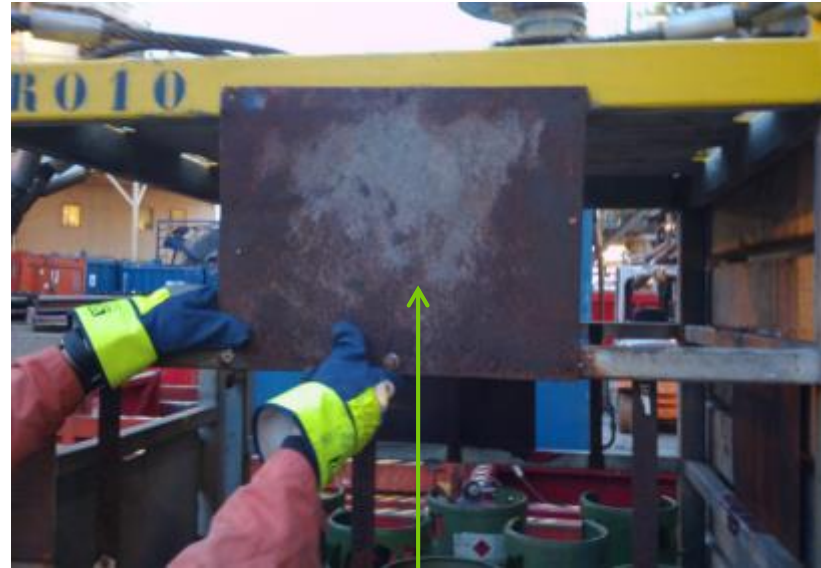
Having returned the signage plate to its original position and examining the condition and corrosion evident on the pieces of bolt and markings present it was apparent that the plate had been designed to be secured with 6 x self taper bolts each installed with a single flat washer to the outside of the gas rack framing. It was surmised by the rig investigation team and the visual evidence considered, that the plate had only three bolts in place prior to the plate being damaged to this extent.

Signage plate returned to intended position as per design

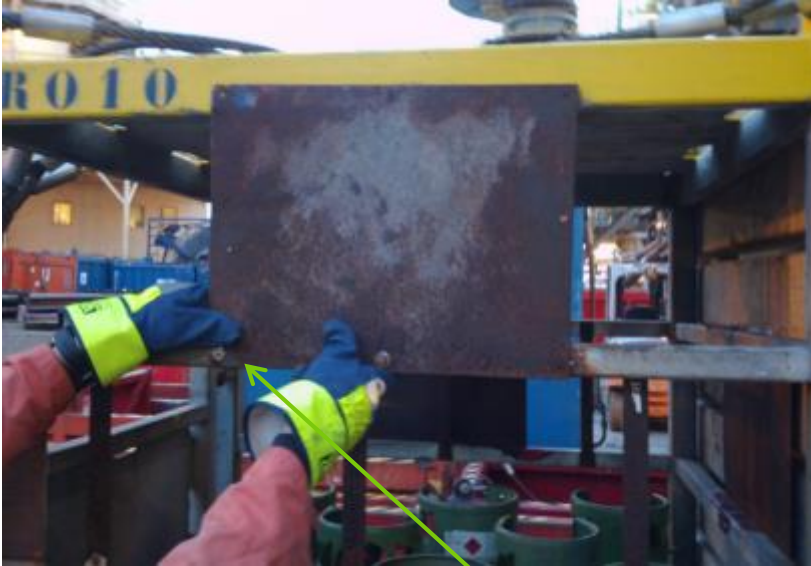
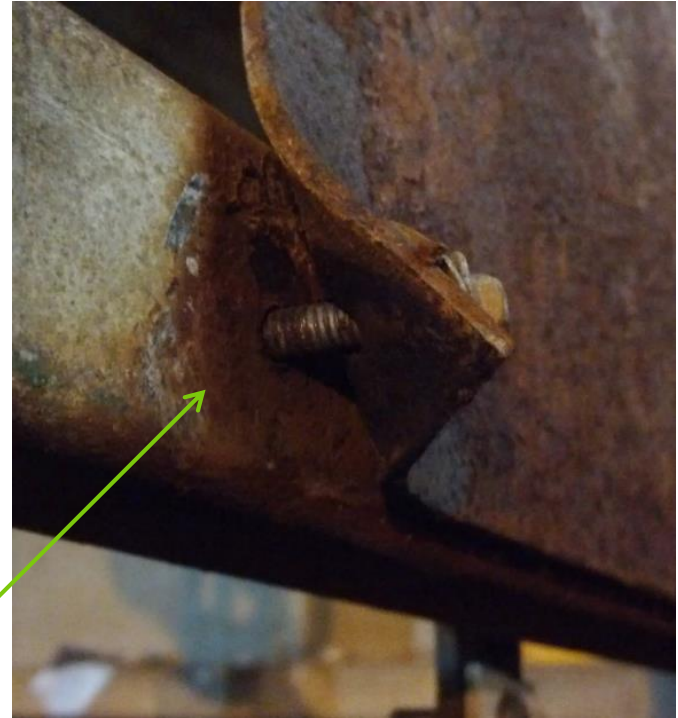
Singular remaining bolt as was found when load was landed on the rig.
Bolt design is a self tapper installed with a single flat washer

ACTIONS

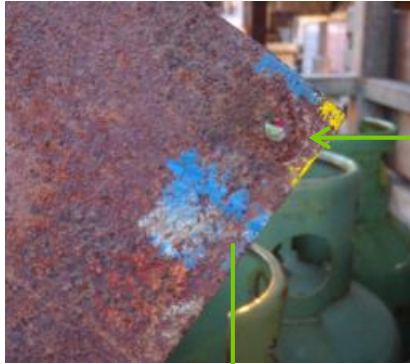
Fresh blue paint evident on top corner (which suggests that rack contacted other cargo or indeed the boat which is also blue, during the transit from Den Helder)
NB -Rig team believe that there may have been a bolt in this corner prior to shipping

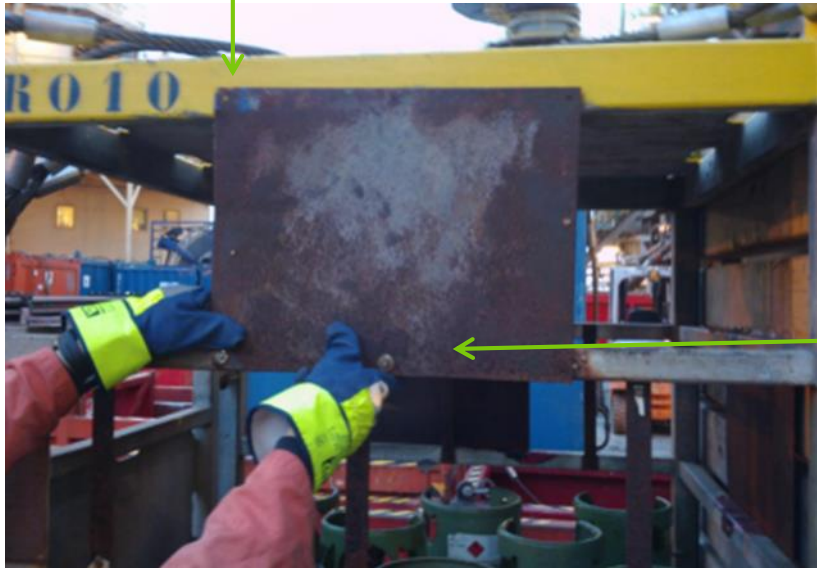
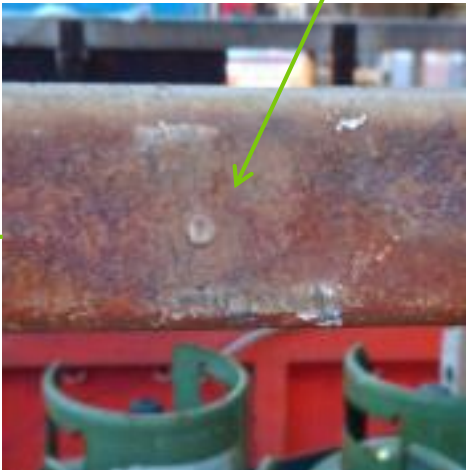
Rig team believe that this bolt was sheared whenever the plate was scraped or contacted by other (blue) cargo.

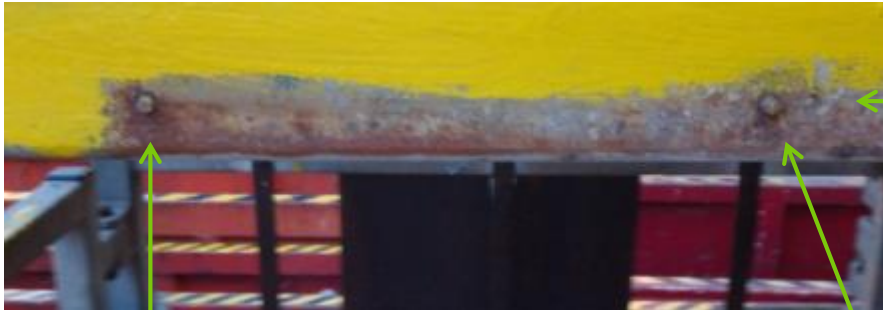
Significant observations that support this conclusion include the fact that yellow paint had been applied below where the plate should have been securely attached to. Similarly one of the broken securing bolts was painted yellow, another two were significantly corroded from previous damage.

Due to corrosion on this bolt the rig team believe that this bolt was sheared prior to transit. This is further substantiated by the fact that yellow paint has been applied below / or behind where the plate should have been firmly secured to.

Rig team believe that this bolt was sheared whenever the plate was scraped or contacted by other (blue) cargo and therefore this corner was possibly secure prior to transit.

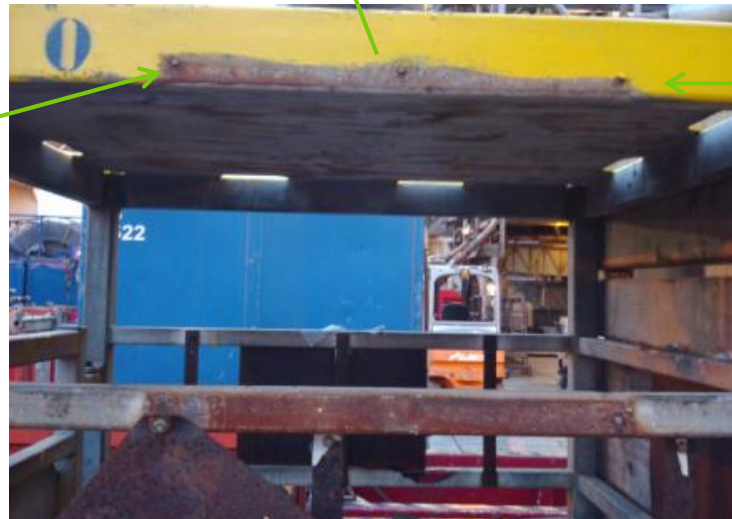
This bolt was obviously not secure prior to transit as it has been painted over.

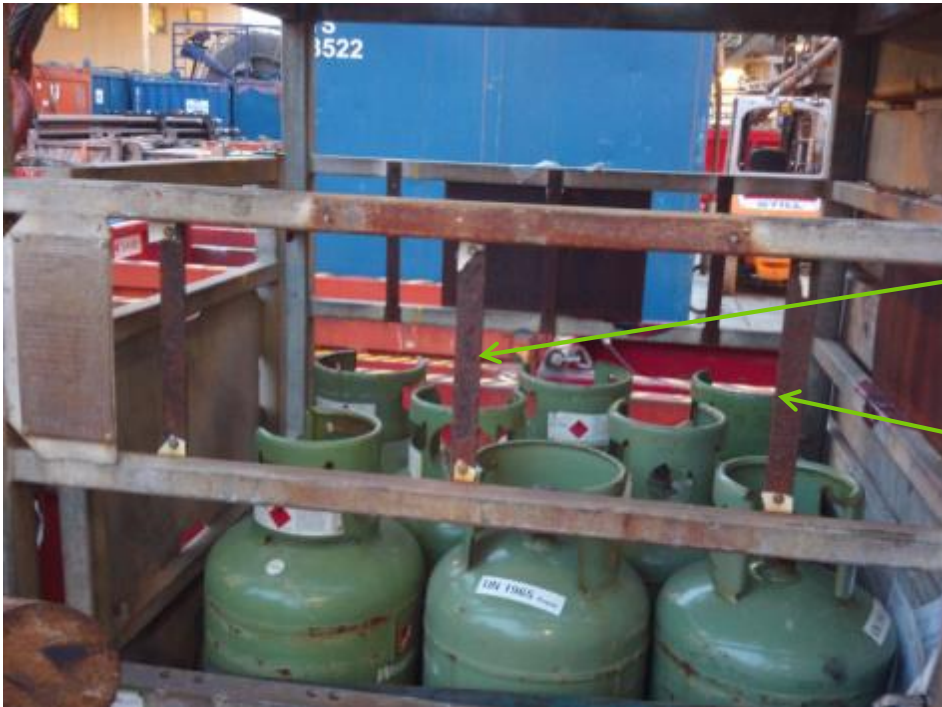
Once the offending plate was removed it was apparent to the rig team that there was previously a different design in place to secure plastic signage plates.

It would appear that the plastic plates also became damaged and / or broke off

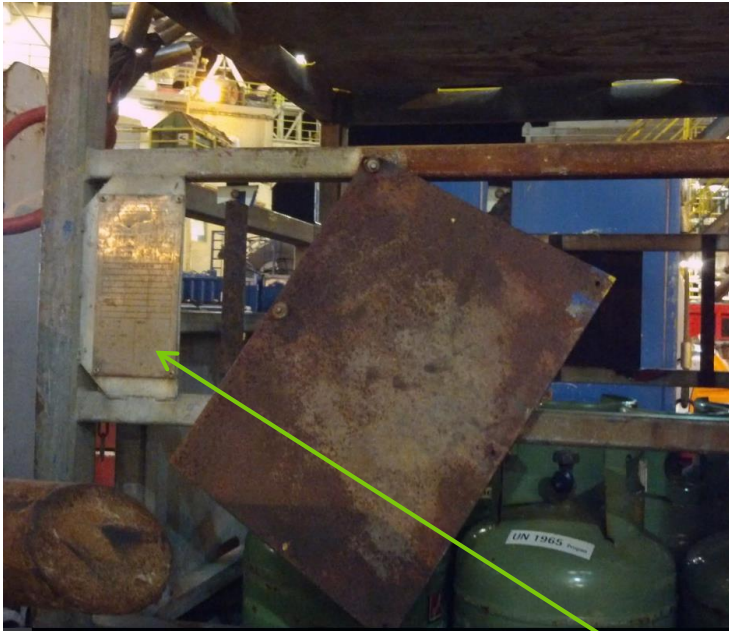
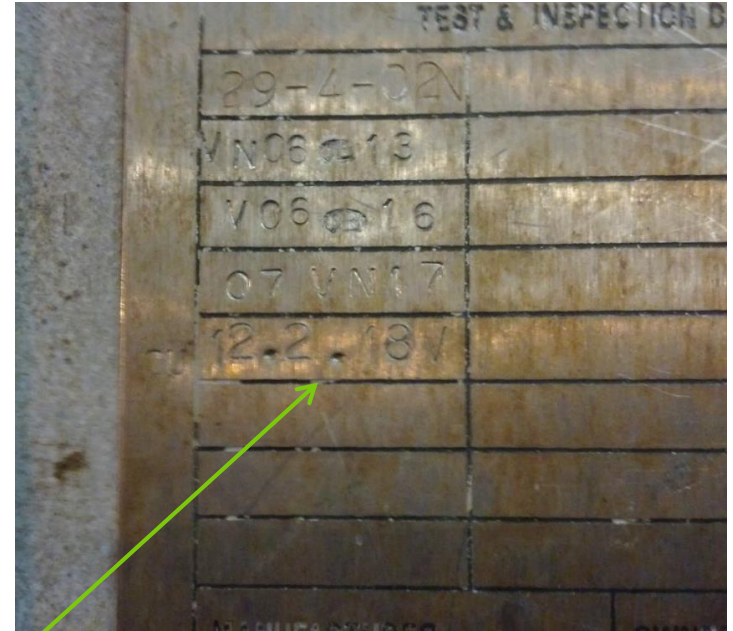
R010 identification plate indicated that rack was last inspected on 12th February 2018

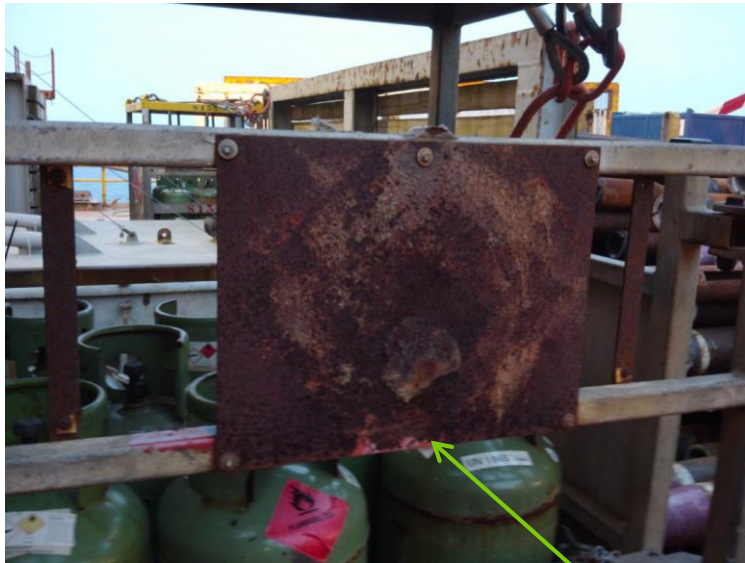
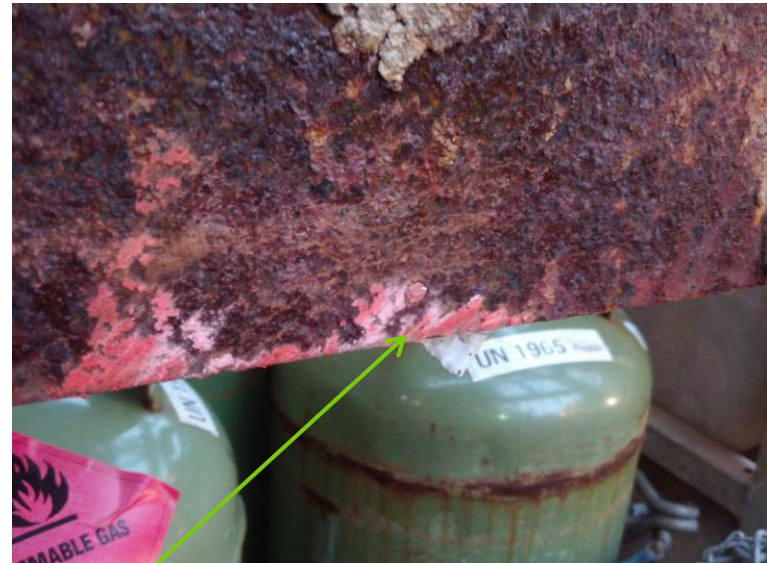
A review of the plate installed at the opposite side of the same rack (R010) revealed that this was also damaged and notable 1 of the 6 bolts installed had been sheared off at some point due to contact with something painted red. This plate remained securely fixed to the rack.

The rig team cannot state whether this damage was caused at the same time or otherwise.

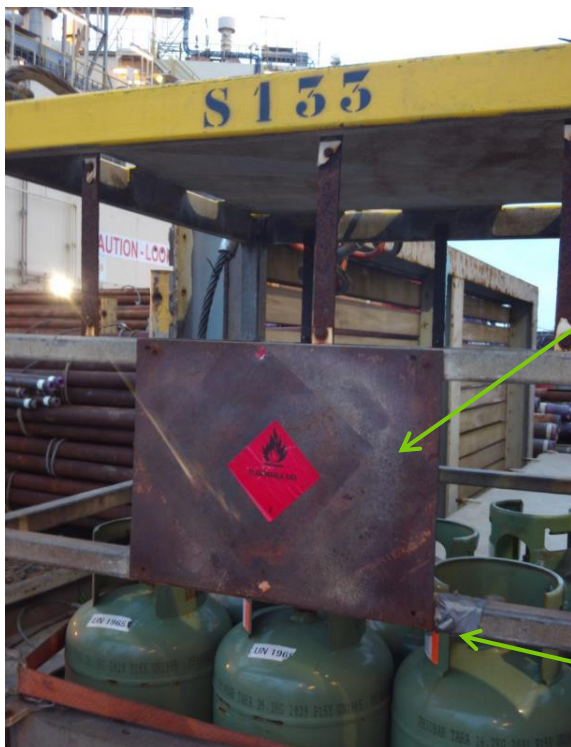
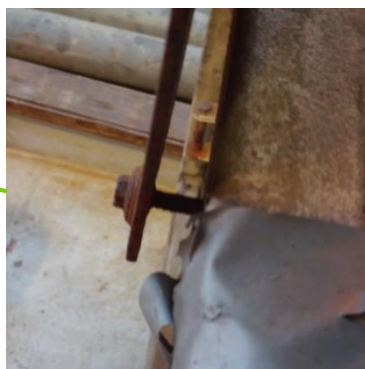
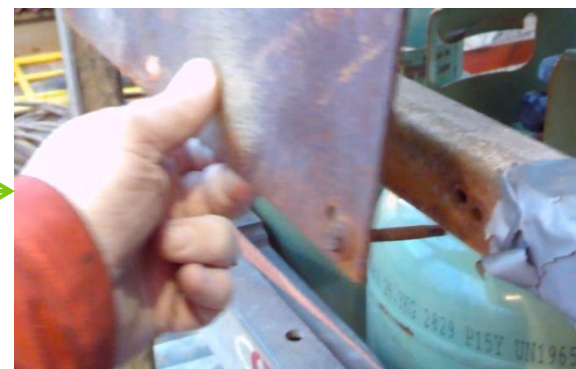
A review of other gas racks of the same design (S133, also received on the same shipment) revealed that various plates were not installed with all bolts as per design and these were only installed with 4 bolts rather than the 6 on R010.

Rack S133 was installed with one plate that looked okay at first glance however on closer examination it was found that one of the four bolts was entirely missing a second at the bottom was very loose and

The two remaining bolts at the top were not suitable and sufficient in that ultimately the rig team was able to pull off and remove the the entire plate by hand.

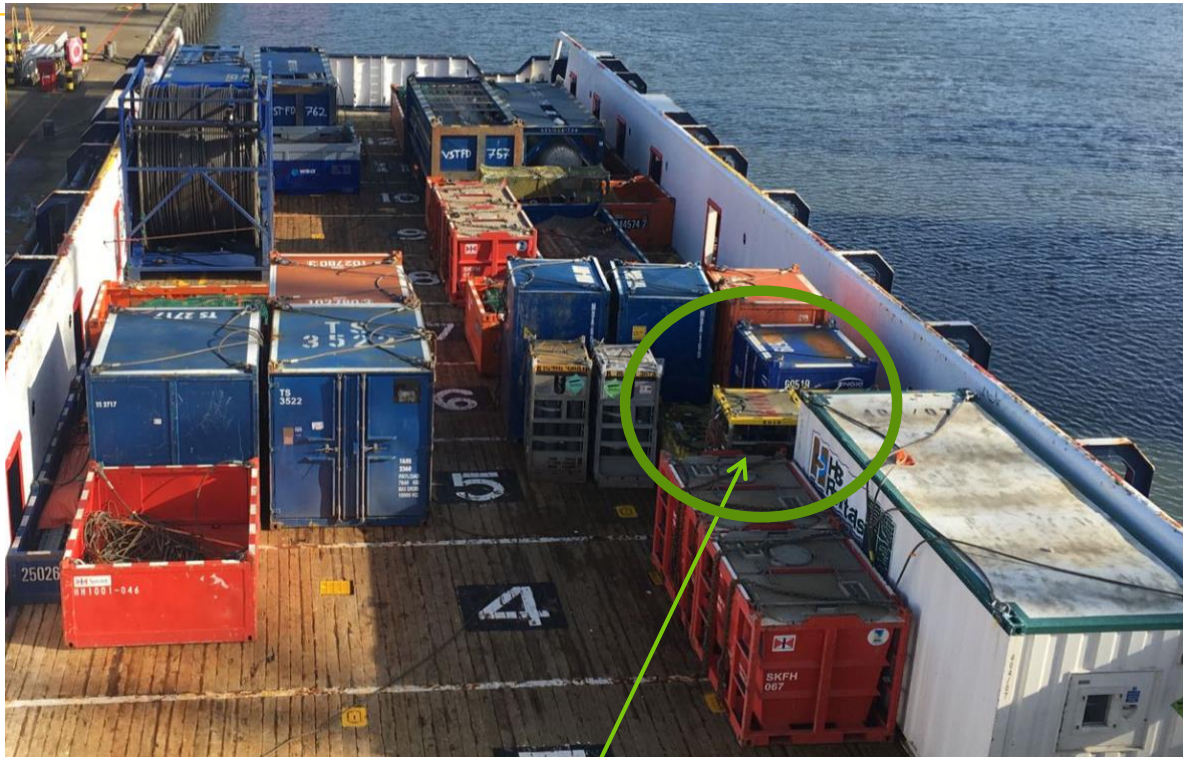
Image above shows the location of the gas racks on board the Highland Citadel prior to the vessel departing Den Helder.

It is noted that there is a blue 5ft container adjacent to the rack where the damage was sighted.

It remains the case that the damage could have been done when landing the blue container or when lifting the gas rack (or elsewhere).

No conclusions have been made in this regard
