# **PETERSON SBS DEN HELDER**

# **DROPS**

**08 OCTOBER 2009**

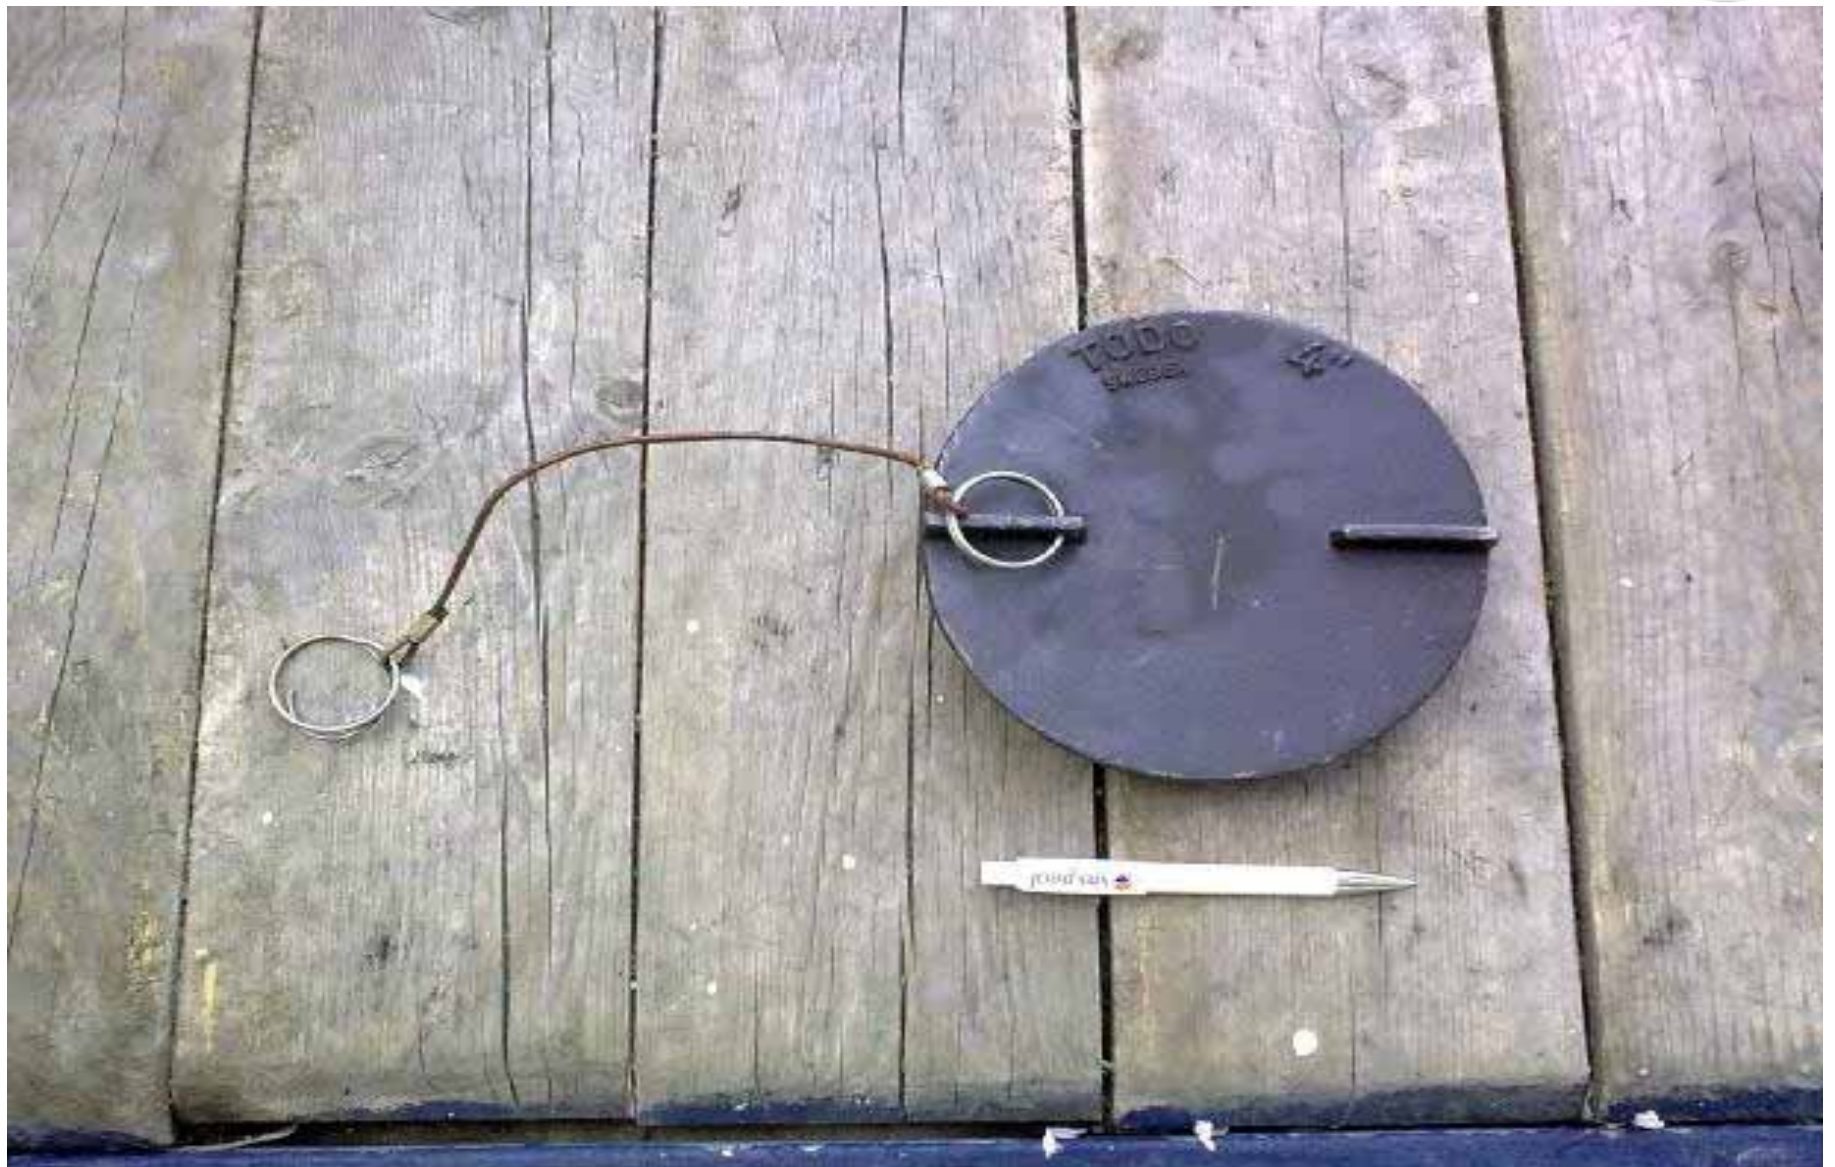
# CAP OF FUEL HOSE COUPLING

- Vessel had to deliver fuel to location and asked for the fuel hose
- On attempting to land the hose on deck the metal cap of the coupling fell down on the deck.
- Height appr. 15 mtrs.
- Weight of cap appr. 4 kg.
- AB's stood clear in safe haven – NO INJURIES!!

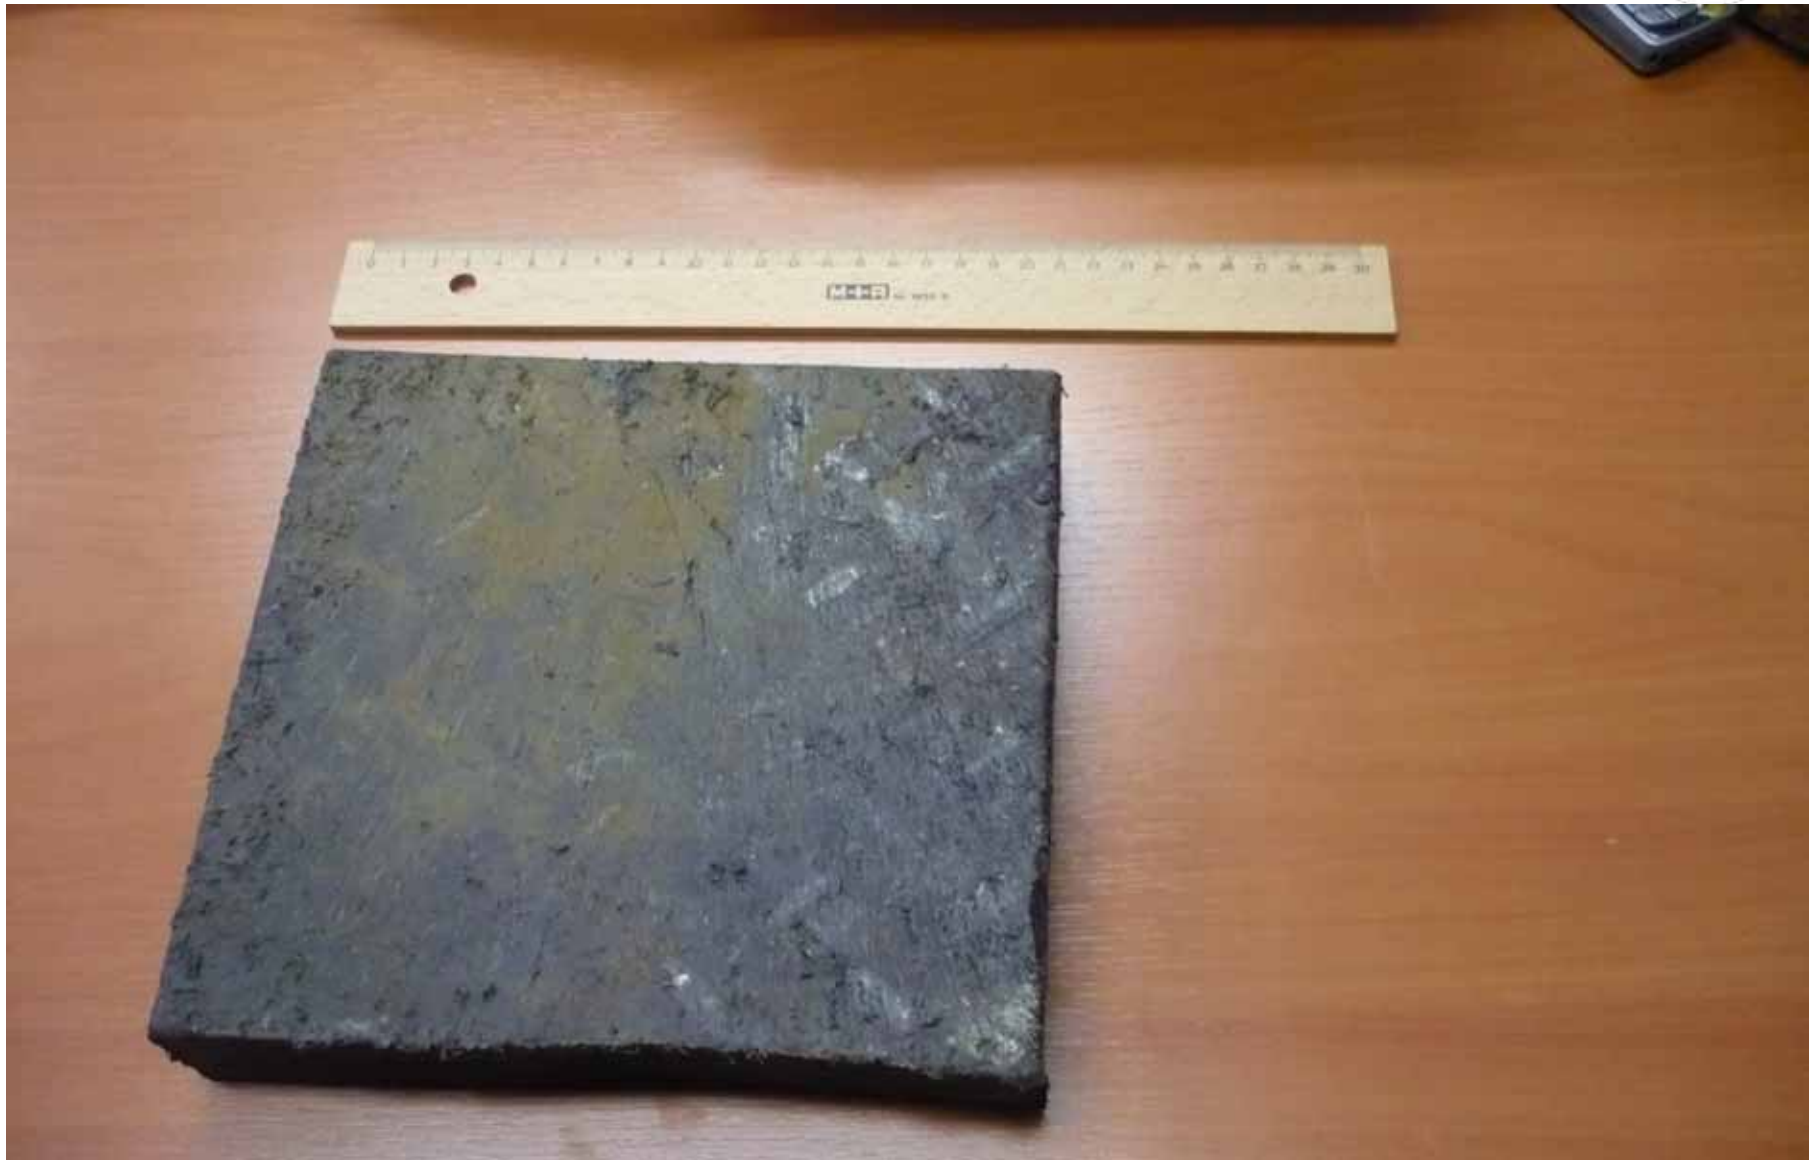
# PLASTIC PLATE

- Vessel was backloading from offshore location.
- A tank struck other backload.
- Piece of plastic fell down on the deck.
- Height was appr. 2.5 mtrs.
- Weight of plastic appr. 5 kg.
- Dims appr. 20 x 20 cm.
- Deck crew stood well clear – NO INJURIES!!
