Prevention of Dropped Objects Crane Theme October 2016

Dropped Object from Repsol Sinopec Resources Cranes 2013 -2016 (Socket Box)

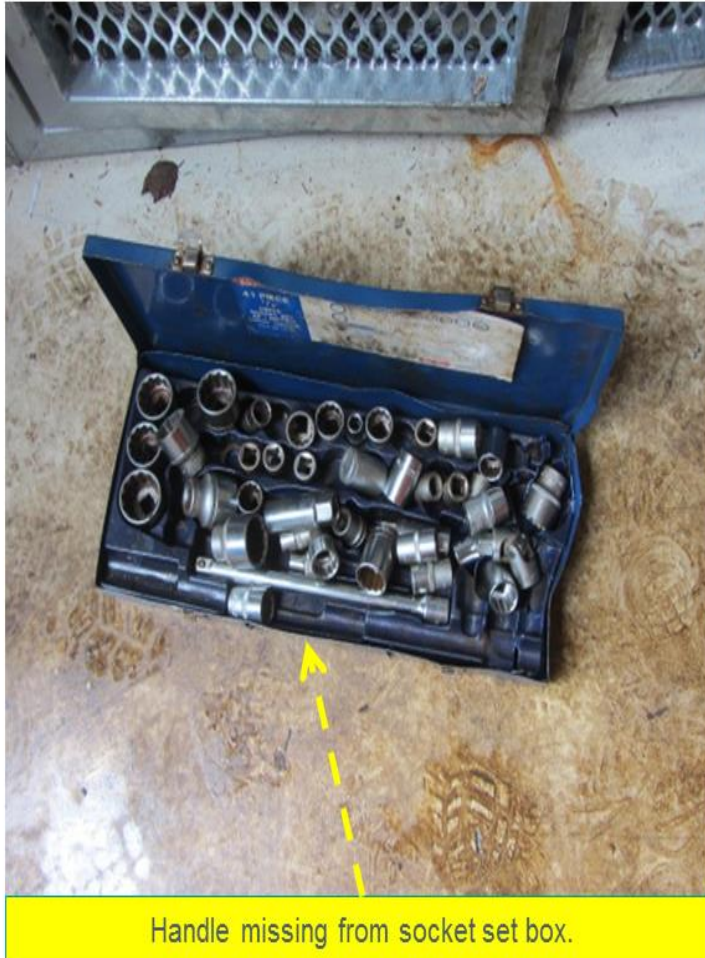
Socket set dimensions
45cm long
19cm deep
5cm high

Weight 6kg (box & contents)

The box opened on first impact,
spilling the contents.

The box itself was the heaviest
item at 1.6kg.

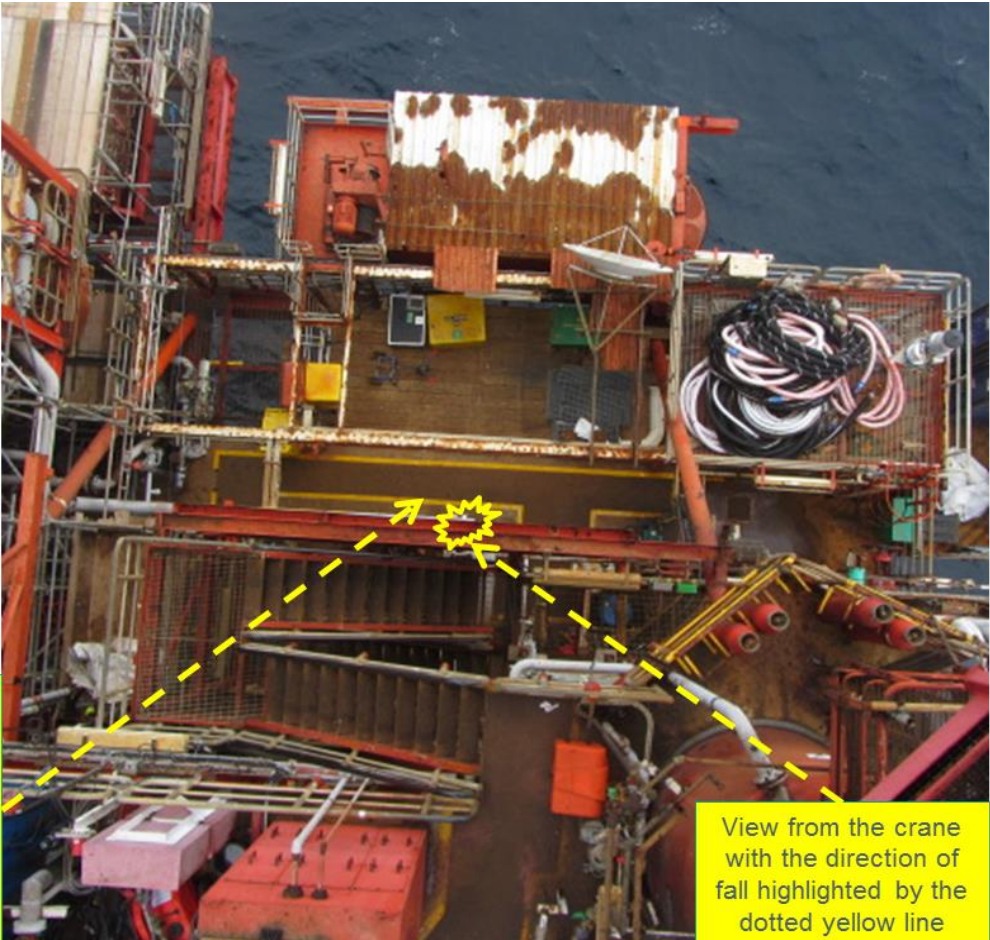
Final impact and resting place of socket set on the cellar deck walkway 7.5mtrs below where the toolbox impacted on its descent

View from the crane with the direction of fall highlighted by the dotted yellow line

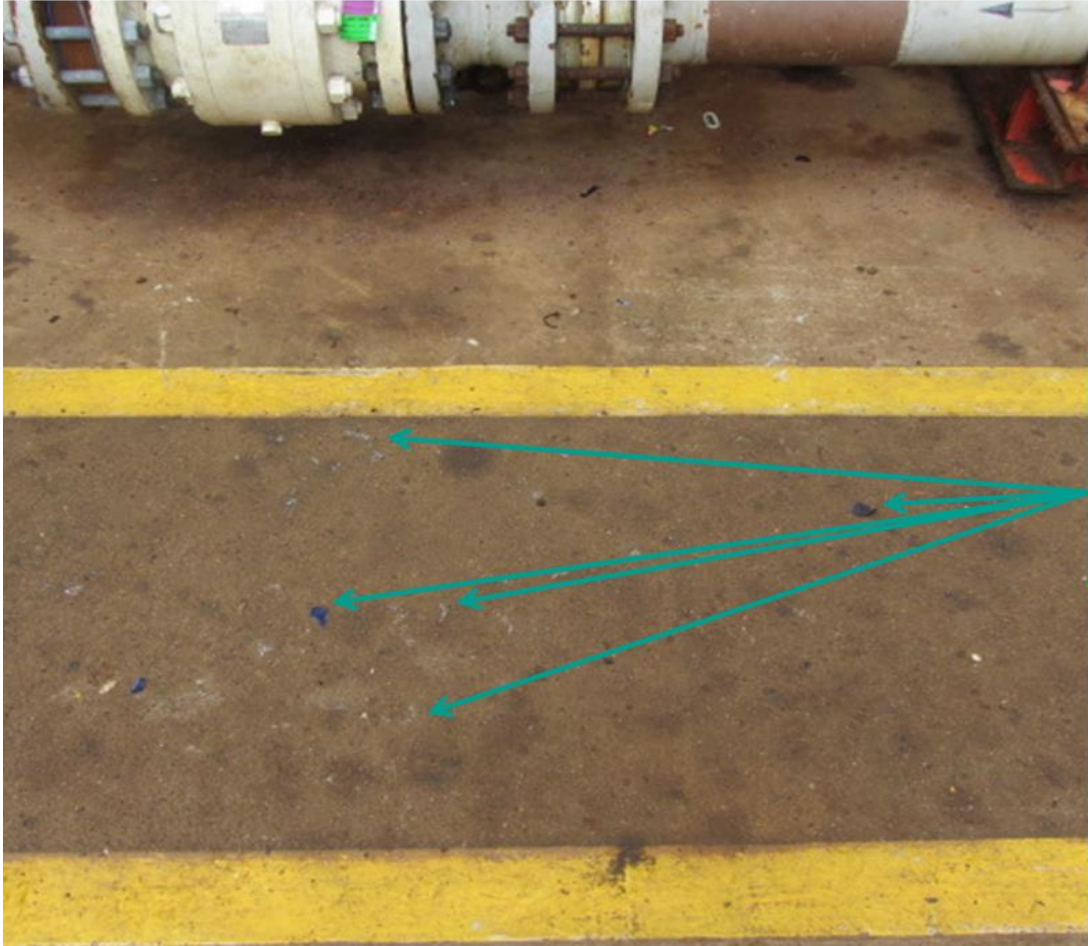
Several half socket shaped impact marks and pieces of the blue plastic inner tray on the walkway of the cellar deck

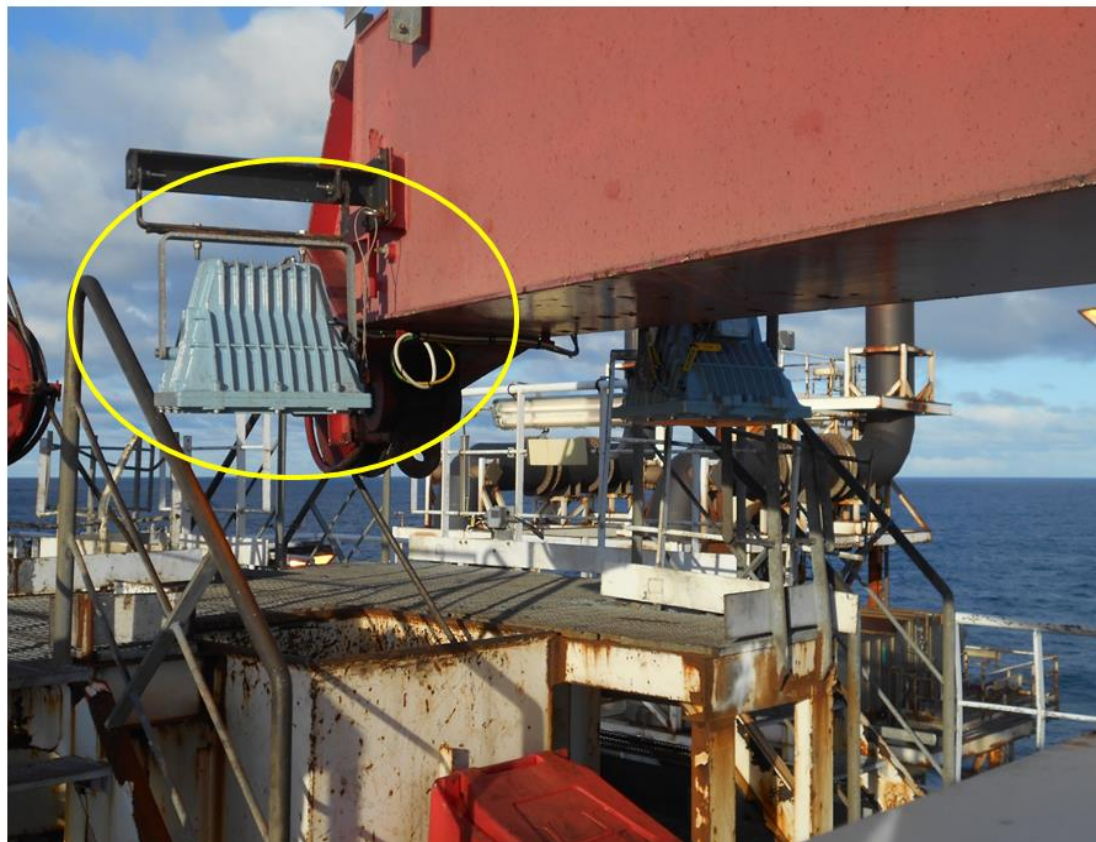
Position of floodlights fitted to AFT crane Boom tip

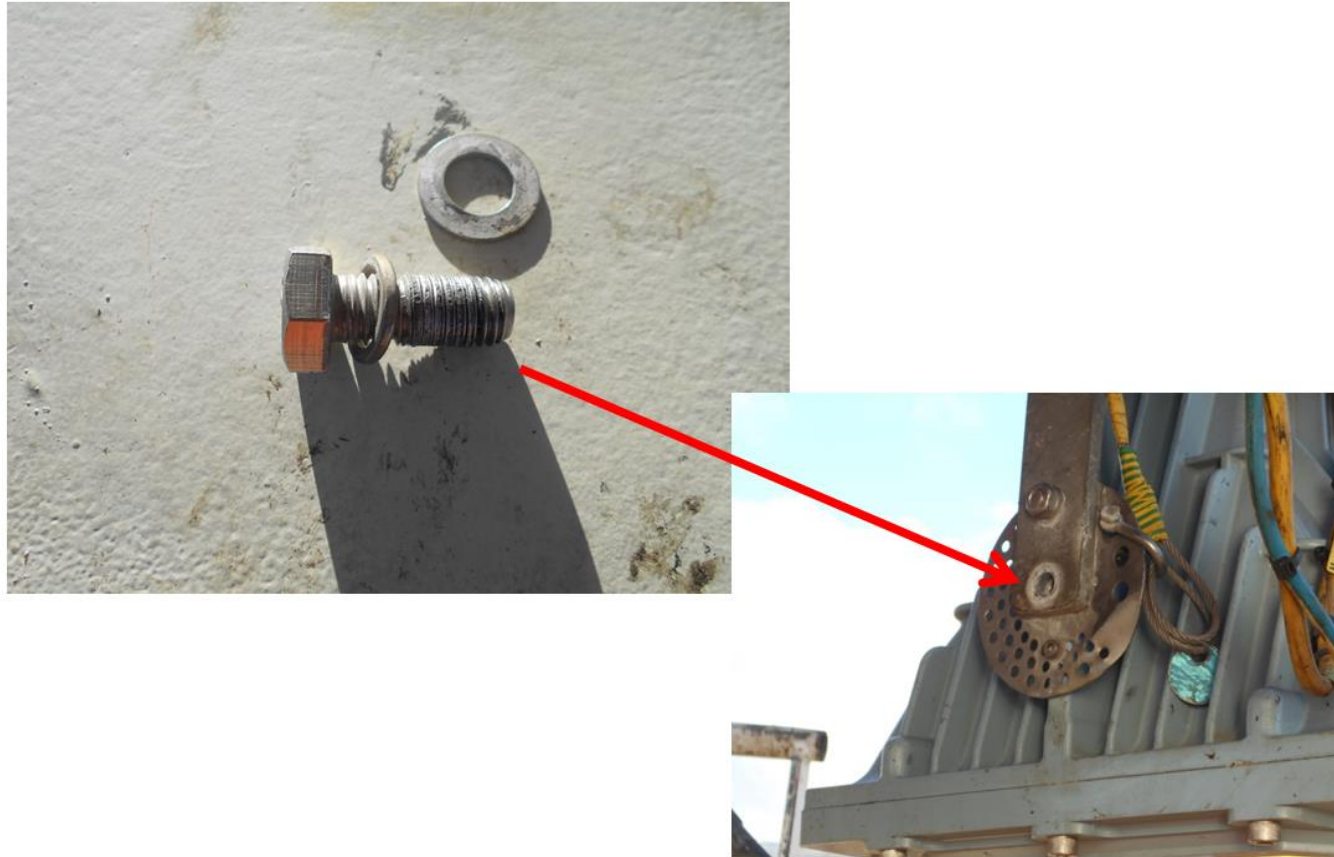
Example of missing bolt, which was the same as from the adjacent floodlight which threads stripped on tightening.

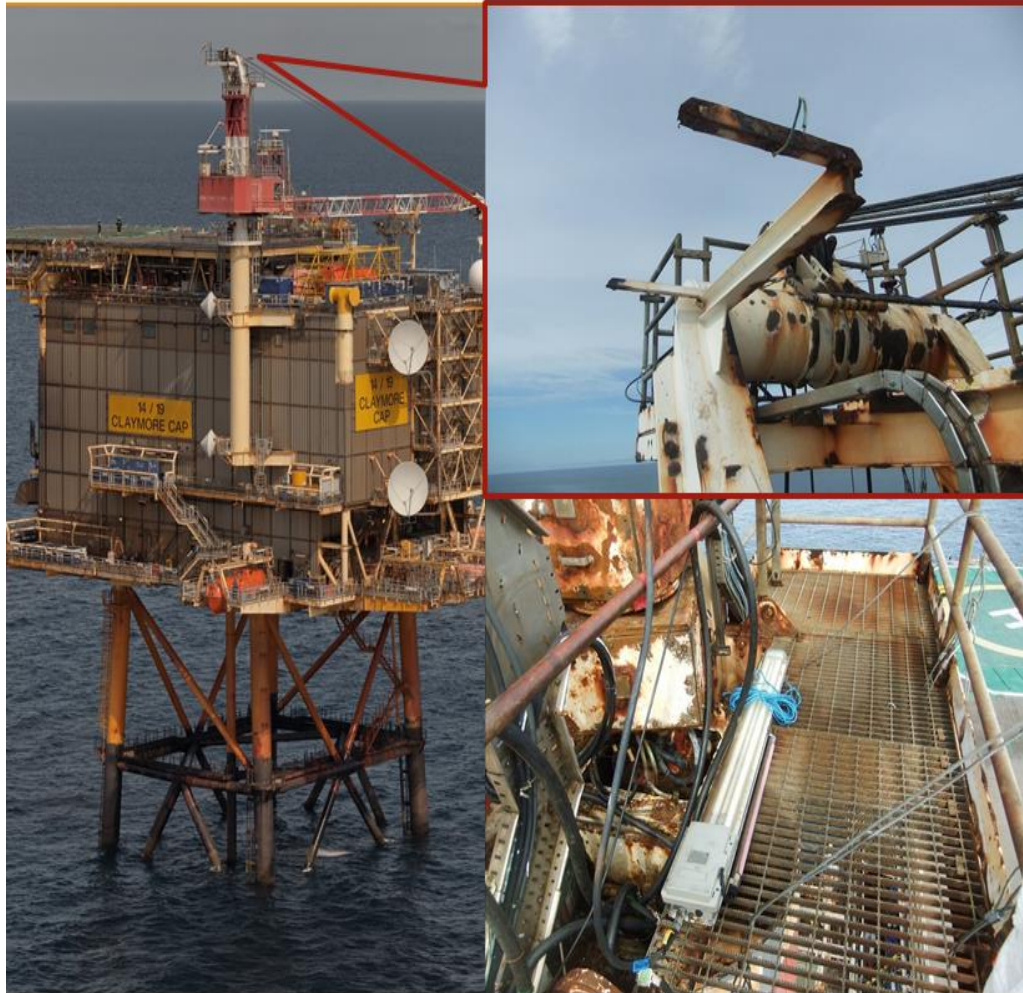
The light fitting became detached from one end and the weight caused the other bolt and earth strap to fail in a pendulum effect with the fitting coming to rest against the gantry below the fitting and suspended from the supply cable.

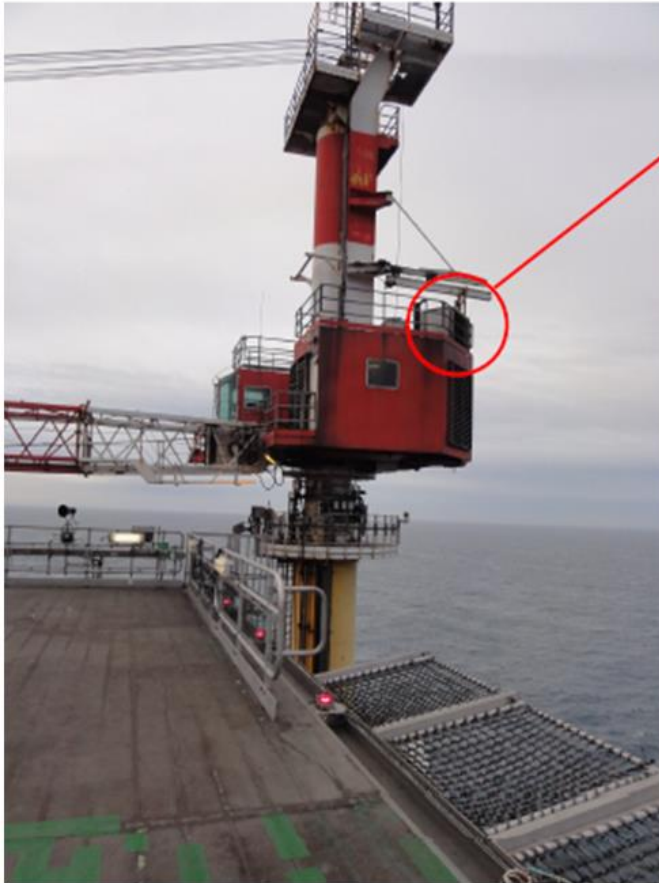
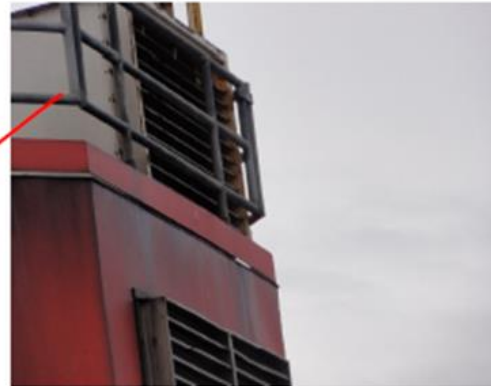
Engine air intake
Louvre landed on
the helideck

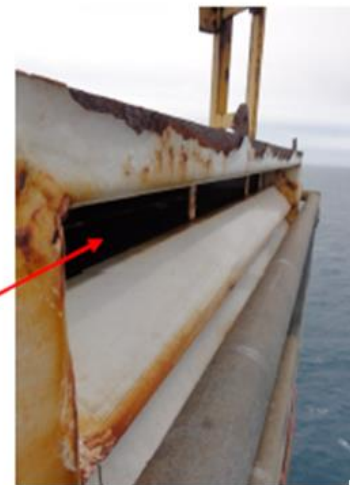
Missing Louvre

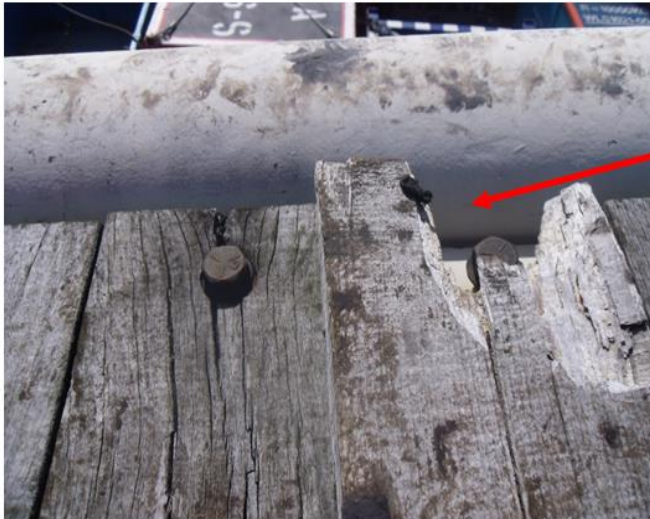
As found condition of the 4th Plank

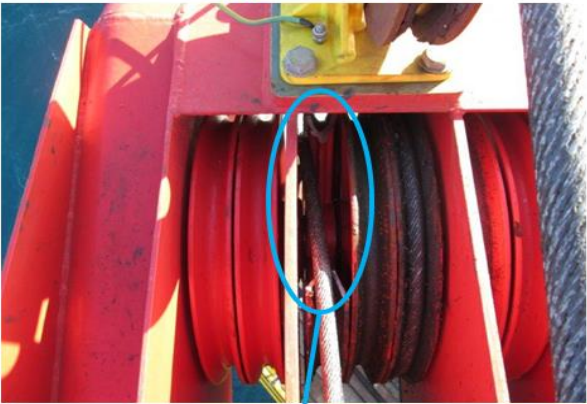
Missing / damaged section of main block cluster sheave

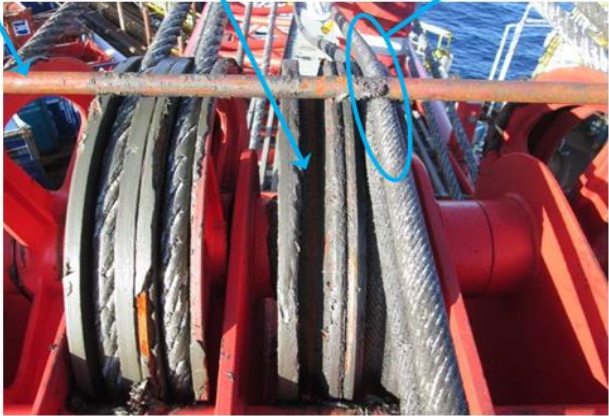
Whip line slipped out of whip line sheave and riding on top of main block sheave.

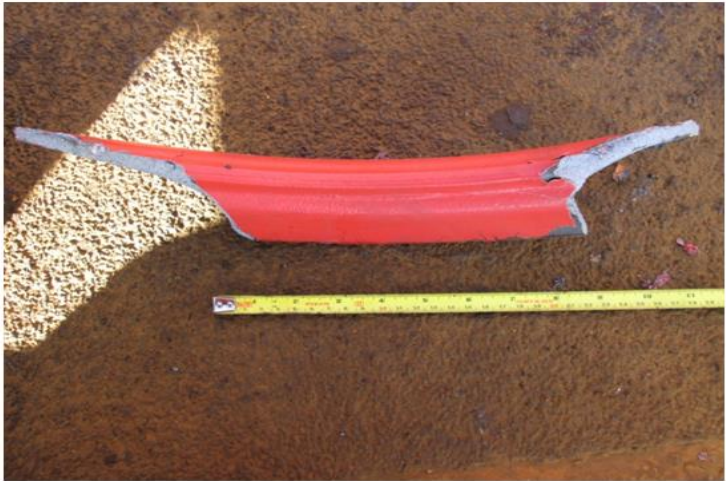
Final resting place (starboard aft pipe deck walkway)

Dropped Object – Weight 1.9Kg, Size 38cm x 6cm x 5cm

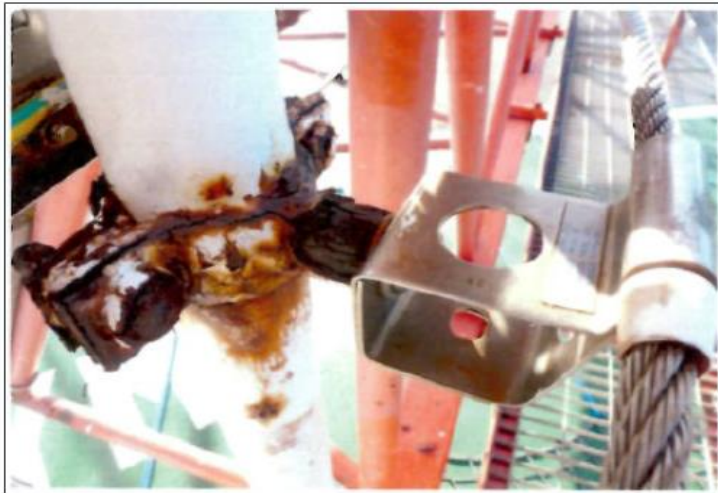
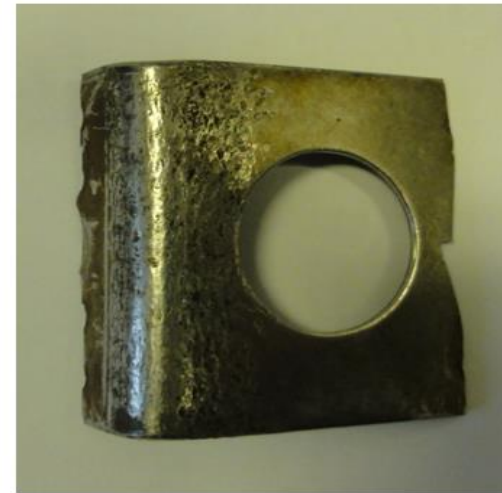
Crane Boom Safety Wire and Bracket Assembly

Broken Bracket
Weight 44.16 grams

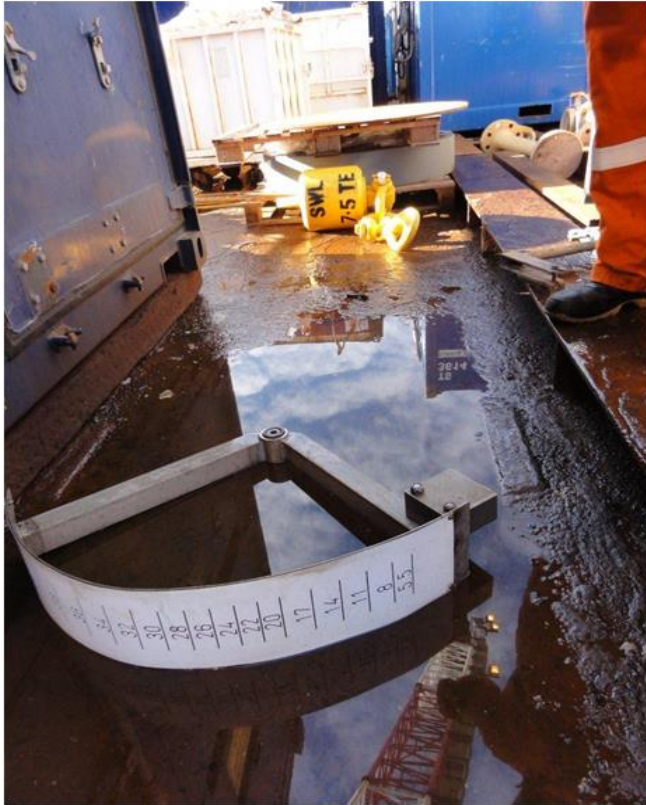
Final position of inclinometer on pipe deck

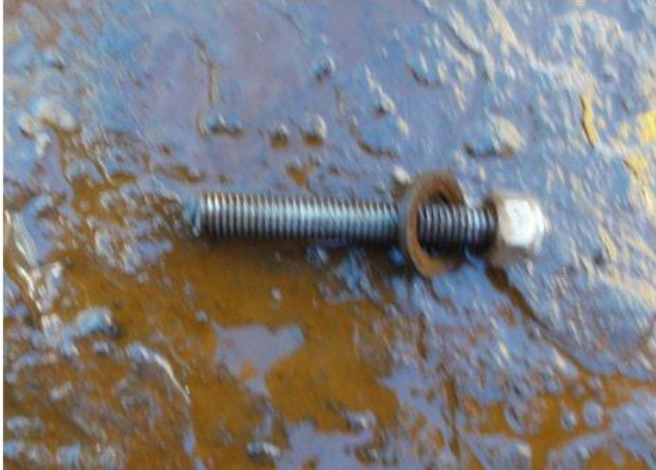
Sheared screwed rod as found on Pipe Deck

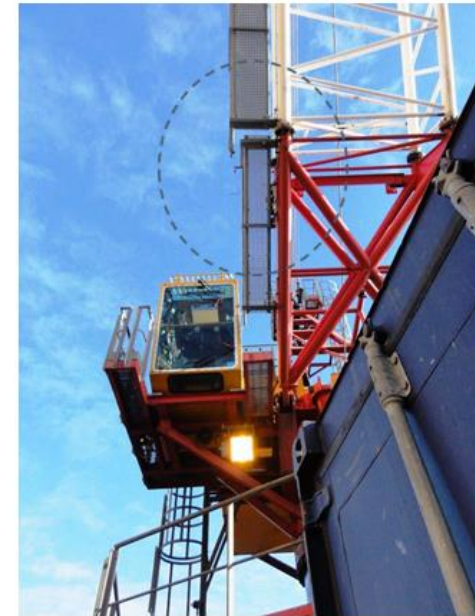
Inclinometer pointer and bracket East Crane, post incident
