Prevention of Dropped Objects Drops Forum 19th Sept 2017 By Lenny West

Overview

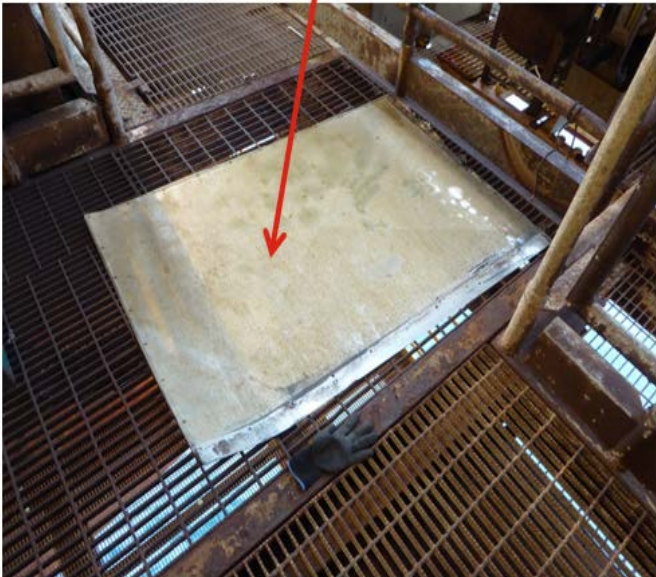
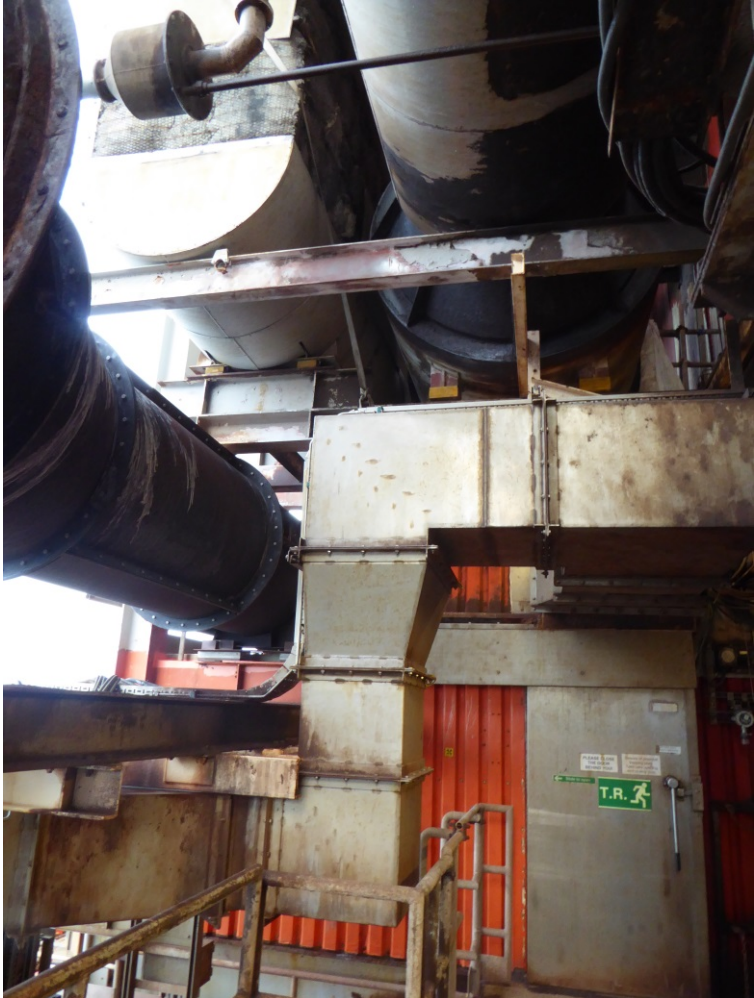
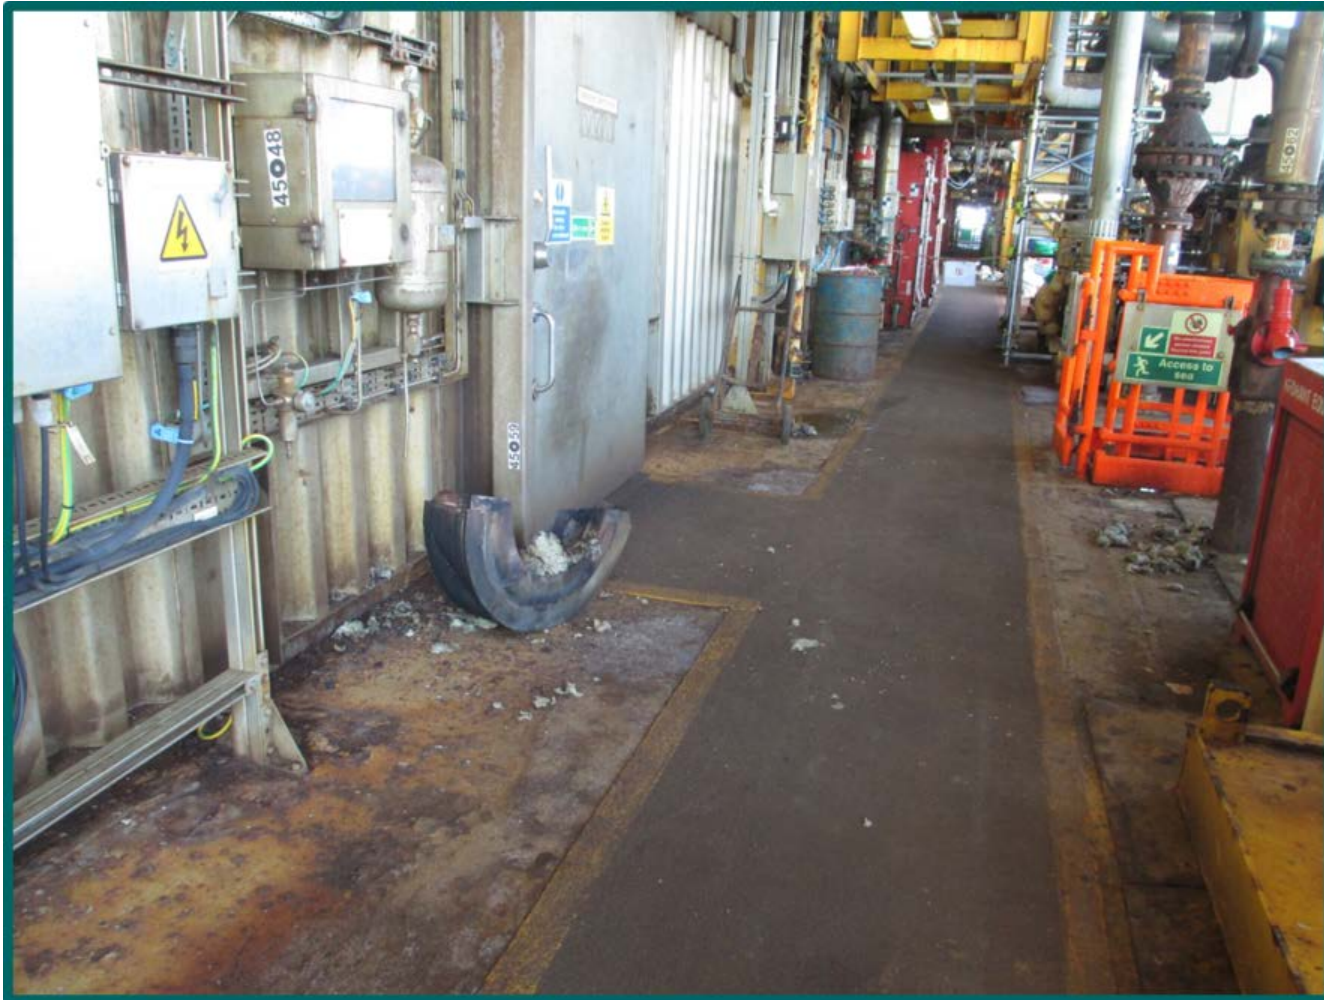
Emergency Generator exhaust ducting dropped 9mtrs to deck. HPI

Root Cause:

The insulation collar & clips have been in place for 20+ years. Also due to exposure regarding vibration during start-ups of the emergency generator, insulation being exposed to environmental elements e.g. wind, rain, and various temperatures this has been a root cause.

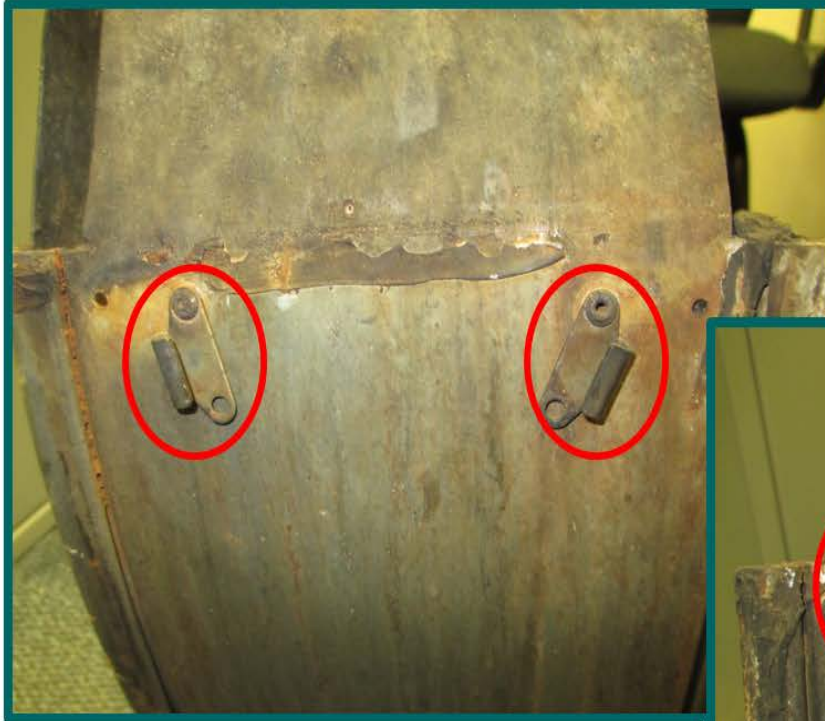
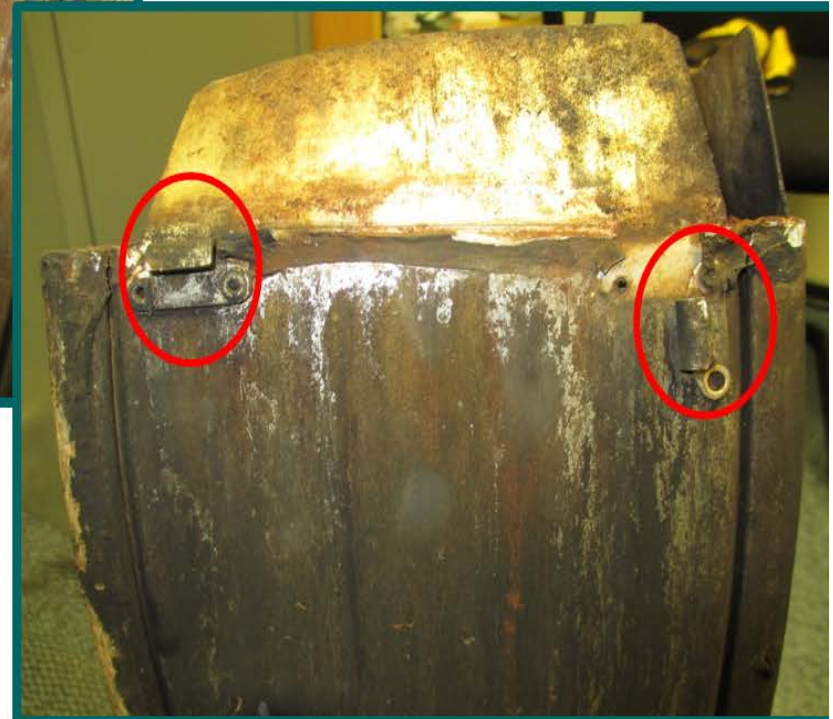
**Damaged securing fixings.
These four riveted clips alone
secured the two pieces of
ducting together**

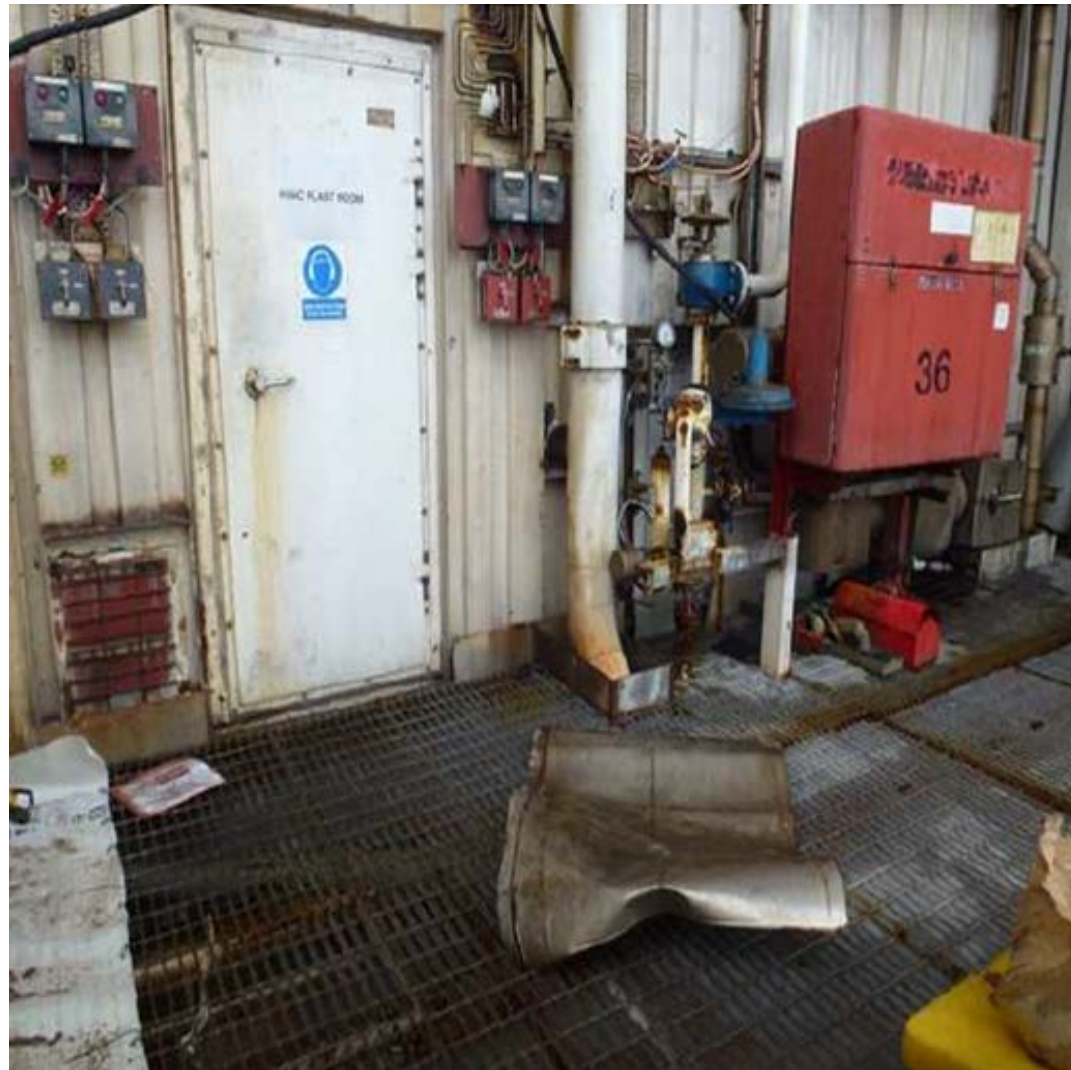
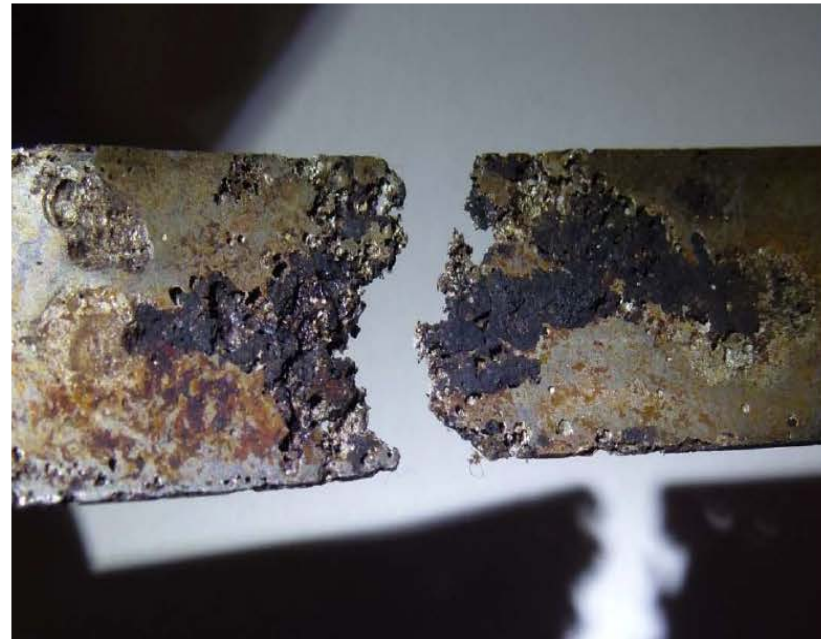
High Potential Incident Dropped Cladding

Root Cause

- **Incorrect banding material used for cladding retention**
 - 304 grade material instead of 316 material
 - 304 not recommended in marine environments due to low resistance to chloride induced corrosion.
- Metallurgy testing
 - No manufacturing anomalies
 - Complete mechanical failure
 - Process of chloride pitting
- Accelerating factor
 - Wind direction and speed
 - 25 kts 138deg (southerly)

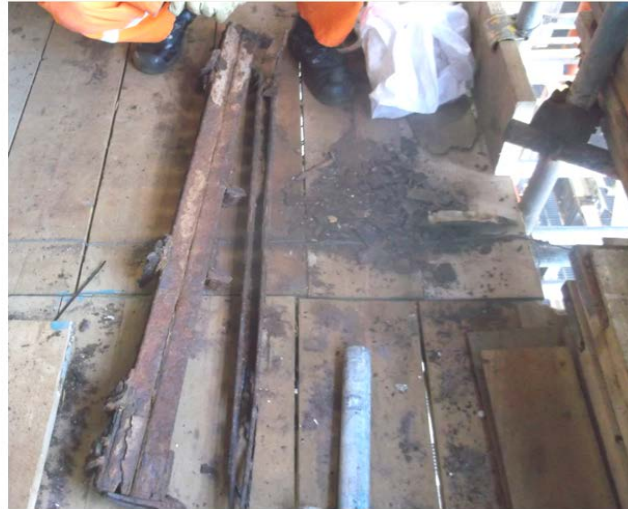
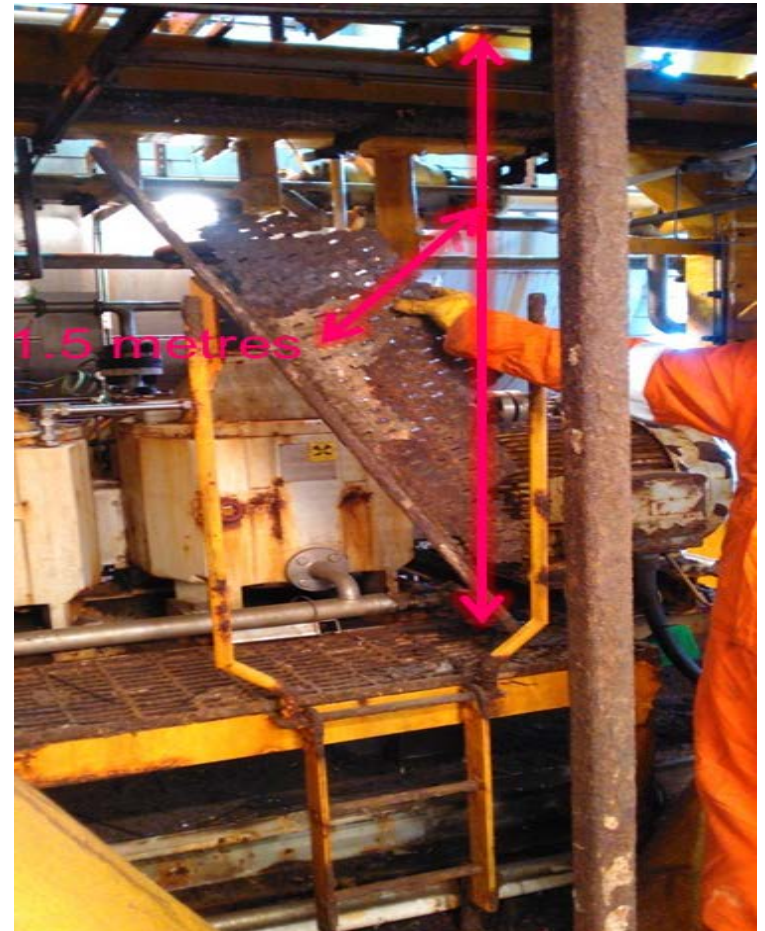
Examples of Cable tray/Unistrut drops

Both pieces of unistrut;
combined weight of
15 kgs
