Chain on OEM lifting assembly snagged

POTENTIALLY SERIOUS INCIDENT

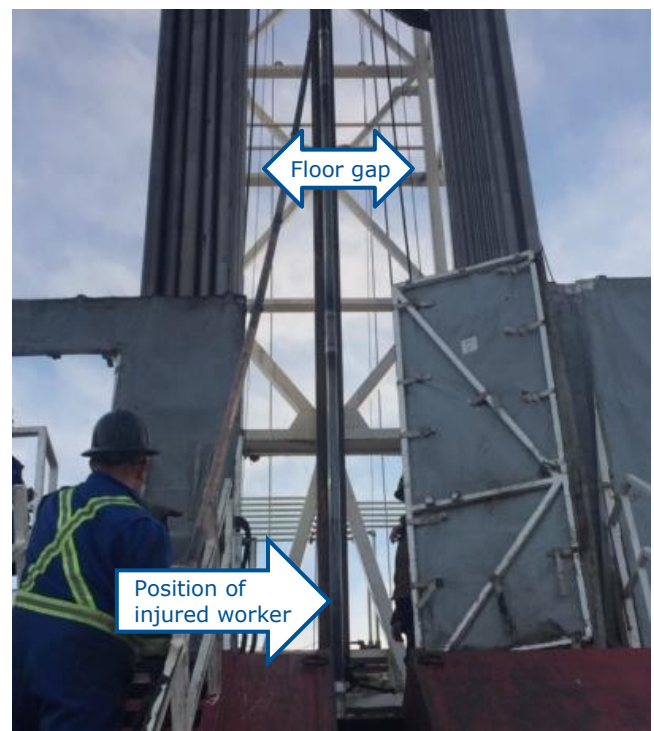
- The two workers had independently inspected the tool and lifting assembly before it was picked up. They verified that the retaining pin was in place.
- The retaining chain of the lifting assembly snagged on the racked pipe which allowed for the pin to release from the gate, allowing the tool to fall.
- This weak point of the design was previously identified, and an improved T-locking handle push pin was available but not all field kits had received the upgrade.
- The worker on the floor was positioned to provide both verbal and visual direction to the tugger operator but was standing in the drop zone to achieve that.
- Due to potential damage to the bottom of the tool, and the skate v-door design, the second worker had to guide the MWD tool up the stairs, which was also in the drop zone.

Re-enactment of the incident. NOTE: there is less pipe in this image than there was in the actual incident, so the floor gap would have been much narrower.

- Assess and update all lifting assemblies with OEM-approved modification.
- Regularly audit all mechanical lifting equipment.
- Identify line of fire and drop zones when handling tools and modify work practices accordingly.

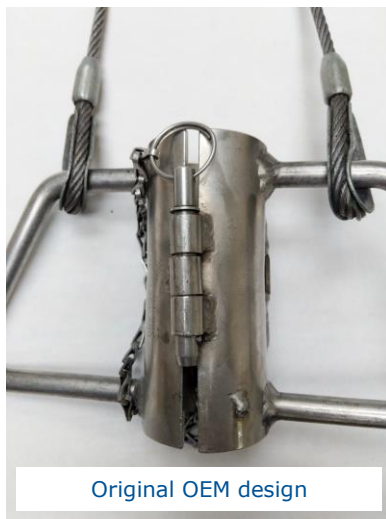
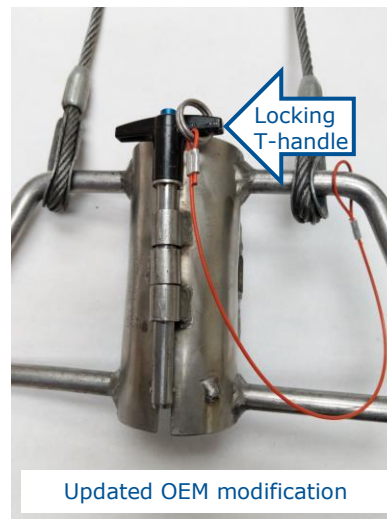
- The OEM design was susceptible to this failure.
- The upgrade for the lifting assembly was missed on the load-out.
- Inadequate hazard assessment of the existing, older-style assembly.
- Worker was positioned in the drop zone to give verbal and visual direction to the tugger operator, rather than at the top of the stairs giving only verbal direction.
