## Drill Line Cuts I-Beam Due to Incorrect Spooling

POTENTIALLY SERIOUS INCIDENT

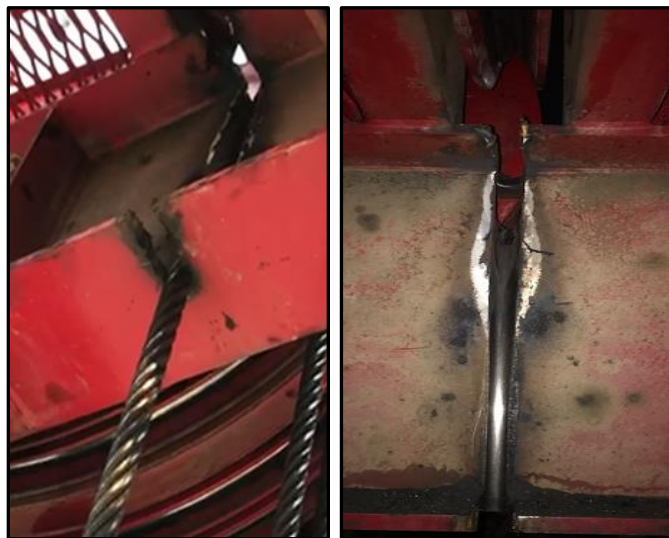
During drilling activities in a deep well, a significantly damaged I-beam located below the drilling rig crown block was identified when a melted piece of metal fell to the rig floor. The drill line was spooled incorrectly and had cut almost completely through the I-beam, which was located below the crown block and water table. This could have led to a serious incident.

- Guards or barriers were not present to prevent the drill line from passing above the water table I-beam (from the block to the fast-line sheave) when the crown was reeved (threaded).
- The job safety analysis (JSA) and rig-specific procedures did not identify this risk or the correct routing of the drill line.
- Personnel, including the supervisor, who were all very experienced, did not identify the incorrectly spooled drill line during string up (rig laid down) or subsequent dropped object inspections.

View of drill line cutting through I-beam

- To prevent a serious incident in the future, evaluate water table I-beams on similar drilling rigs and install guards to prevent the drilling line from being spooled incorrectly.
- Place a decal on the water table with instructions and an arrow indicating the drill line must be spooled under the water table.
- Revise JSAs to include correct routing of the drilling line from the traveling block to the fast line sheave under the water-table I-beam and not above.
- Revise the rig-specific operating procedures to include correct routing of the drill line, including photos of correct and incorrect spooling of drill line at the water table I-beam.

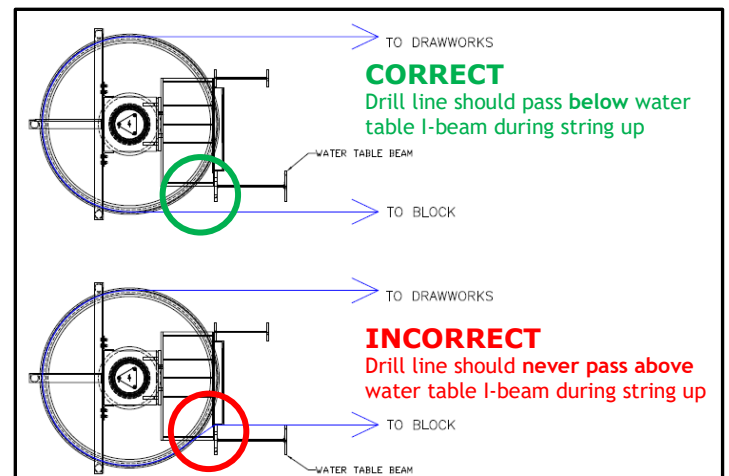
View of correct and incorrect orientation of drill line

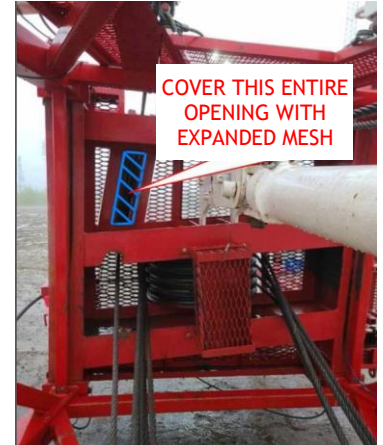
View of engineering guard to prevent improper spooling of drill line
