SCAFFOLD WORKER HIT BY FALLING SCAFFOLD BOARD INCIDENT

20-JULY-2011

PEARL GTL

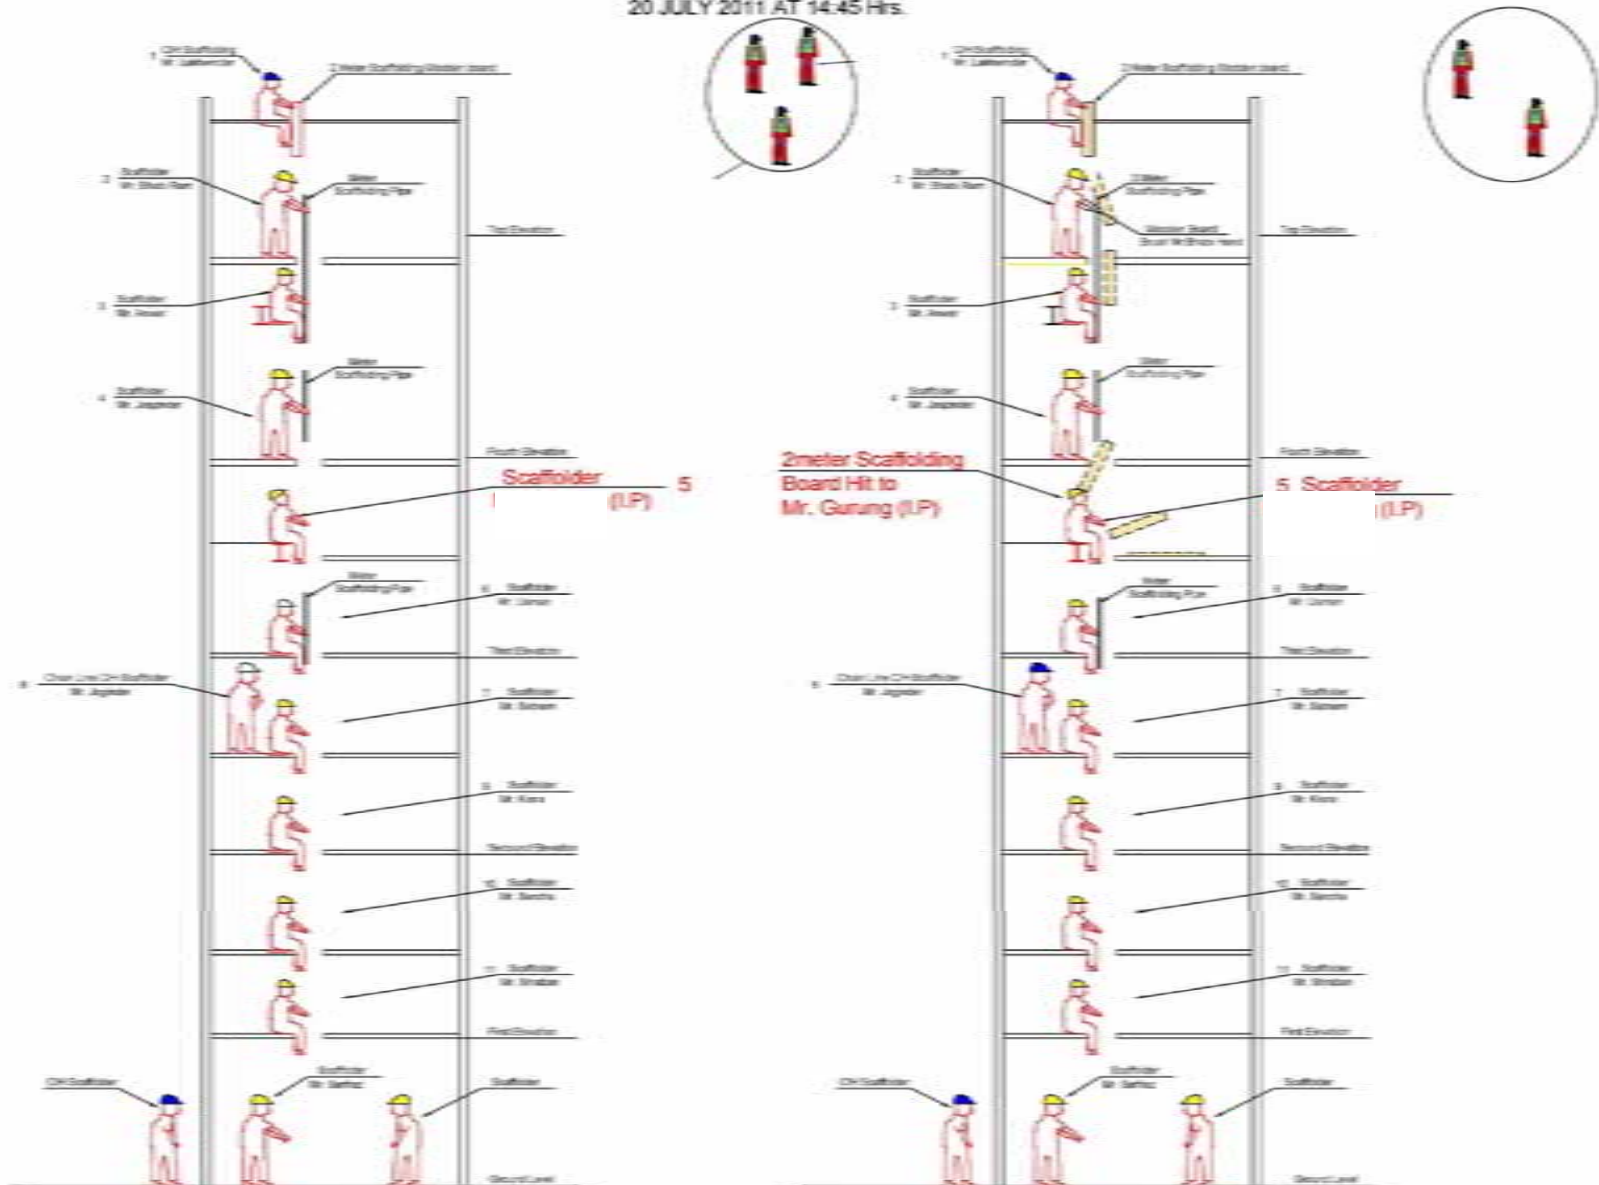
SCHEMATIC DIAGRAM OF THE MAN CHAIN

Description: On 20th July 2011 at around 1445 hrs. Scaffolder was assigned to pass scaffolding material, working in a Man Chain of 10 people and was hit on the helmet by a two meter wooden plank of scaffolding that dropped from 6 meter height. Due to the impact, the helmet was struck down against the IP's forehead causing a 4 cm laceration to his forehead and pain to his neck.

PHASE II - BB 11 SCAFFOLDING INJURY
20 JULY 2011 AT 14:45 Hrs.

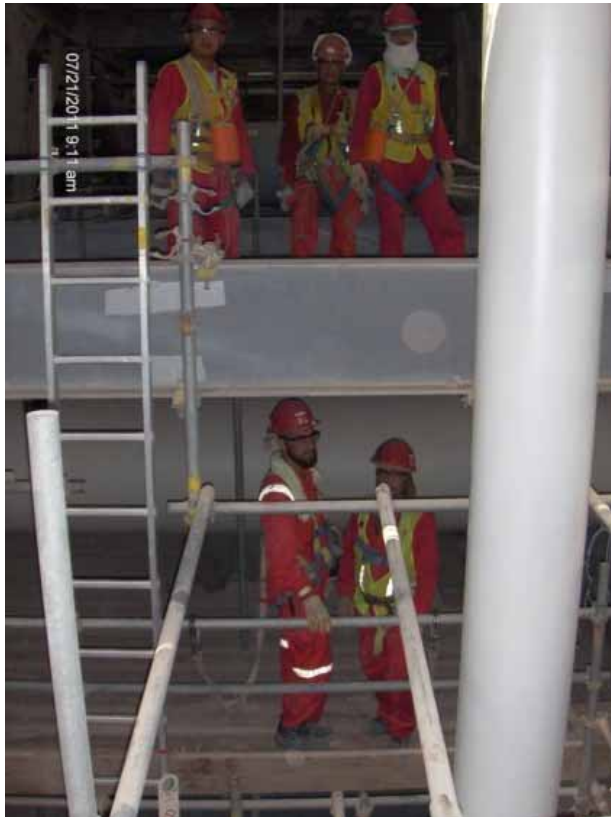
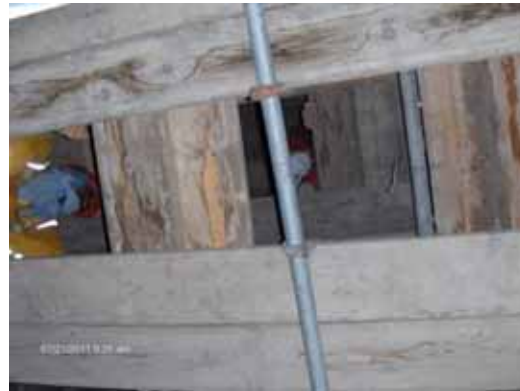
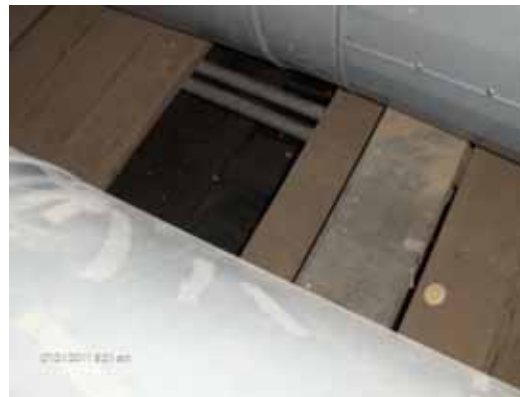
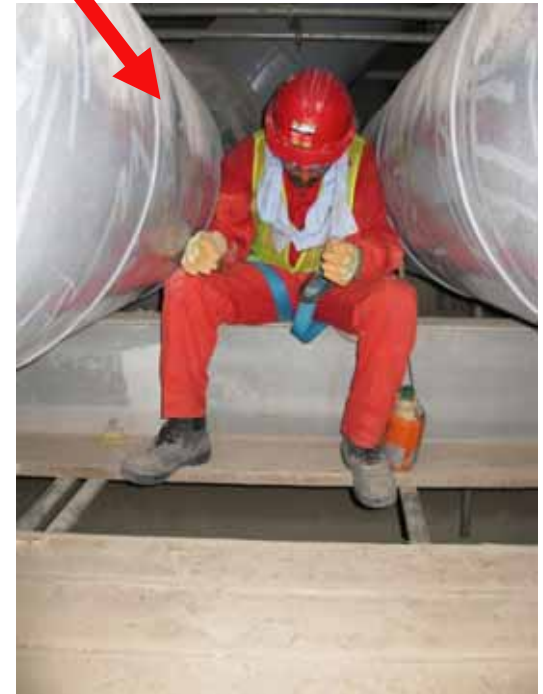
SCAFFOLD DISMANTLING INCIDENT LOCATION

Position of Injured Scaffolder
