ABERDEEN DRILLING CONSULTANTS

DROPPED OBJECT STUDY

DRILLING CONTRACTOR YARD AND WAREHOUSE FACILITY

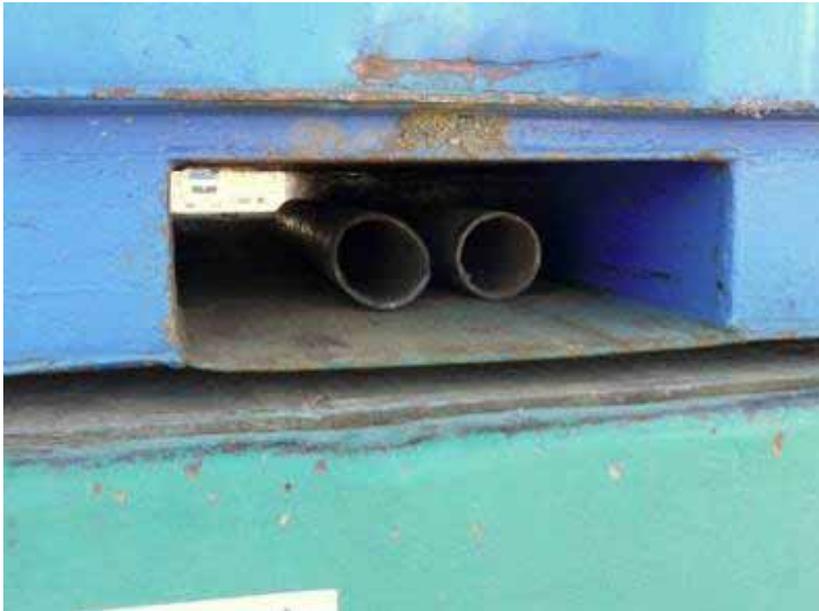
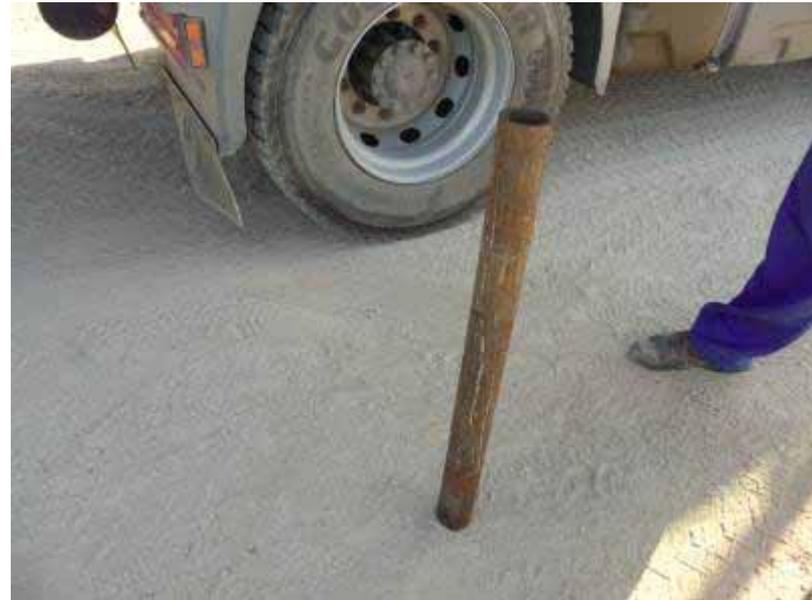
Three very significant potential dropped objects were found in the forklift pockets in the shape of the presently redundant stanchion posts for the flat bed trailer.

A TOFS was called immediately and a safety conversation held with the driver who admitted to having put them there. He had always done this, even though he had heard of incidents whereby the stanchion posts had fallen off the lorry in transit.

It transpired that there was no dedicated storage for these stanchions other than the sockets in which they are used, as required.

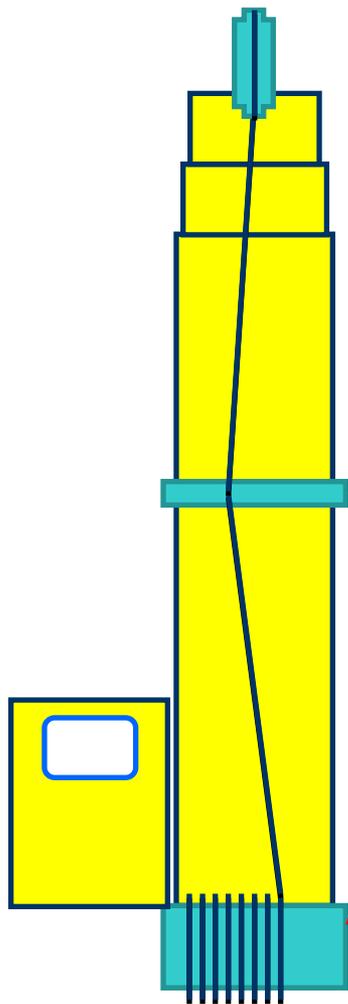
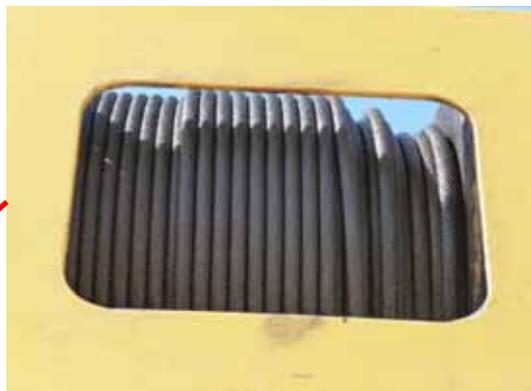
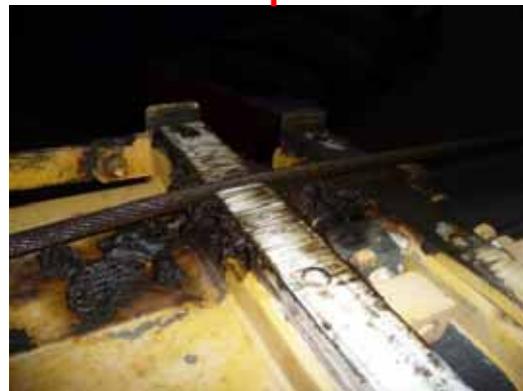
The yard crane, however presented several improvement opportunities. Of greatest concern was the poor spooling on the winch drum, as a result of a severely grooved wear plate on the boom, which had apparently gone unnoticed before. It was recommended that the maintenance and frequency of checks be further reviewed.

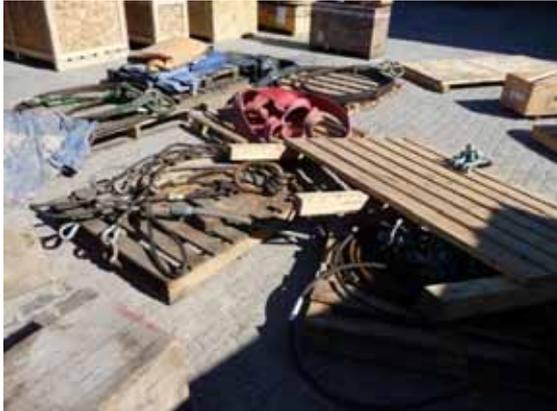
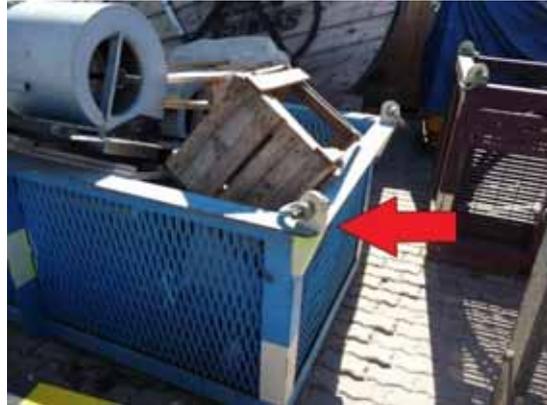
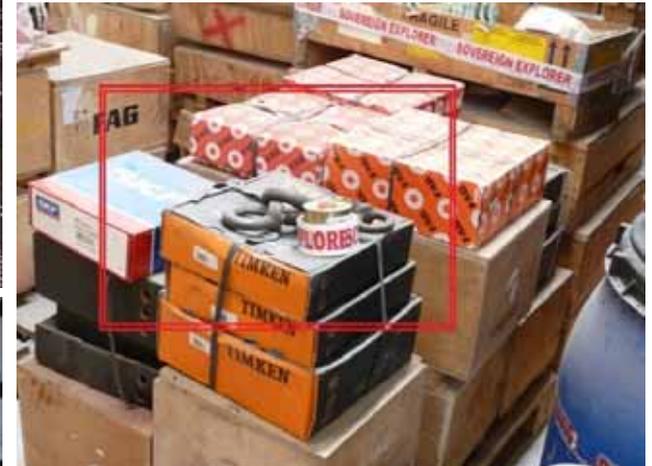
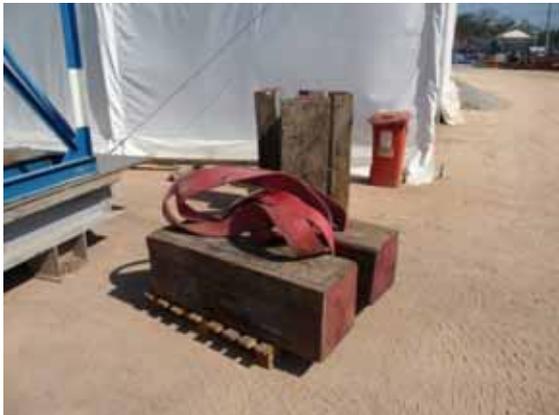
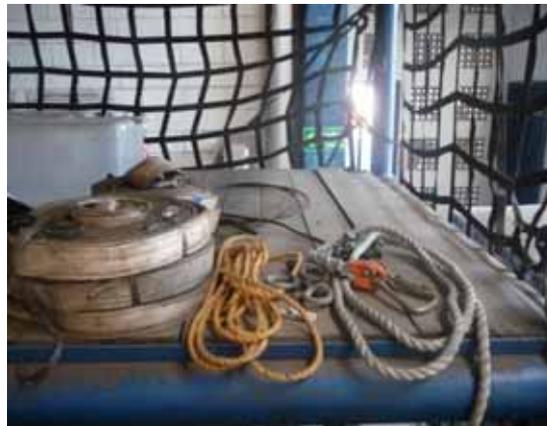
The control of lifting equipment was found to be very poor. Rigging loft and quarantine procedures, as is normal offshore, were not in place. There were many observations of slings, shackles and canvas strops etc., in various conditions, lying around the yard, or attached to equipment and therefore available for use.

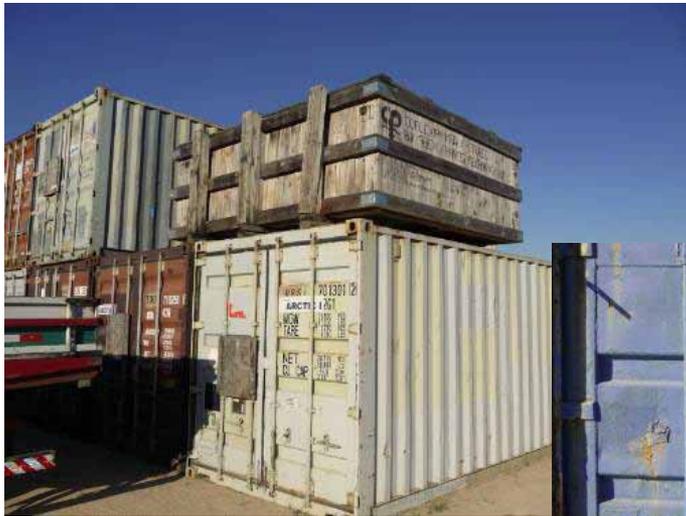
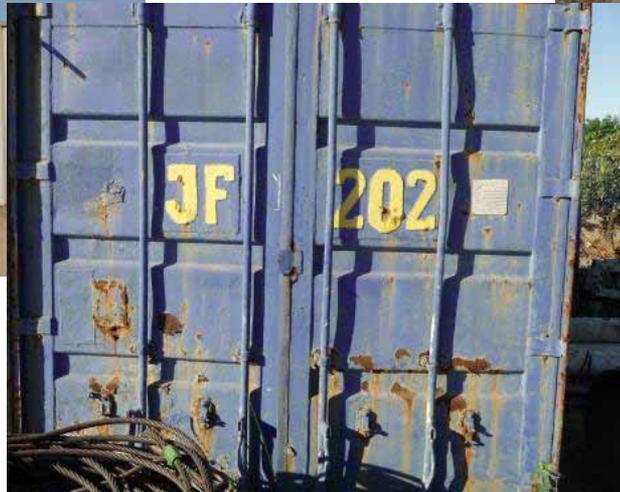
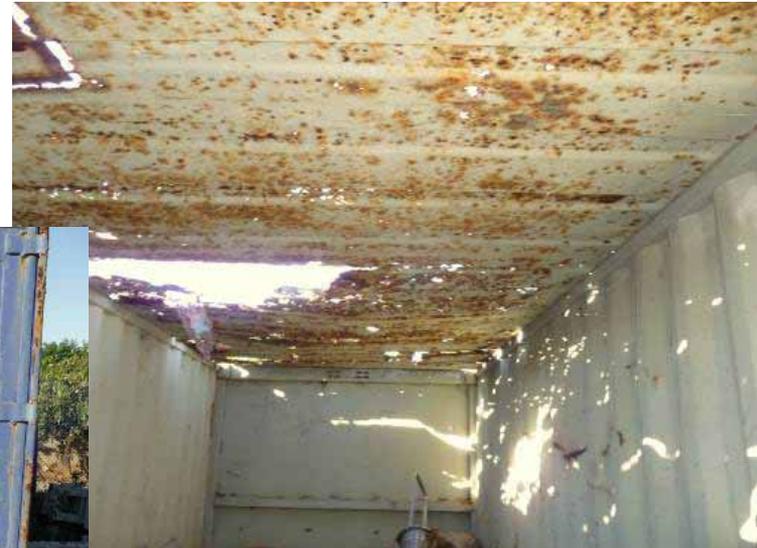
Several observations were noted where crates and palletised equipment were being stored on top of storage containers. The structural strength of these units, which are designed to be stacked, obviously is found within the outer frame and uprights. Roof panels are not designed to support loads and are subject to corrosion. An extreme example regarding such corrosion and wastage was found in the south yard

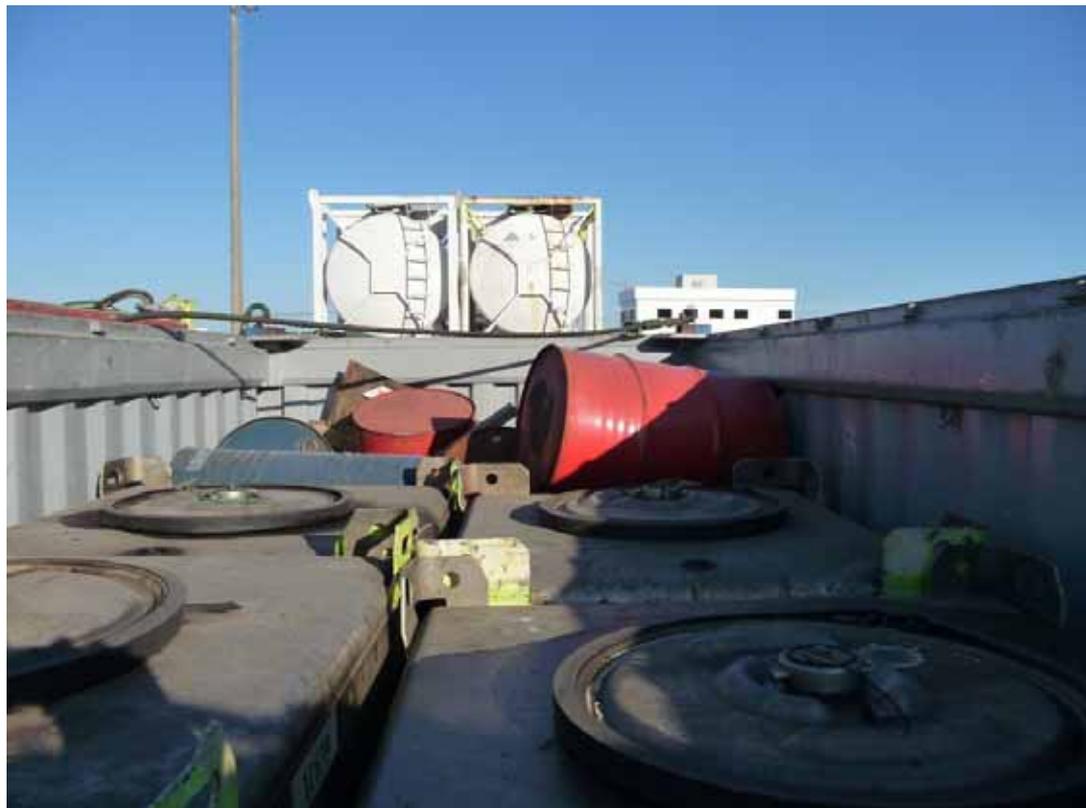
ADC witnessed a container, recently returned from offshore, which was poorly loaded. Several barrels were piled up at the rear of the lube oil tanks, such that when the lube oil tanks were removed, by forklift or lift trolley, the barrels were bound to fall and collapse, this could easily have resulted in chemical or oil spillage and / or personal injury

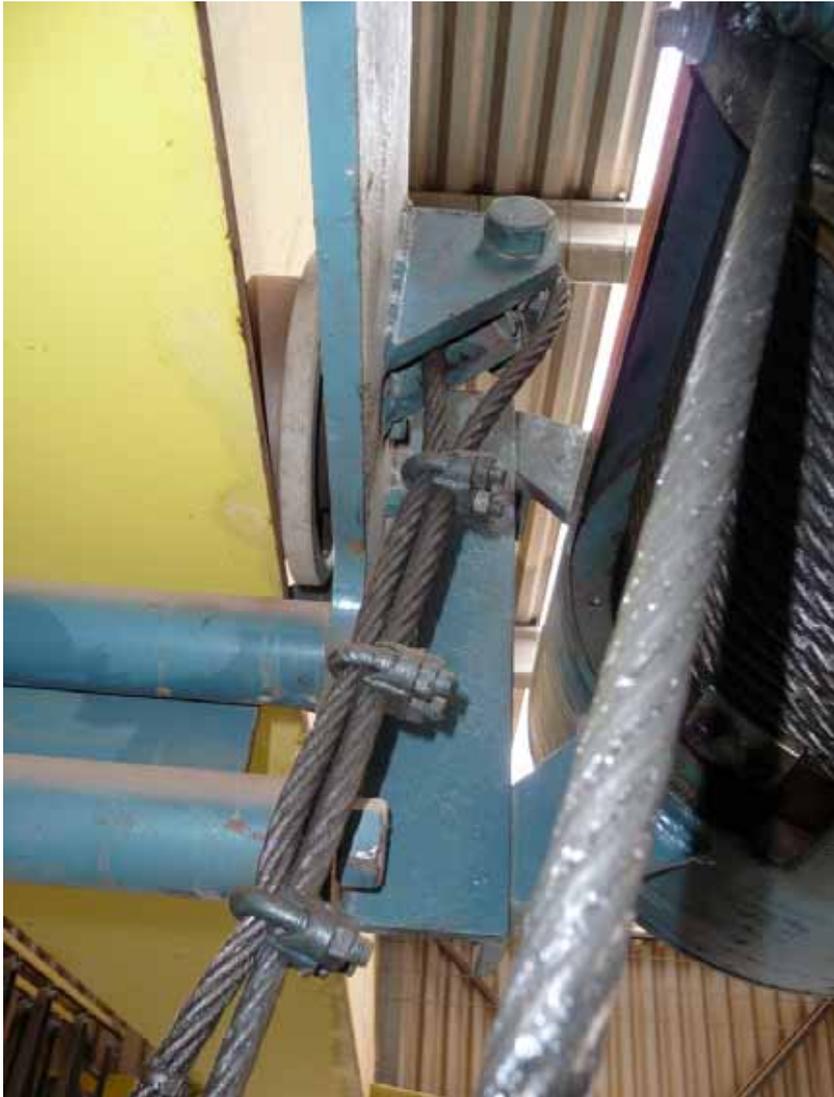
One concern noted, was the use of bulldog grips on the deadman termination of the gantry crane in warehouse 1.

The 10th edition of the International rigging and lifting handbook, recognised throughout our industry, forbids this practice and does recommend the use of an open wedge socket.

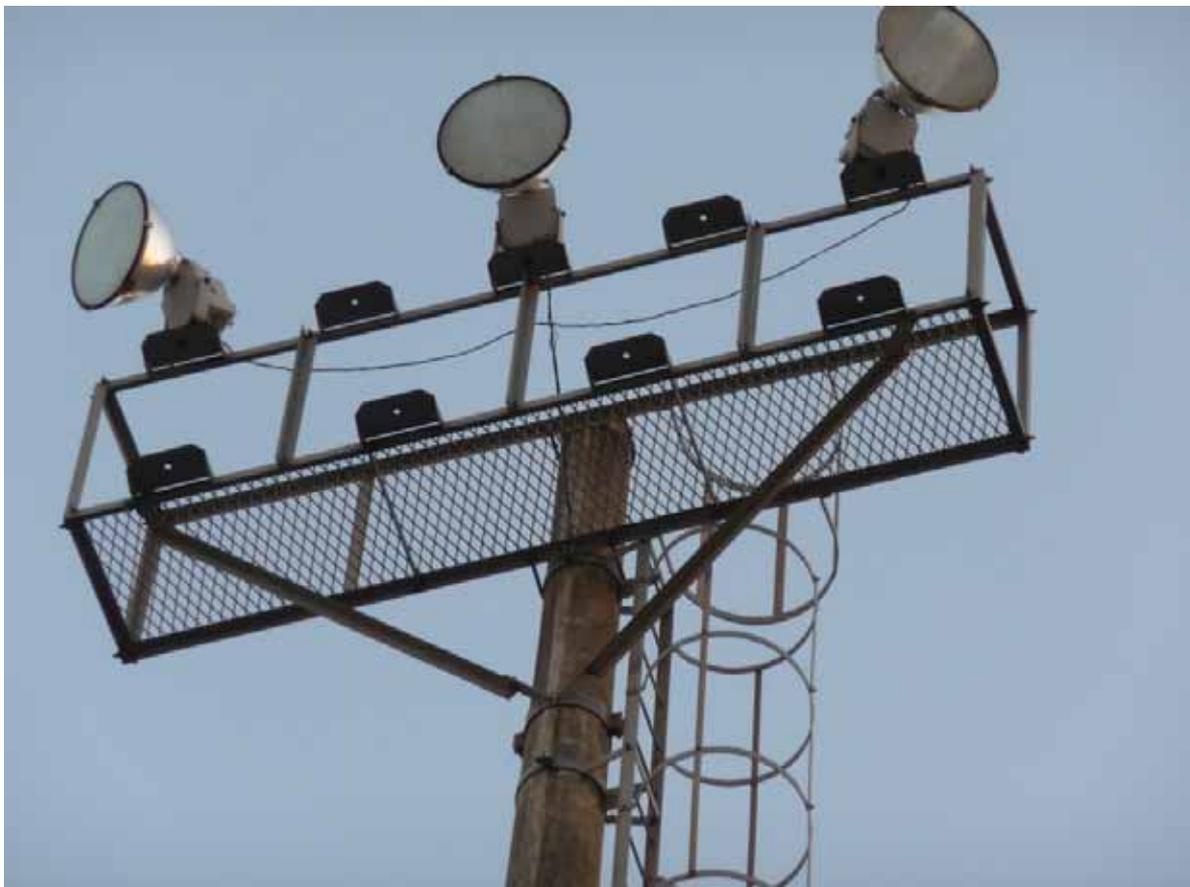
There were several floodlights installed around the two yards. It was stated that these were maintained by a third party company as and when required and that rather than using the affixed ladder the yard crane was utilised to man-ride in a work basket.

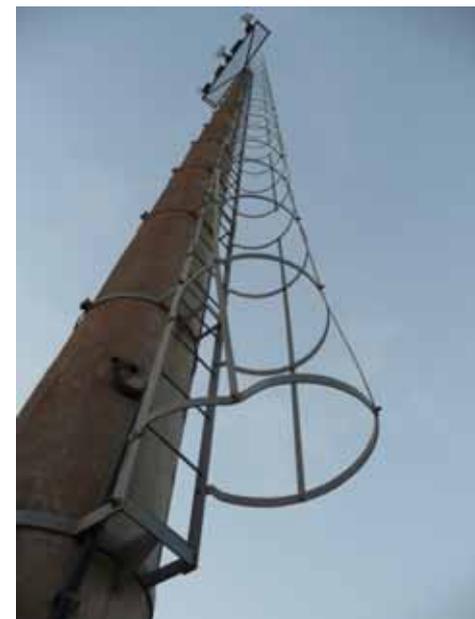
As stated previously each platform could be accessed by a ladder and backscratcher system which would eliminate manriding in the uncertified basket.

None of these ladders was installed with a fixed ladder system, as would be required offshore by most companies fall protection policies and procedures.

Similarly there was no secondary retention on the light fittings or CCTV cameras installed.

It was recommended that rescue plans be developed and documented.
