**PBL-2008-DEC-29-SNH**

<b>HSE ALERT</b>	Number	NSM-HSE-AL-003
		Prepared / reviewed:	A Leslie / K Murdoch
		Approved By:	K Knott
		Issue Date	January 26 <sup>th</sup> , 2009

### WOODEN CRATES IN AN OFFSHORE ENVIRONMENT

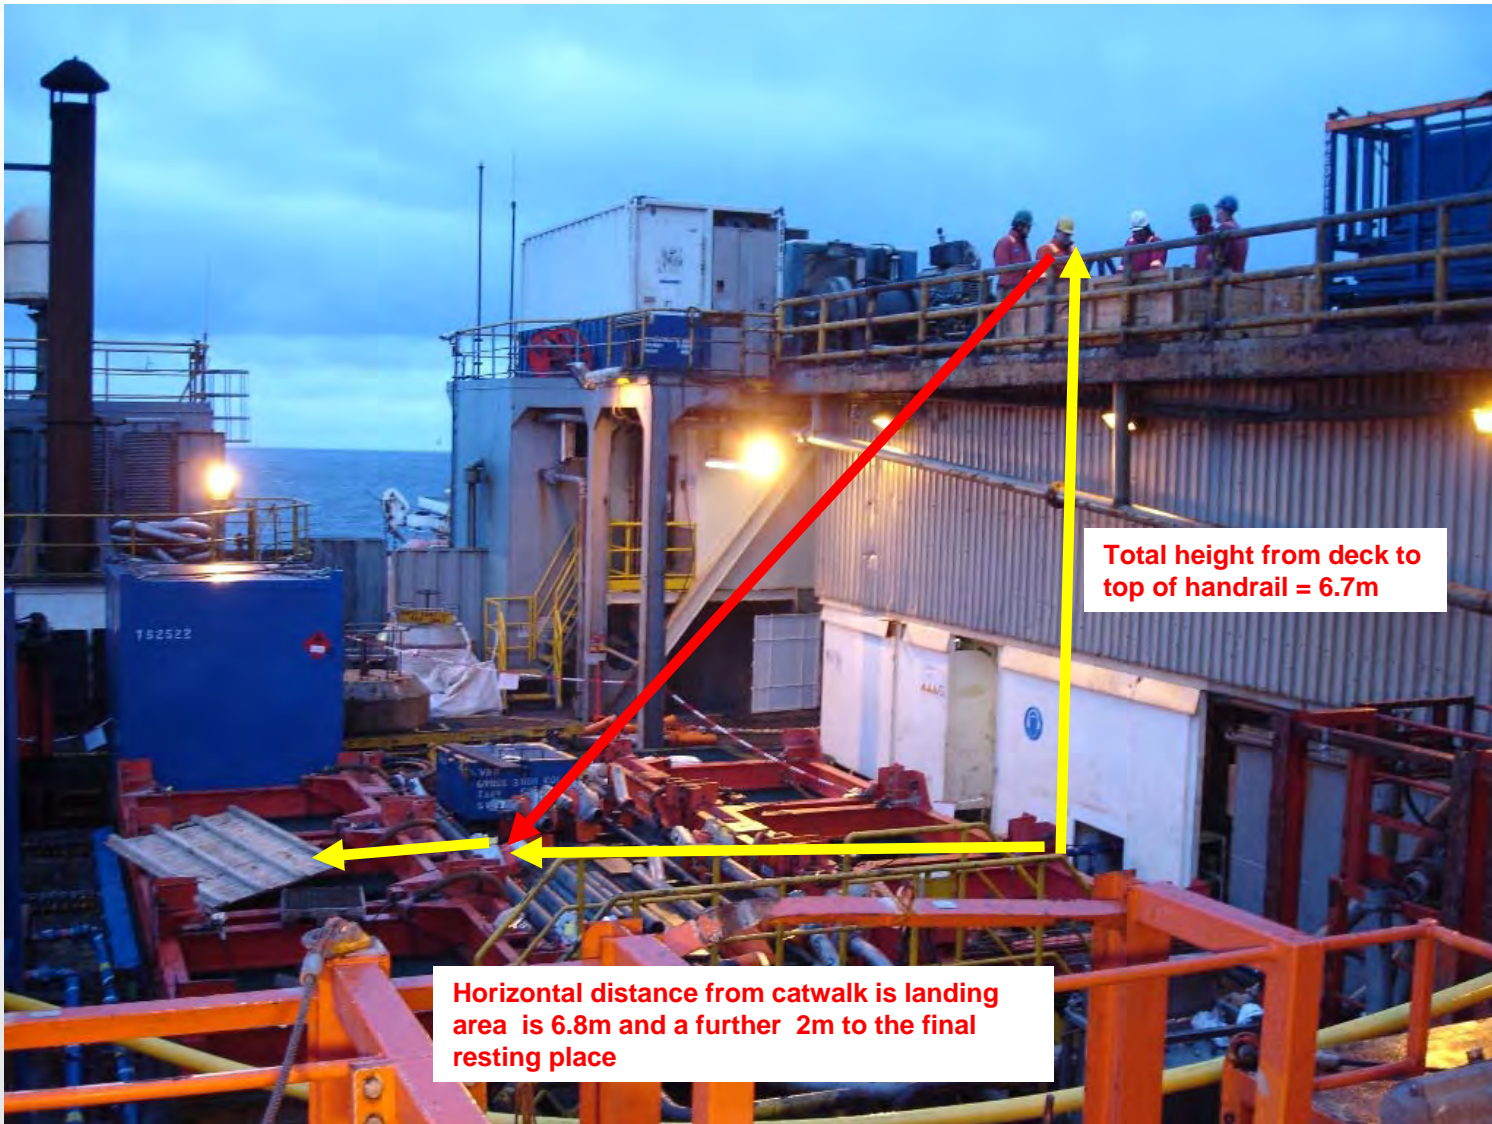
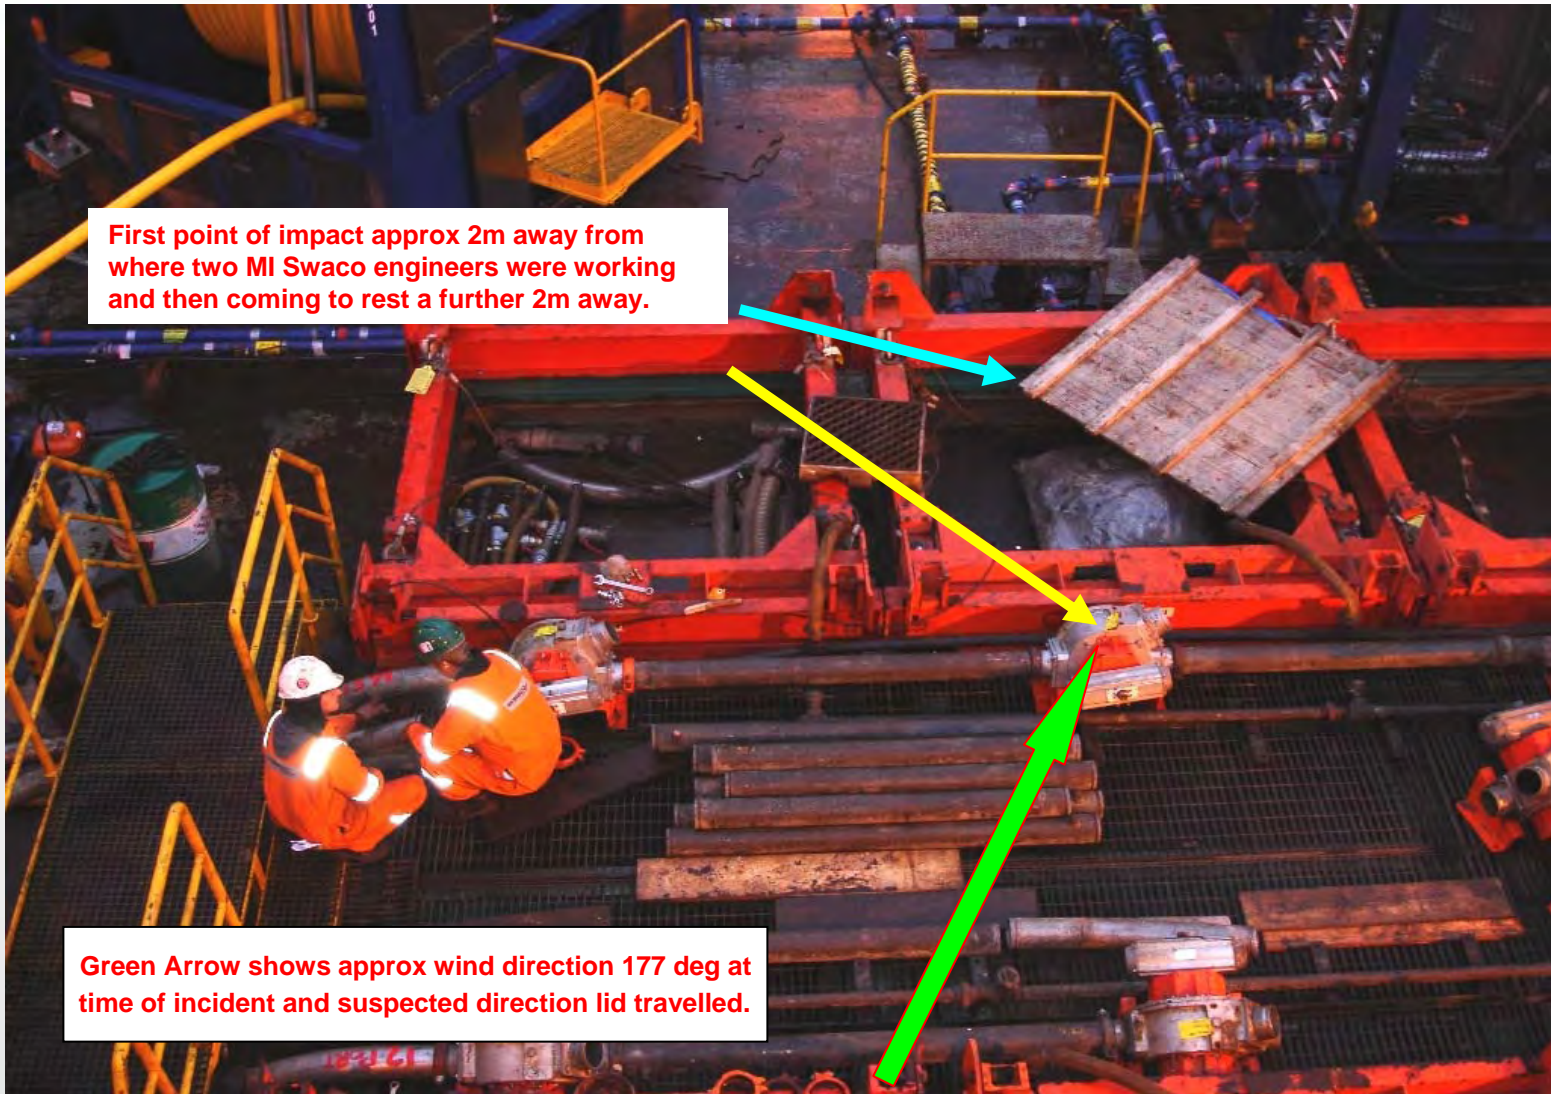
First point of impact approx 2m away from where two MI Swaco engineers were working and then coming to rest a further 2m away.

Green Arrow shows approx wind direction 177 deg at time of incident and suspected direction lid travelled.

**What happened?**  
 Wooden crate lid weighing 37Kg was blown from raised catwalk to Well-Test deck 6.7M below

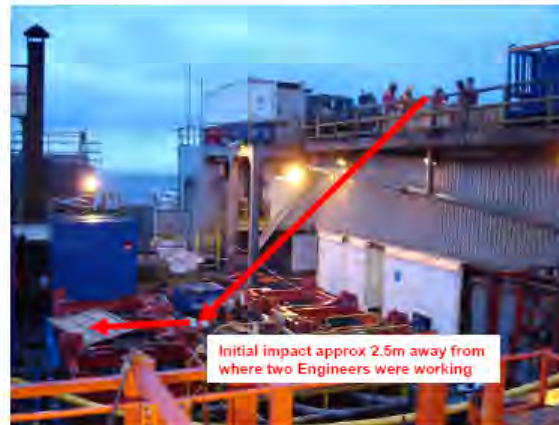
A recent incident occurred on one of our units whereby a wooden crate lid was dislodged from the main body of the crate by high winds. The crate lid, weighing 37Kg, fell 6.5m to the deck below, where two nearby service partner employees were working.

- The wooden crate lid had been checked for security just hours before being dislodged.
- The crate lid was secured by nails, which had failed to fully penetrate the crate side panels.
- In general there was poor understanding of the necessary lifting practices required for lifting wooden crates slung directly to the crane.
- The control of personnel working in sheltered (leeward side) open areas during periods of high winds had not been fully assessed for potential dropped objects / flying debris.
- Several wooden crates used for the storage of spare parts outside, were no longer deemed suitable for continued storage or lifting without further security.
- Wooden crates were being deployed for the shipment of well equipment to and from the rig.

Check the security of all wooden crates and their lids prior to any periods of high winds; ensure nails are not used as the sole securing device through the addition of straps or banding.

Review the long term storage of spare parts in wooden crates that are exposed to the elements. Ensure crates are adequately secured or moved to internal storage areas.
