Prevention of Dropped Objects: No-Go Zones and Red Zones

Shell EPE HS&E Learning Bulletin

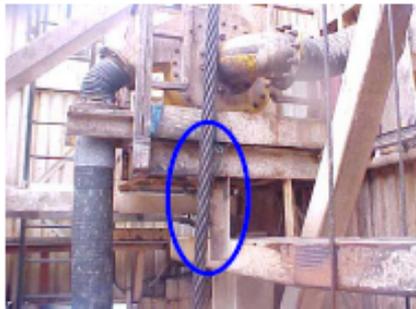
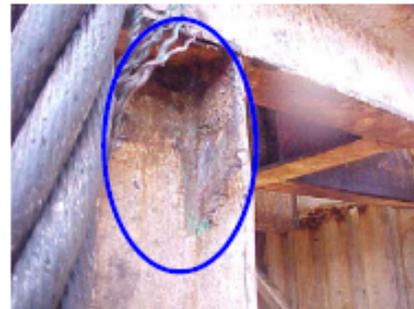
What Happened: Whilst running in hole this morning the derrickman released a stand of drill pipe towards the elevators, but missed the elevators allowing the stand to drop into the safety rope. Unfortunately the safety rope was not fully secured and the stand contacted the top drive system blower frame. A piece of old frame was dislodged and consequently dropped to the drill floor. The approximate weight of the dropped object was 650gms. No-one was injured. Upon inspection it became apparent that the original weld on the blower frame bracket had been corroded away.

The dropped bracket came from the TDS blower frame (part of an old frame replaced some time ago). During previous derrick inspections the bracket appeared to be fully welded on to the derrick structure.

- Ensure correct method of securing safety rope is followed in future. The floorman working in the derrick was relatively inexperienced in his position – all crews to be briefed and coached on the findings of this incident.
- The dropped object was a remnant from a previous blower frame. Numerous independent and rig-based derrick inspections did not identify this bracket as a hazard. The inspection of the dropped object made apparent that the original welding was of a very poor standard.

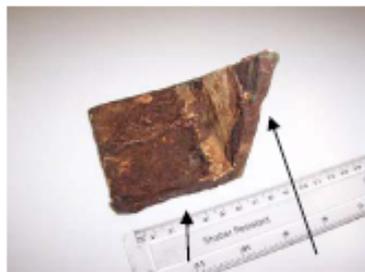
Original full weld contact corroded away

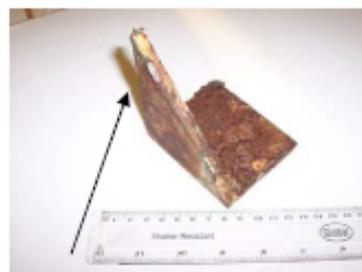
Remaining weld contact point

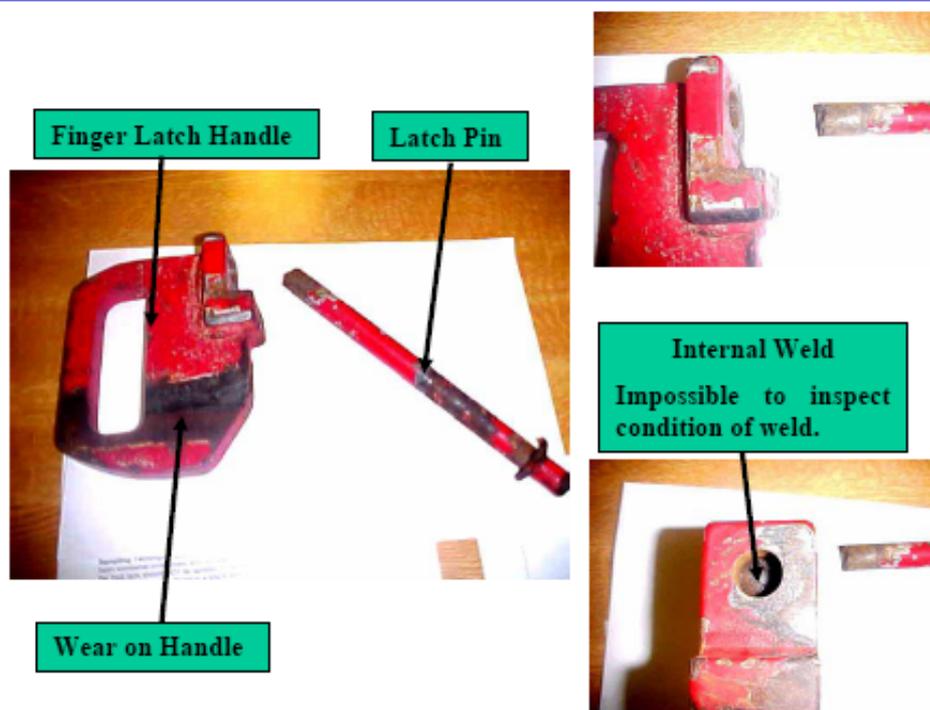
What happened: During a period of waiting on severe weather, a finger latch (1.5kg) was found on the rig floor. The time of the actual incident is unknown. Inspection of the failed finger shows failure of the pin within the finger latch handle recess where it is impossible to inspect. Significant wear is visible on the handle itself. The latch was used to store a singular stand which was not amongst a cluster of other stands. Inspection of other accessible fingers in the derrick revealed 4 with bent pins which were changed out. These fingers showed no signs of the excessive wear associated with the finger that failed.

All non essential personnel were confined to the accommodation during the period of very severe weather and it is likely that the latch dropped during this period. Outside restrictions had been removed as the weather improved and personnel had been working on the rig floor (derrick was still out of bounds due to wind) prior to the finger latch being discovered, but not necessarily prior to it having fell.

- Initial action was to install secondary fall protection to a number of fingers for trial and review. Geograph line passed through the handles of 2 rows of fingers as a secondary fall protection. Trial inconclusive. Half the crew liked them, the other half didn't.
- Manufacturer investigated failure mechanism. Fingers to be modified as per manufacturers (RB Boss) recommendations. Fingers being replaced with modified fingers in batches of 10.

- Carry out a derrick inspection after periods of waiting on weather.

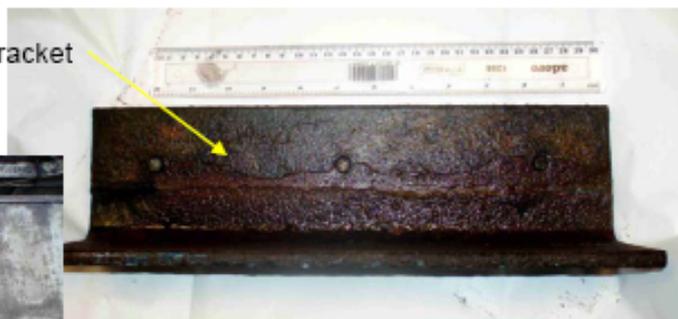
Dropped Object – 5kg bracket

The drill line cover had just come back onboard after refurbishment; the deck crew lifted the cover up to the outside of the drill floor - to the drill line spool and lowered the cover into position. One of three 'L' shaped steel support brackets (5kg)(4" x 13.5") fell approximately 40ft to the heavy tool store roof below. The bracket fell due to corrosion of the retaining bolts.

- There was no way of checking the bolts and brackets prior to operation due to lack of access.
- The potential of dropped objects was identified on the TRIC card and precautions (barriers) put in place.
- Job was carried out under General deck lifts LOLER and SMS and TRIC had been held for the task.
- Scaffold to be built and remaining two brackets to be checked
- PIR to be raised to find alternative solution to brackets.

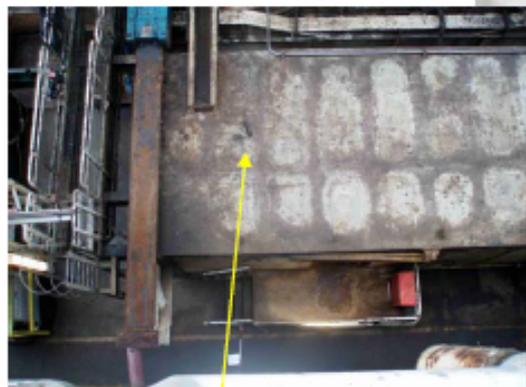
Landing area of bracket on heavy tool store roof

The bracket landed on the heavy tool store roof, a none accessible area, with no walkway in the drop zone, and therefore no potential dangers to personnel.

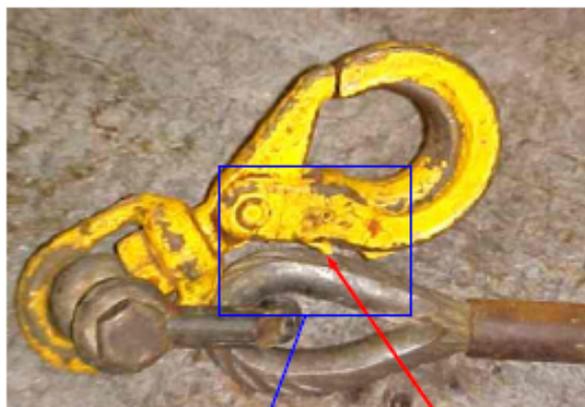
An operation was in progress to lift guide posts out of the side of the v-door. The posts were being lifted one at a time vertically with the Port crane. During the port post lift, it initially resisted releasing from its socket. A TBT identified the dropped object risk and it was discussed to remove all non essential personnel and to keep potential drop zone clear of personnel. Hence there was no risk to personnel in this incident. Tension was subsequently increased and at approx 1.5 ton pull on the crane, the post jumped free. The momentum and interaction between sling and crane hook resulted in the hook opening and releasing the load which then descended down the v-door and along the catwalk. Investigation is currently ongoing.

Trigger hard up against pennant hard eye

- Inspection of the BKL 18-20-8 Gunnebo safety hook identified no defects. Attempts to knock the latch open or pass the sling through the gap failed. It has been quarantined for inspection.
- The only trial to trip the safety latch was by rotating it back on itself until the release trigger came into contact with the pennant hard eye (see photos opposite). This is only speculation as to the cause of the failure however.
- The hook is of a newer type, specifically designed to prevent this type of occurrence.
- Always consider possible failure of equipment during any TBT and ensure all unnecessary personnel are well clear of any hazards.
