Experience transfer Falling Tubular

Blohm & Voss SDS elevator

Product Update Notification Of Side Door Elevators

Subject: SDS Elevator for One Hand Operation

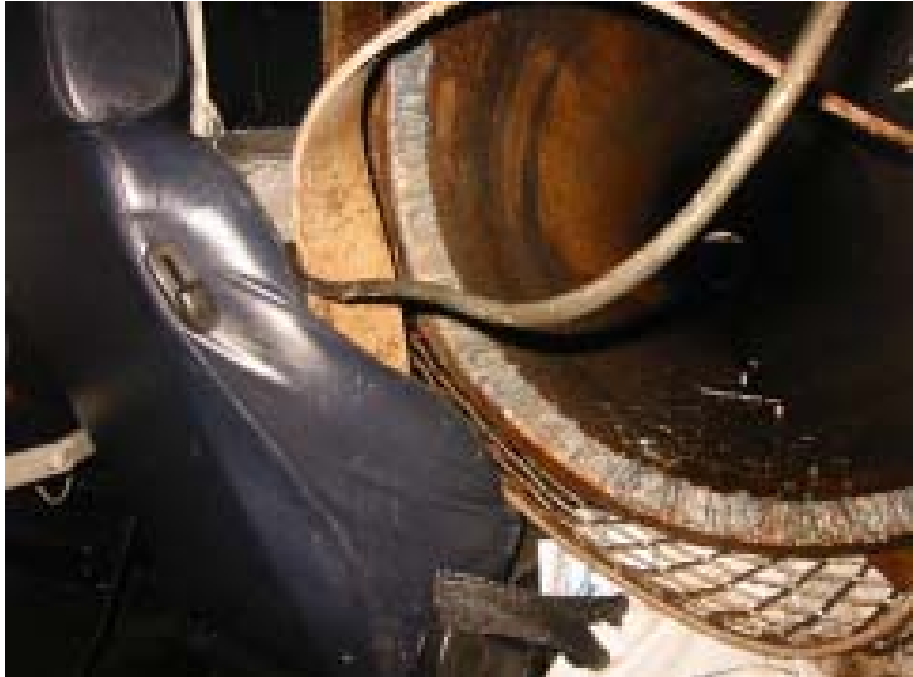
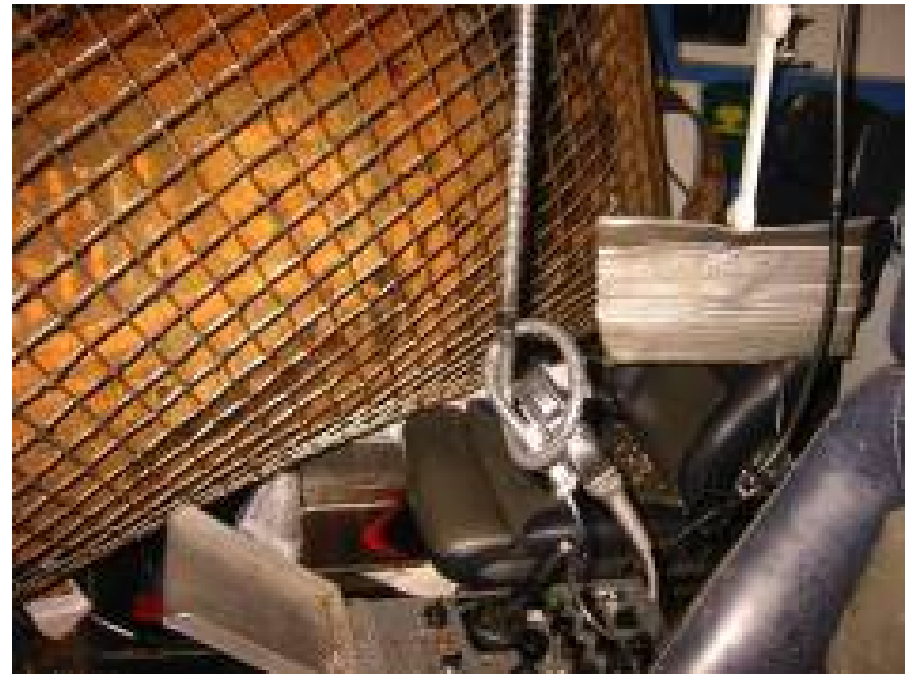
2007: the drillers fast reaction saved his life, when the 30" conductor came falling through the roof

- Statoil has had two serious incidents involving the B&V SDS elevator
 - One in 2007 and one in 2009
- In both cases the elevator, for some reason was installed with the opening facing downwards, it should always be installed facing upwards (latching on in an upwards movement, because the load should rest on the elevator body not the door)
- In both cases the elevator was not properly latched, the securing device could still be installed due to wear, and of course failed due to the load
- Extensive damage to the drillers cabin in 2007, 48 hrs downtime to repair damages to the Catwalk machine in 2009
- B+V issued a Product update notification, with modifications to the latch securing device on these elevators in 2007
 - The elevator involved in the 2009 incident was **not** modified

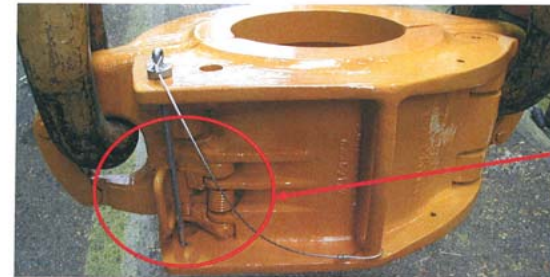
picture 1: Existing Side Door Elevator

Old Design

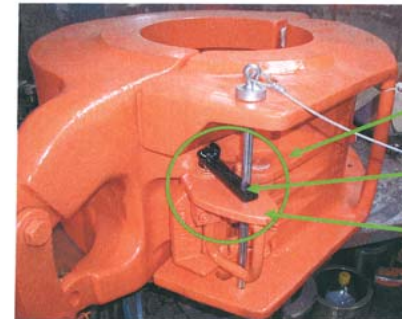
picture 2: Side Door Elevator safety improvement

Locking plate

New Latch
including wider
upper plate

This procedure is valid for all SDS Elevator with "One Hand" opening design which has been modified with below listed Safety Kit.

- New Latch
- Safety Pin Assembly
- Locking Plate
- Spring

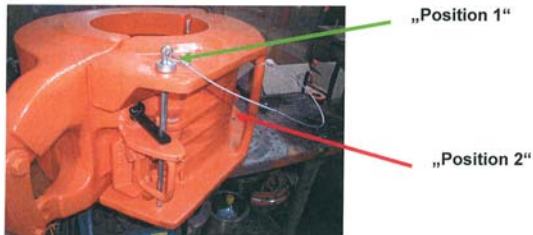
picture 3: Pin in save position

1. The Elevator is Closed and the Safety Pin is in „Position 1“

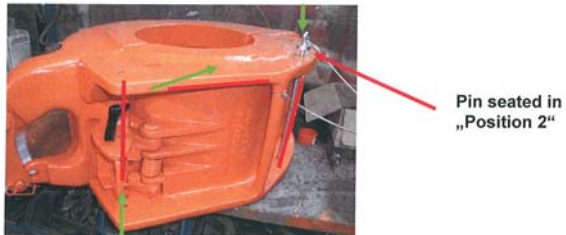
picture 4: Move Pin to parking position

2. Remove the Safety Pin from the „Position 1“ and put it into the „Position 2“(parking position), open the Elevator

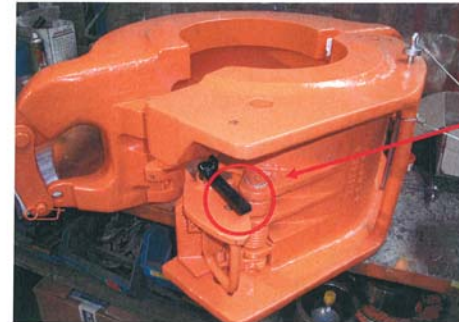
picture 5: Elevator open

3. Open the Elevator. Remove from Pipe

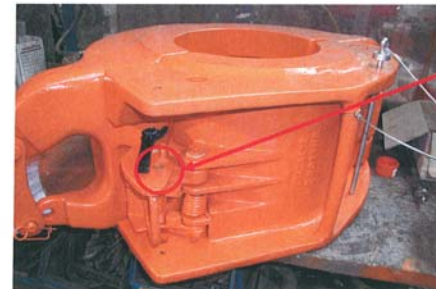
picture 6: Elevator closed, but not secured

4. Put Pipe in, Close the Elevator.

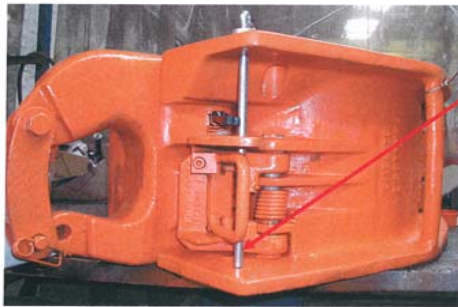
picture 7: Elevator properly closed Pin in save position

5. Remove the Safety Pin from „Position 2“ to „Position 1“
If the Latch is not properly locked, the Pin can not be set!

„Position 1“

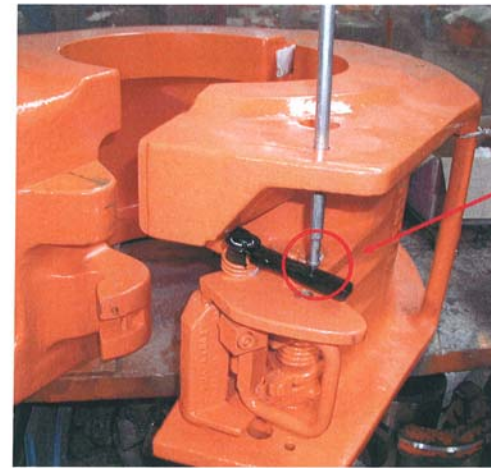
Safety Pin can not be set, when the Elevator is not properly latched

picture 8 Safety Pin can not be set, while plate is locking the hole

Plate is locking
Hole to set Pin
