# **Preventing Dropped Objects – The KFELS Way**

**Keppel FELS Limited**  
**Issac Yeo**  
**Senior Project Superintendent**

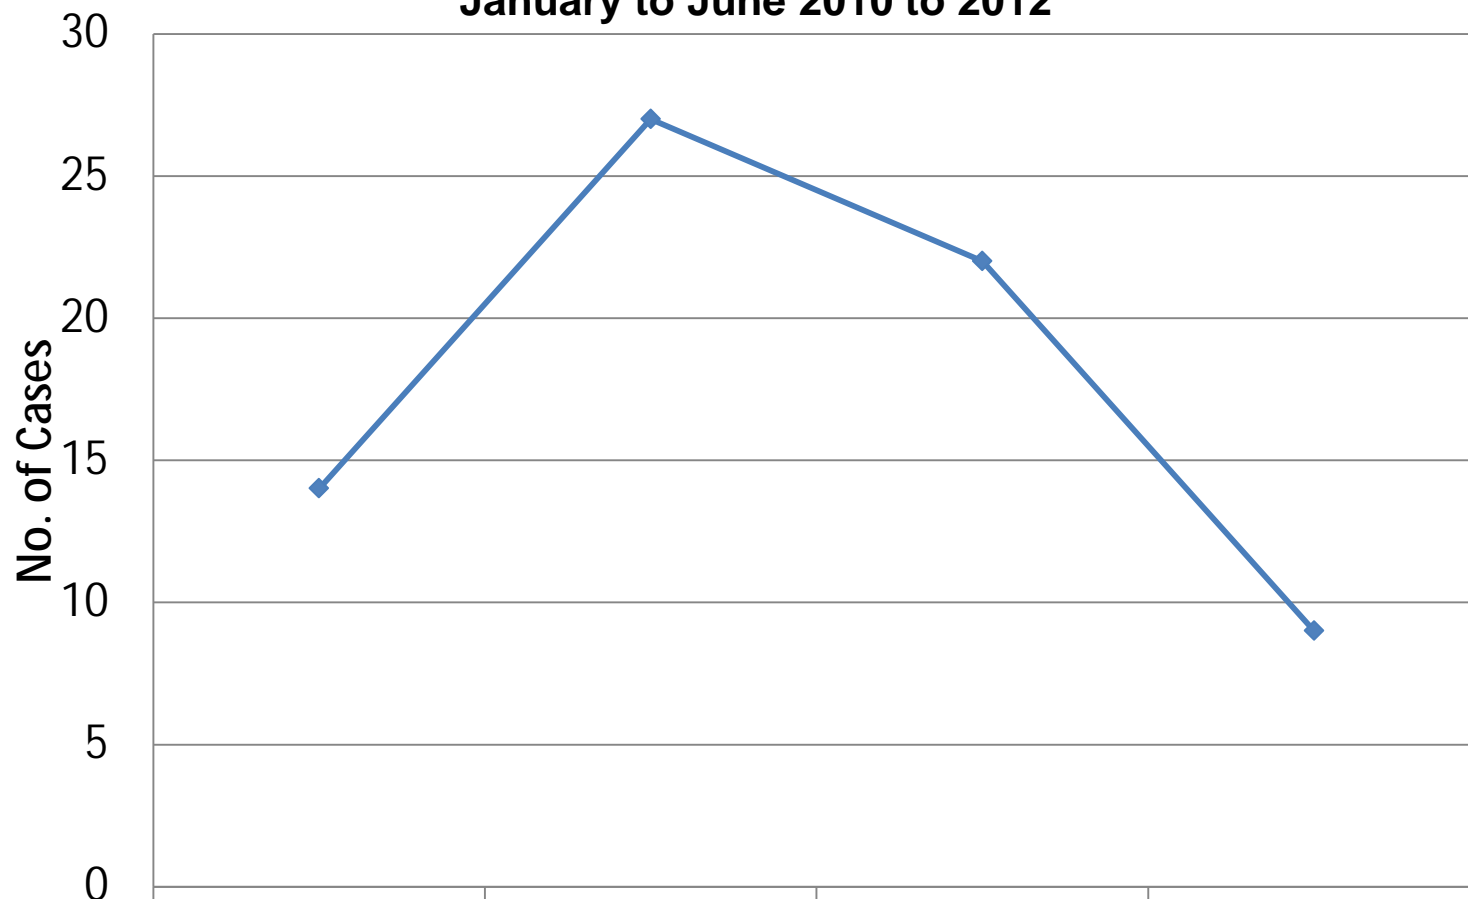
**INCIDENTS BY FALLING OBJECTS**  
**January to June 2010 to 2012**

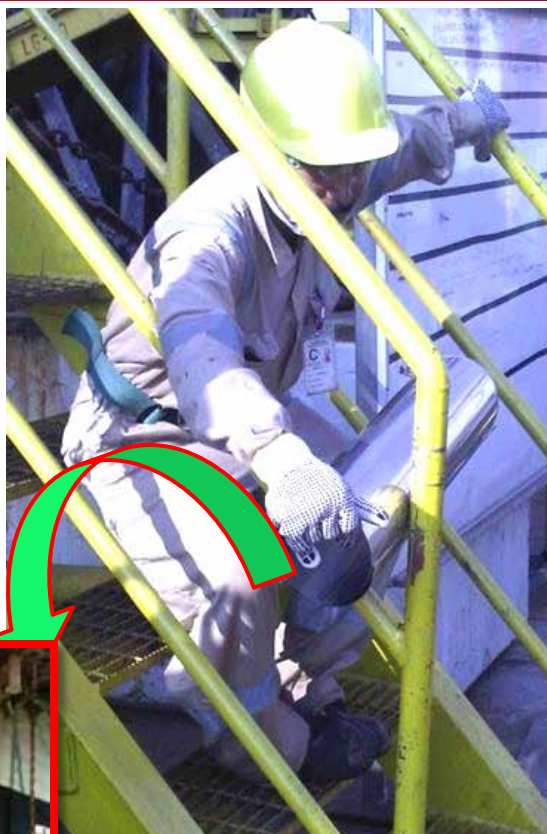
**Carrying steel cladding  
and lost his balance  
while descending down  
an inclined ladder**

On 4<sup>th</sup> May 2011 at about 1820hrs, a fire watchman on a pontoon deck was strike on his head with his safety helmet by a sheet of rolled stainless steel cladding (2 feet in length) while he was watching over hot works being carried out. This single sheet of rolled stainless steel cladding was investigated to have fallen from a height of approximately 70feet due to mishandling by a worker while he was carrying it on his way down an incline ladder to the main deck. The impact of the falling cladding caused the safety helmet to break into half and injuring the fire watchman.

- The worker was walking down the inclined ladder, his left hand was holding on the hand railing while his right hand was holding on the sheet of stainless steel cladding.
- While walking down, worker slip on the wet step of the incline ladder.
- Worker reacted instantaneously gripping hard on the hand railing while his right hand loss control of the rolled stainless steel cladding sheet.
- The rolled stainless steel cladding sheet slipped out of the intermediate railing and fell down to the pontoon deck.

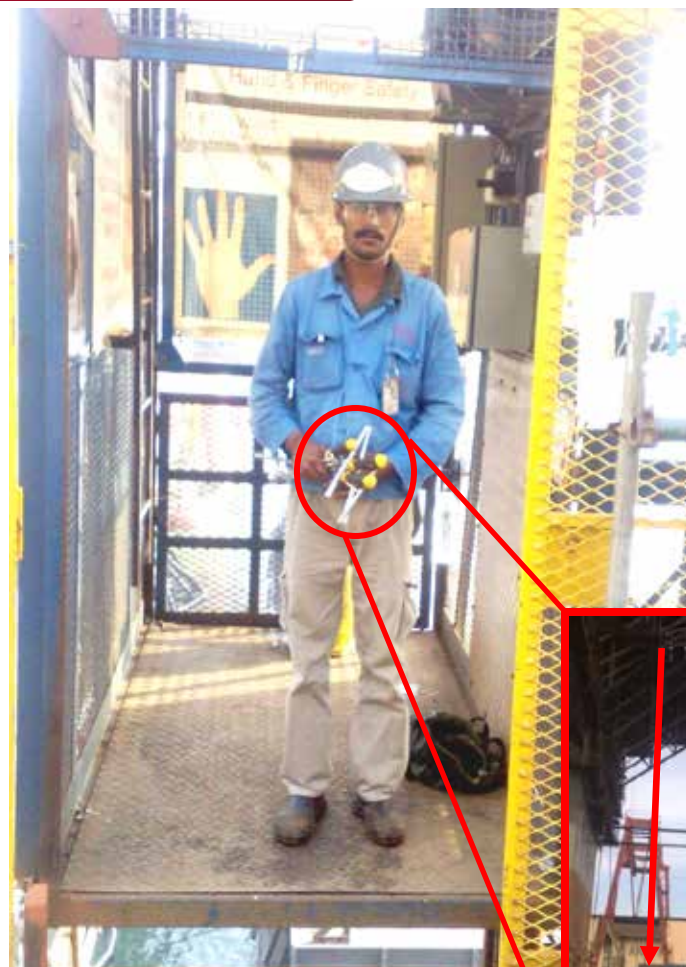
**Carrying bundle of loose  
materials/tools when  
using elevator**

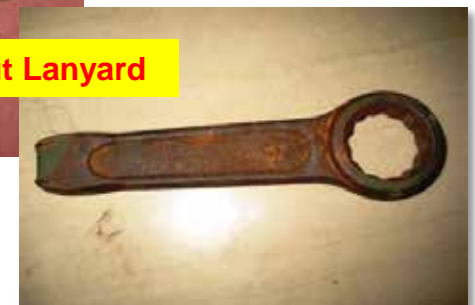
Without Lanyard

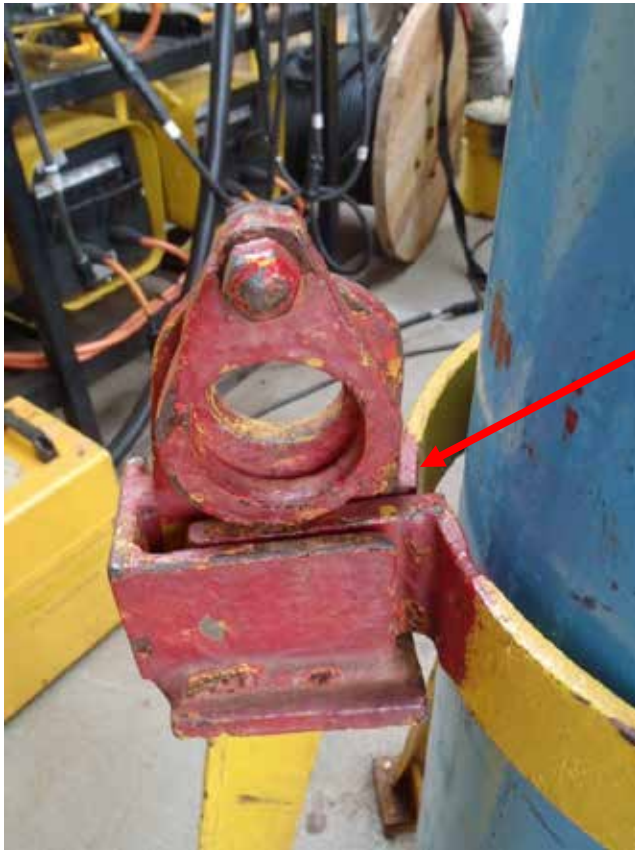
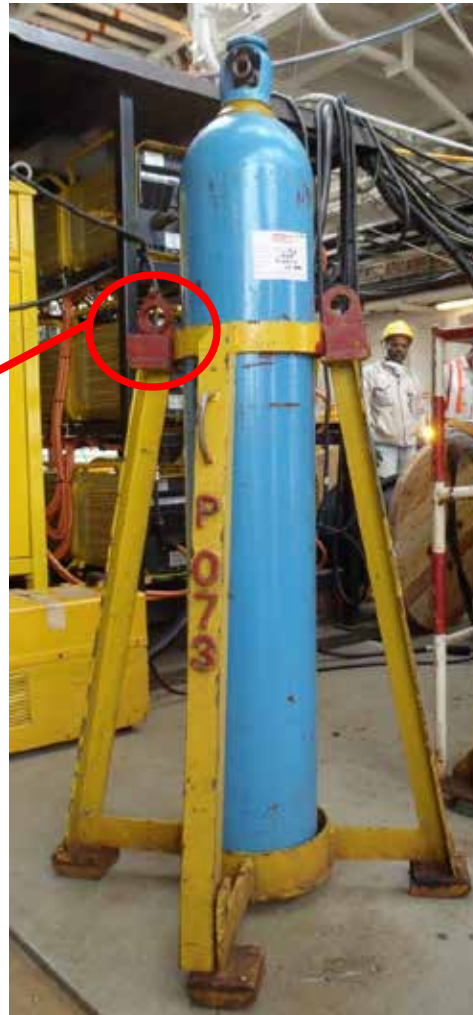
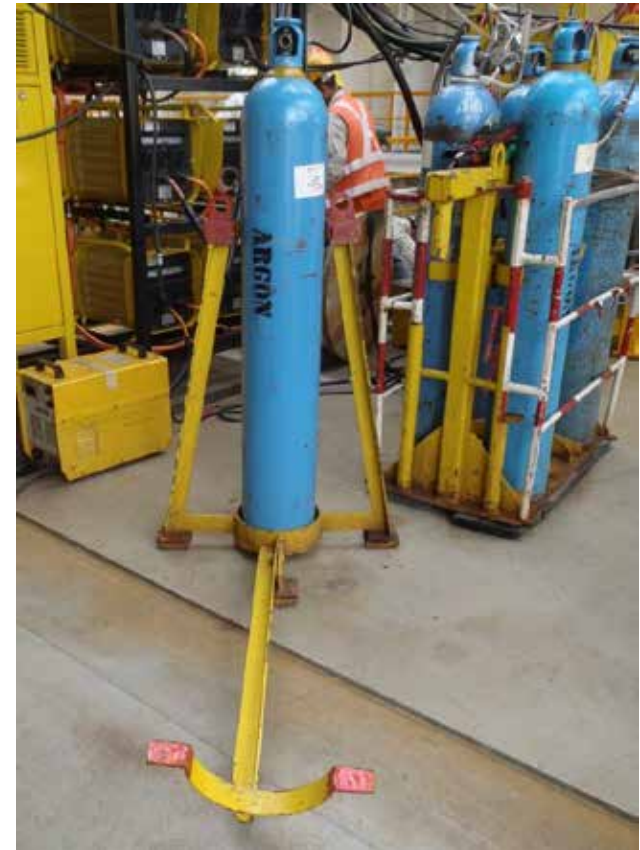
## Customized Design - Single Gas Cylinder Rack

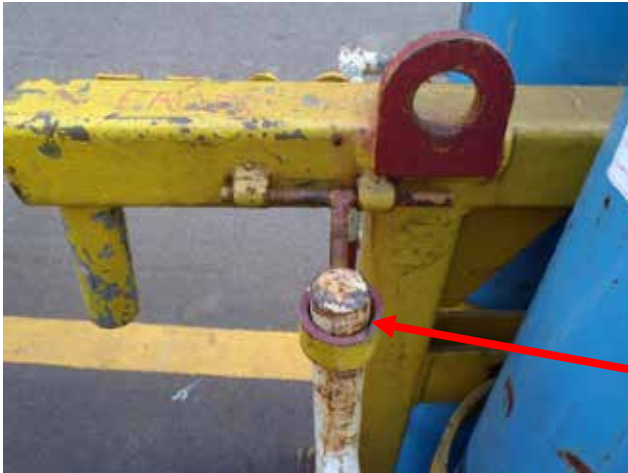
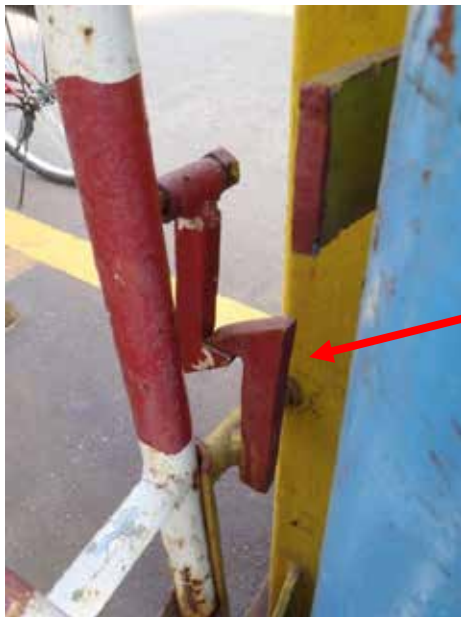
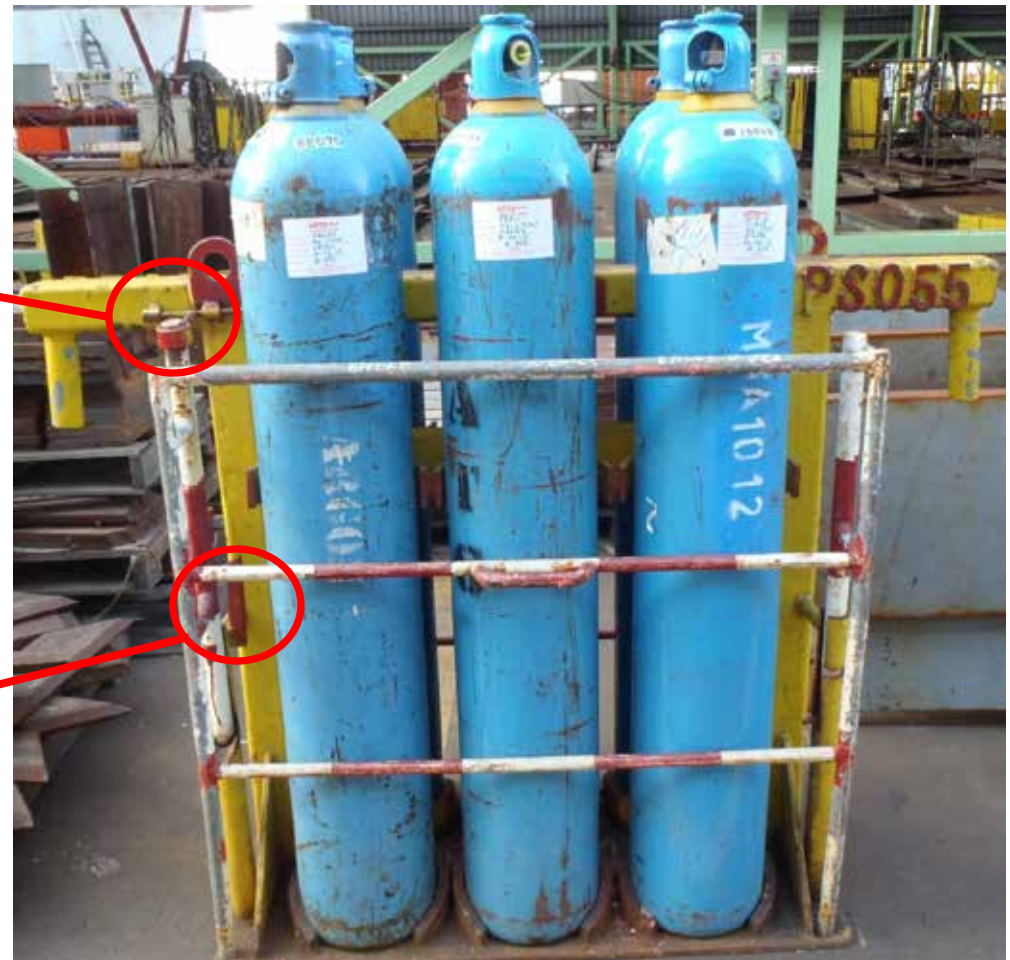
Customized Design – Multi Gas Cylinder Rack
