Dropped Object Management

Key Learning's from Recent Inspections

SWIFT RIG 10 West Navigator Island Constructor

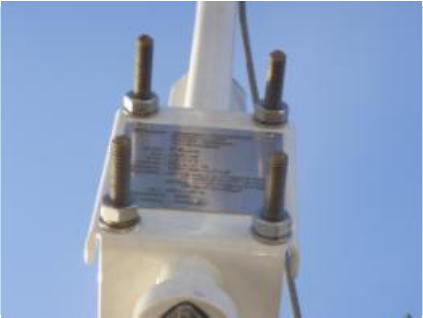
13	Drilling Mast	<p>Top of the mast:</p> <p>The u-clamps for the antenna on the top of the mast are not secured. One Nord-lock washer is installed.</p> <p>The Nord-lock washer is installed against a regular washer. This is not a recommended use of the Nord-lock washers.</p>	<p>Install Nord-lock washers on all bolts.</p> <p>When installing Nord-lock washers the manufacturer guidelines must be complied with. Reference to Nordlock assembly instructions: http://nordlock.no/default.asp?url=350.16.37</p>	4	New Nordlock washers are installed by the inspector.	DOS O

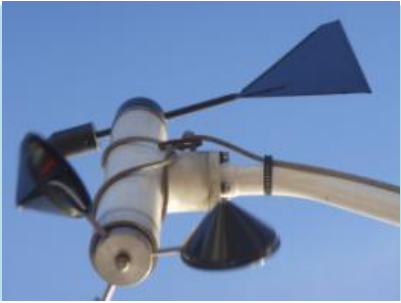
15	Drilling Mast	<p>Top of the mast:</p> <p>The safety wire on the wind gauge is fastened with a key ring.</p>	<p>Remove the key ring and install a four part shackle on the safety wire.</p> <p>Ref. SfS DOM p. 94-95, with further references.</p>	4	Installed shackles, and re-secured by the inspector.	DOS O

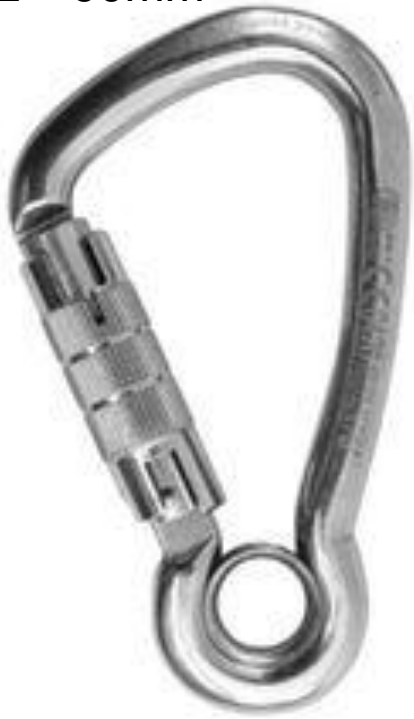
AISI 316L – 90mm

- Three action twist lock system
- Drop test certificate 10kg, 2 meter x 5time
- Total traceability
- SWL and Batch numbering
