MSF – Dropped Objects

01/12/2015

THE RISK TO MARINE PERSONNEL

Subject: Dropped Object

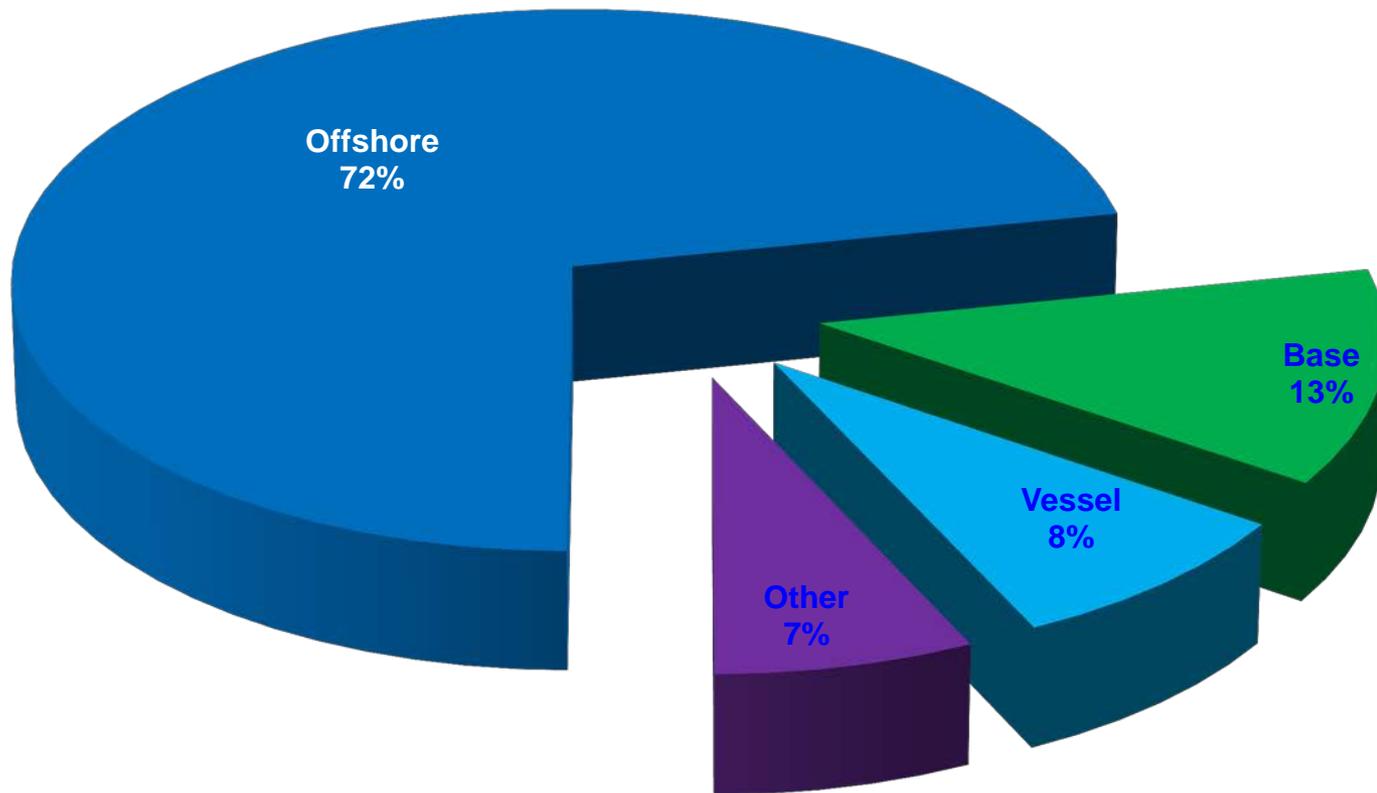
Potential / Dropped Objects Breakdown

*Figures are based on incident reports 2011-2015YTD

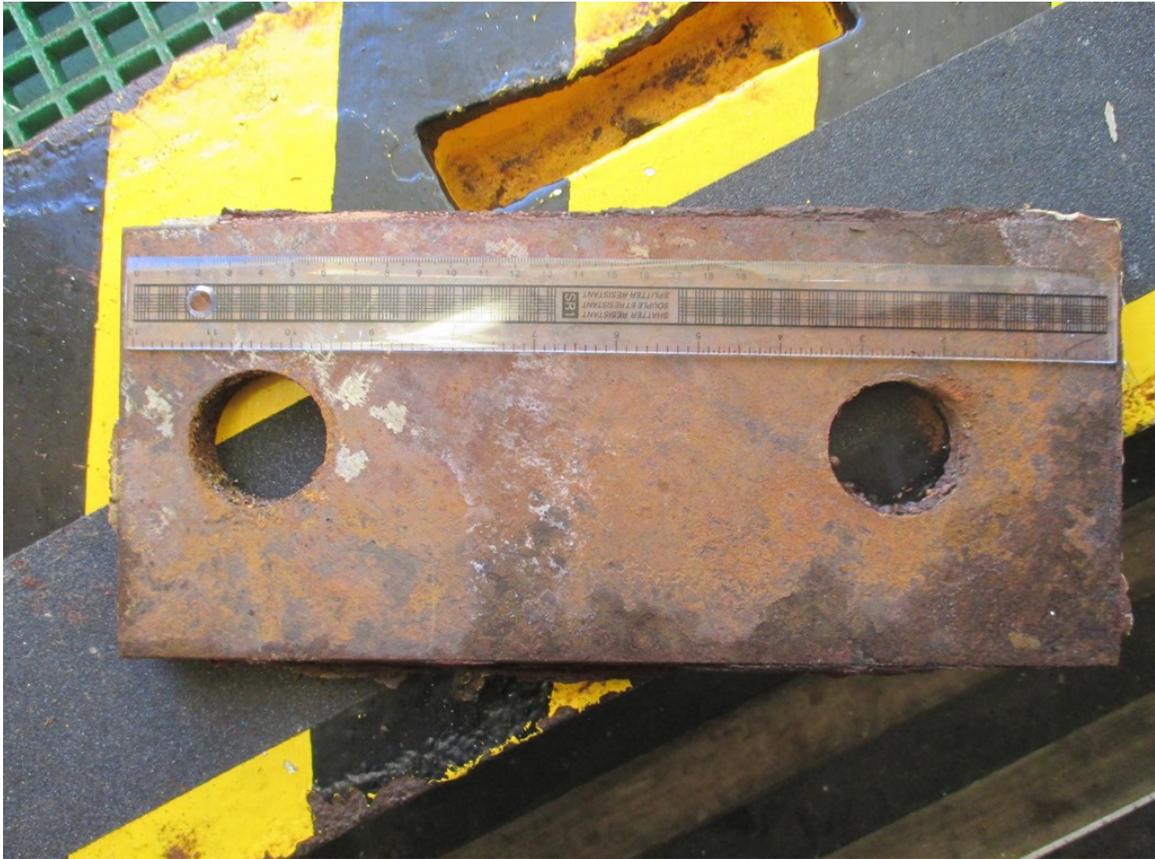
Loose piece of steel plate

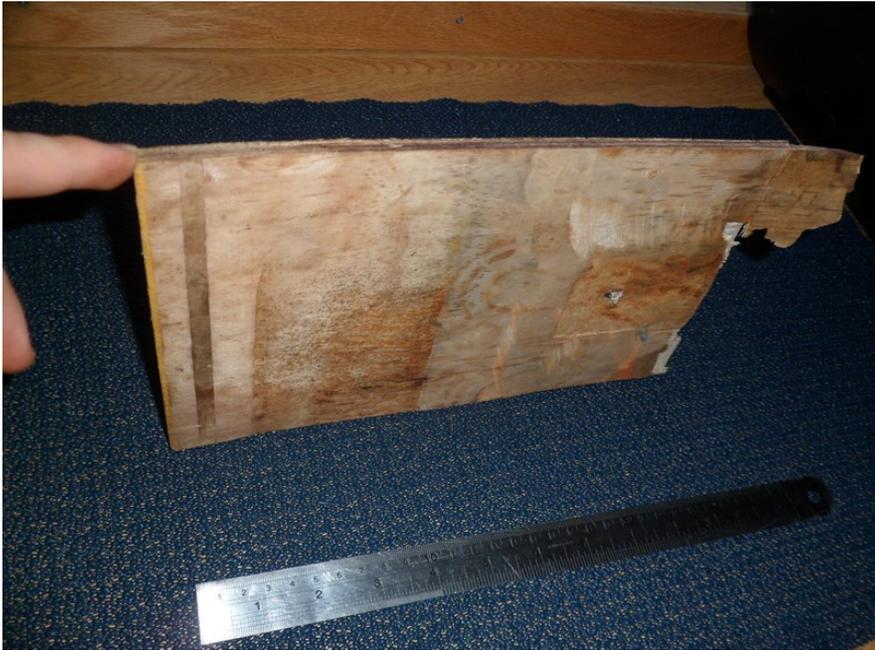
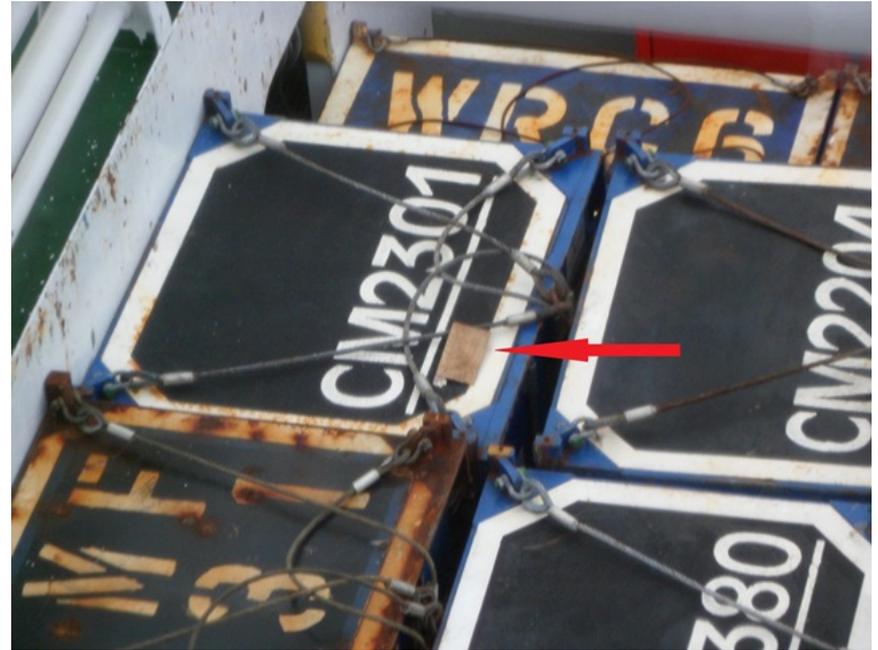
Piece of plywood

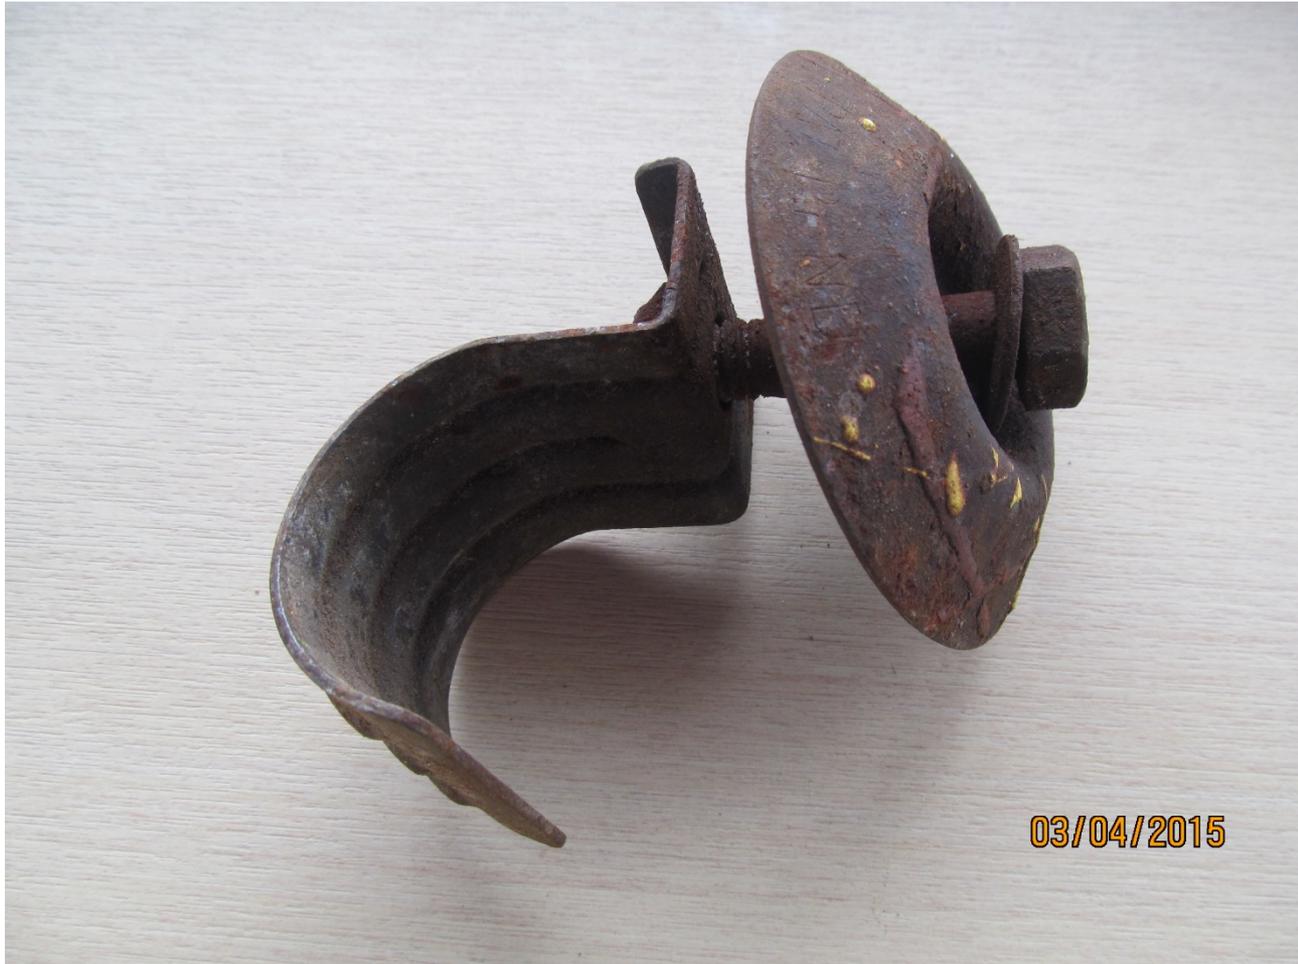
Metal Clamp

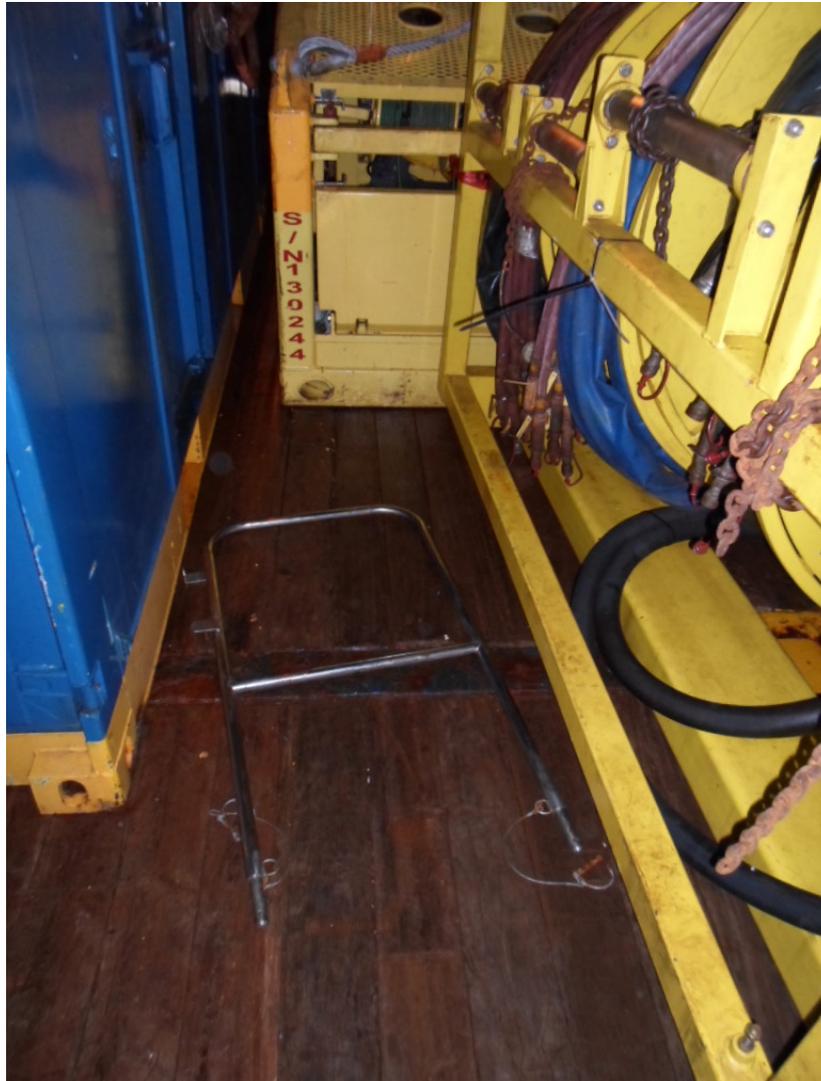
Section of handrail

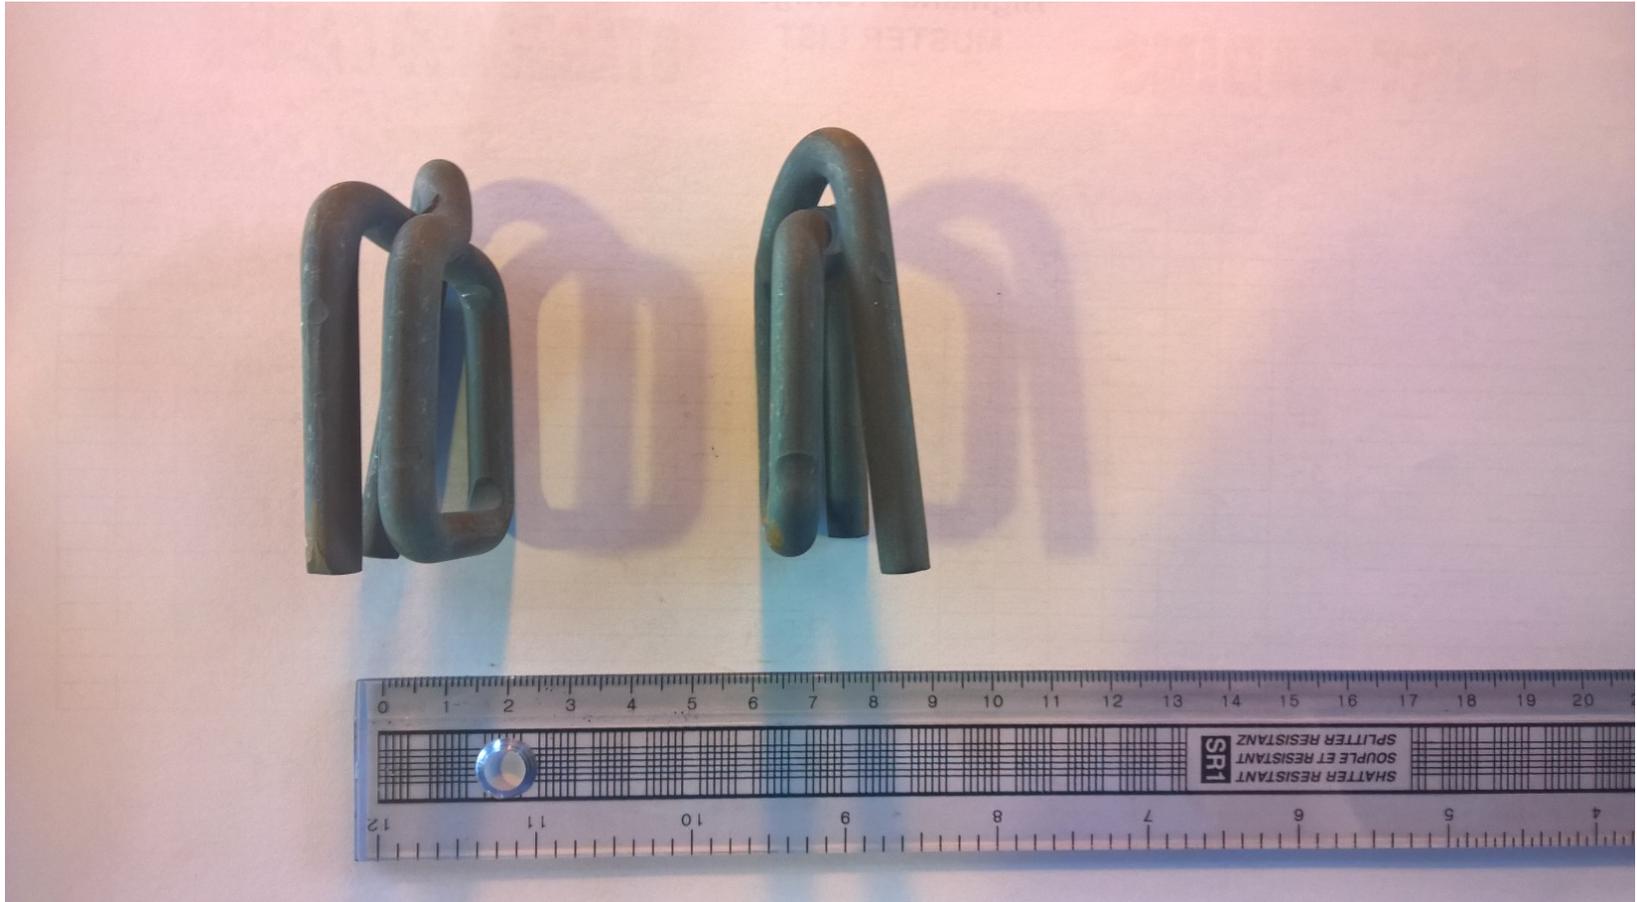
2x Metal Brackets

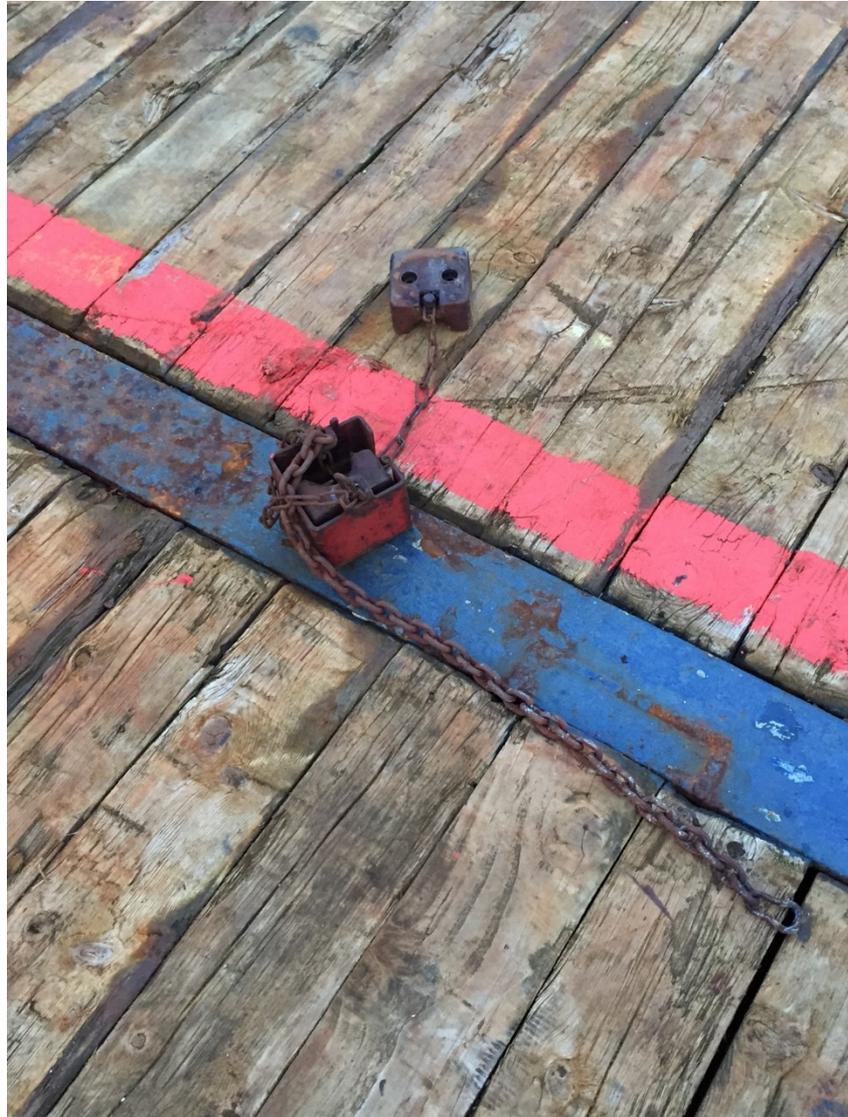
**Safety stop block
and chain**

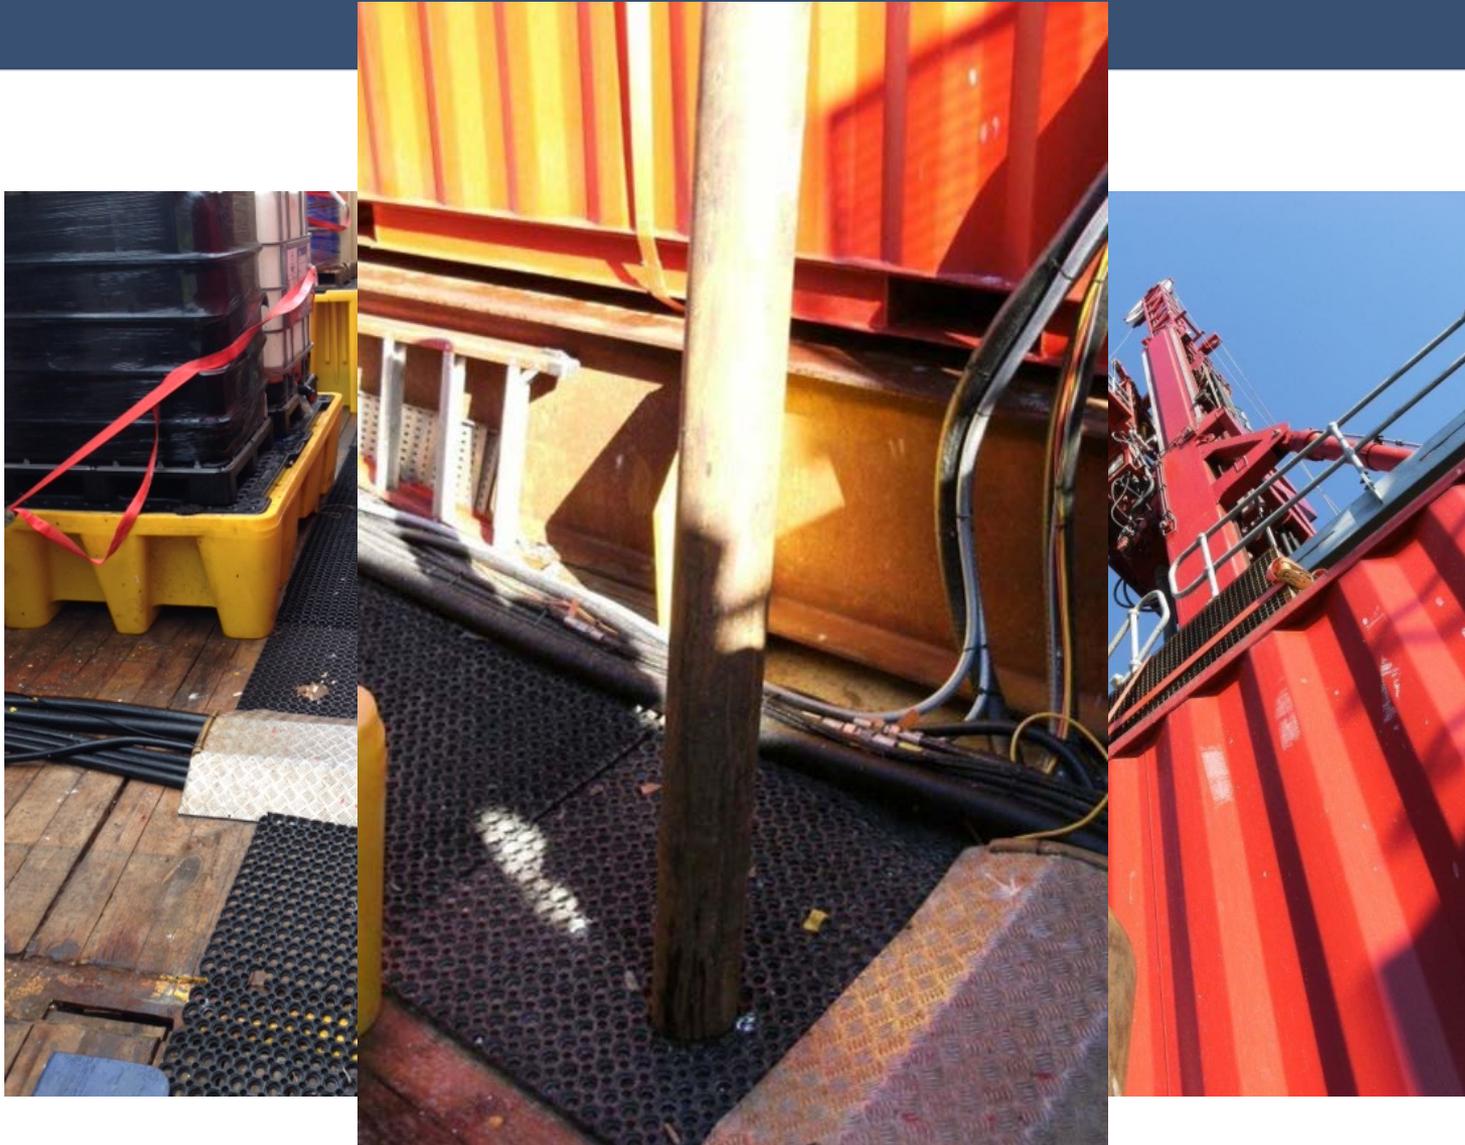
Drill pipe dropped from Drill Mast Rooster Box

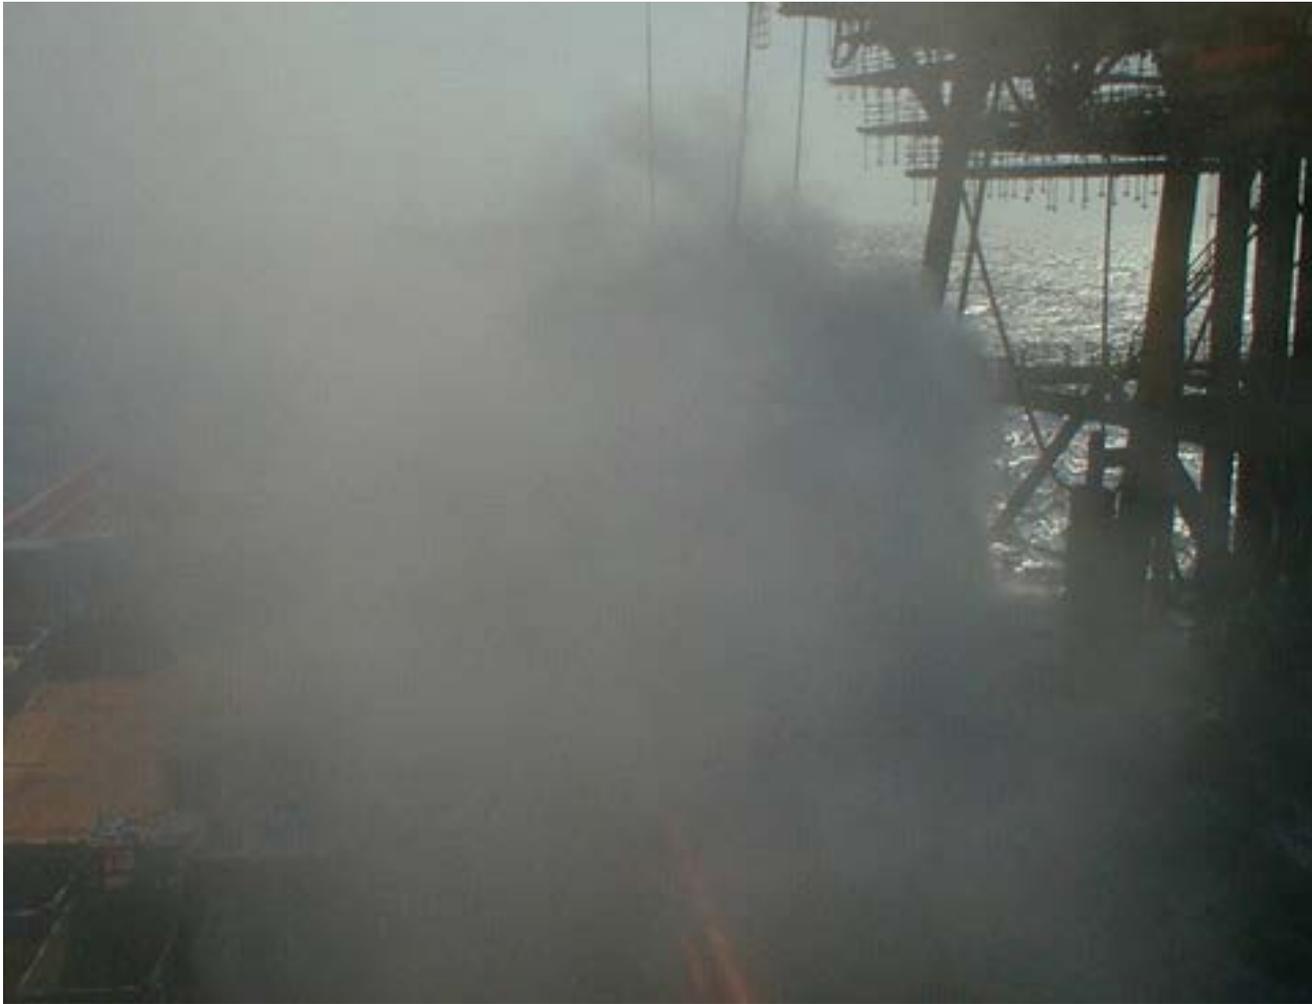
Overboard Discharge
