Safety Alert

Number: 18-11

Subject: Potential Dropped Object on Top of a Container

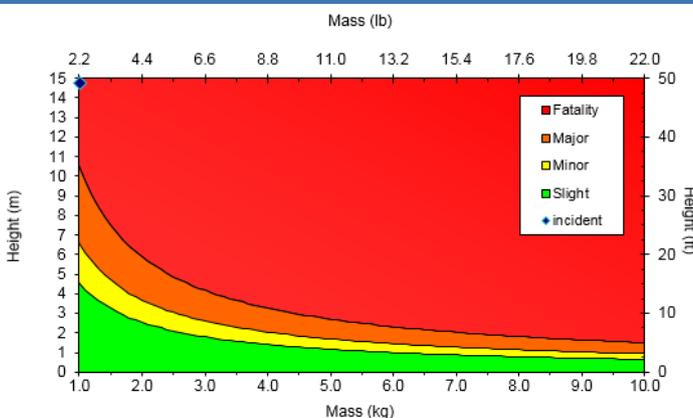
Photographs / Supporting Information

While hose watching during bunkering operations, a Deck Foreman noticed an object on top of a container onboard the Supply Vessel.

The object was later found to be a large piece of wood weighing 1kg. With a possible fall height of 15 – 30 meters during lifting operations. There was the potential for a fatality.

The origin of the wood is not known. CCTV images were captured of the container arriving at port and prior to being lifted onto the vessel – the wood was not seen on top of the container at either of these points.

Therefore, the wood appeared on top of the container at some point between being loaded onto the boat and arriving at the installation

Vessel Master was contacted, who arranged for the object to be removed.

No preventative actions were taken – It was a great spot by the deck crew.

This event demonstrates the importance of pre-lift checks and good observation at all stages in the supply chain.

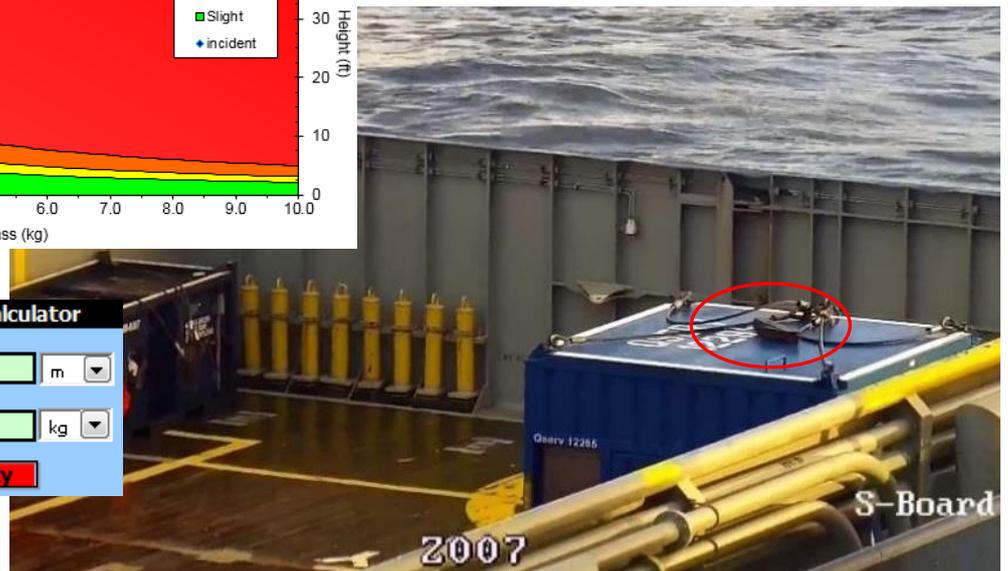
Outcome Calculator

Height: m

Mass: kg

Outcome: **Fatality**
