# Dropped Object Incidents on Chevron operated assets

**January 2010**

There were three RIDDOR-reportable Dropped Objects on Chevron operated assets in January 2010:

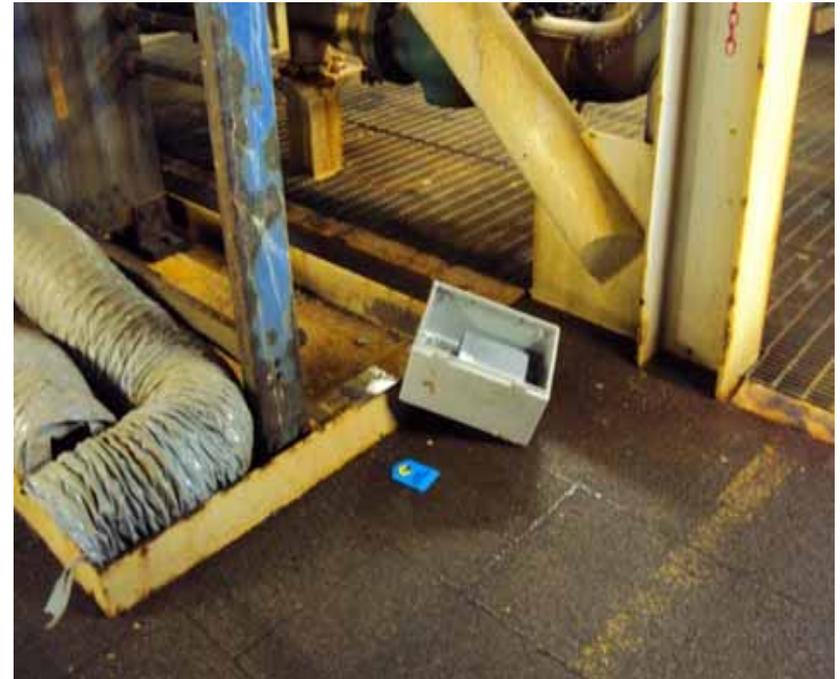
# Electrical Equipment Enclosure fell from skip

Whilst preparing to lift a general waste skip away from lay down area, the deck crew attached the crane hook to the lifting assembly of the skip. The lifting assembly was buried underneath general waste. As the assembly was lifted several items of waste material fell out off the skip including an electrical equipment enclosure, weighing approx 7.5kg This item fell over the handrail and down to the inboard level directly below (approx 8-10m). No personnel were in the area.

- The design of the lay down area did not allow for clear and safe access to monitor lifting legs while skip was being used (location of the skip was too close to the edge of the deck).
- Failure to comply with requirements of procedure which requires the load to be checked to ensure there is no potential for parts of the load to fall prior to undertaking the lifting operation (accepted practice was to use a controlled lift to extricate legs of lifting assembly from debris).
- All personnel involved in this lift should have been sufficiently trained and competent to recognise the hazards that were present and to control them according to procedure. The Banks man was not positioned such that he had an unobstructed view of all edges of the skip once debris began to rise when lifting assembly was tensioned.
- Stop Work Authority was not used by any member of the deck crew.

- Reminder to all platform deck crew to ensure they are in full view at all times of all skips when trying to clear lifting assembly leg obstructions. Also deck crew to ensure skip openings are left completely clear of lifting leg assemblies when landed, and periodic monitoring program of skips during use.
- Skip location to be reviewed to allow better access to view contents and also to provide a catchment area if items are dislodged
- Increased awareness of all platform personnel about the use of skips and hazards around segregation, lifting assembly legs, netting use and overfilling (through TBT and OIM Forums).
- Wire mesh to be installed to bumper bar areas to provide improved dropped object protection.

- All members of deck crew to be asked to sign acknowledgement that they have read and understood requirements of the procedure and that they are aware of the requirements placed on them by this procedure.
- Review Lifting Plan for lifts of waste skips to ensure it adequately identifies and addresses specific hazards associated with loose items contained within skip.
- Increase the awareness of Stop Work Authority, as this opportunity presented itself but was not taken.
