Preventing Dropped Objects – Introduction of the KCAD Maintenance to Operations Handover Certificate

**KEVIN POPE**

5th December 2019

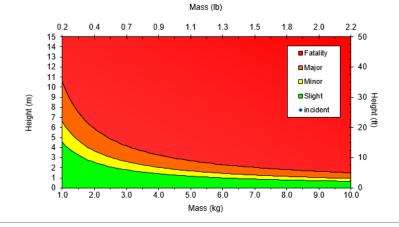
A piece of cable tray parted and fell from the Bridge Racking Crane (BRC) Drag Chain to the Rig Floor below.

Weight of parted cable tray = 1.1kg

Height = 27 metres

The piece of cable tray & positions of crew members
