# Dynamic Dropped Objects

and Offshore Helicopter Operations

# The scenario

## Helicopter approach to support vessel helideck

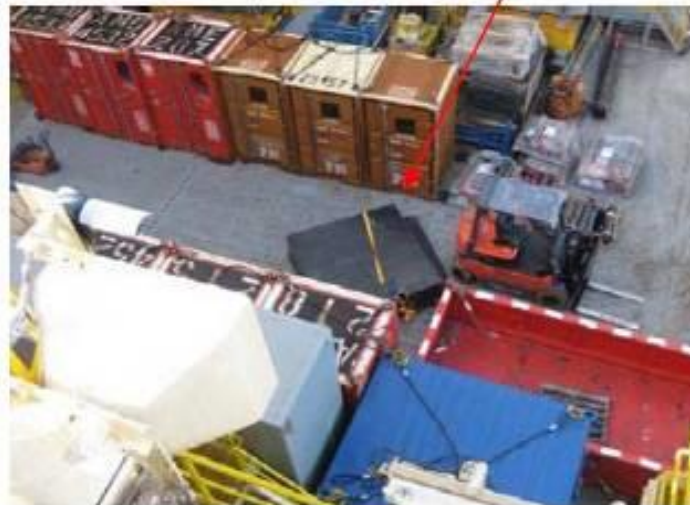
**Facts:** A Billy Pugh personnel transfer basket and fibre glass box were blown from the emergency generator roof to the main deck below. The incident occurred when a crew-change helicopter was landing on the helideck. The box and the Billy Pugh, of an estimated combined weight of 200kg fell a distance of 10.6m, with a potential of 20797 joules. The box struck the corner of a container before reaching the deck. The corner of the box was damaged, but the Billy Pugh was not. No injuries were sustained. The area on the main deck that the box landed on was not a designated walkway and the area was clear for helo ops.

Outline of where box was situated & final position where it came to rest

even heavy objects (more than 200 kg), or objects seemingly unlikely to be moved by helicopter downwash should be assessed as potential hazards. Re-inspect helidecks with this scope.
