TUBULAR HANDLING RECENT FINDINGS

PRESENTED BY:
Stewart Gillies

TUBULAR HANDLING

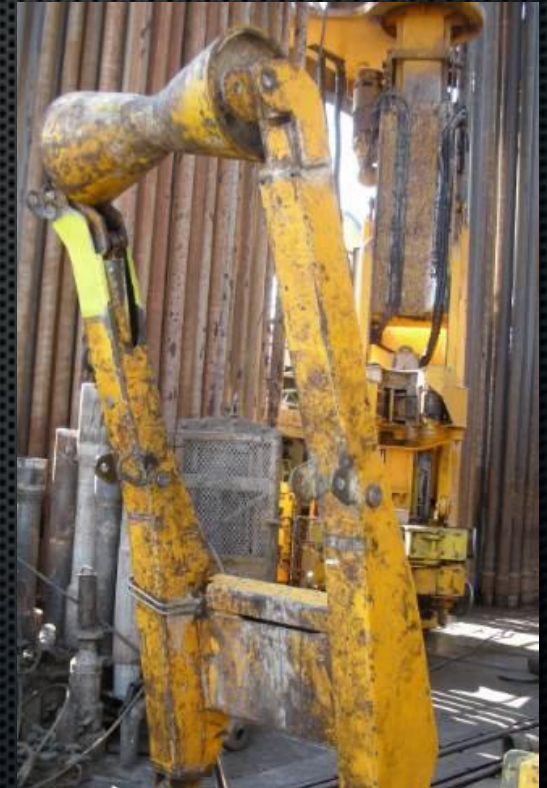
Missing parts

Pipe securing clamp fitted as designed.

As Fitted on Rig
Clamp missing

Clamp Roller

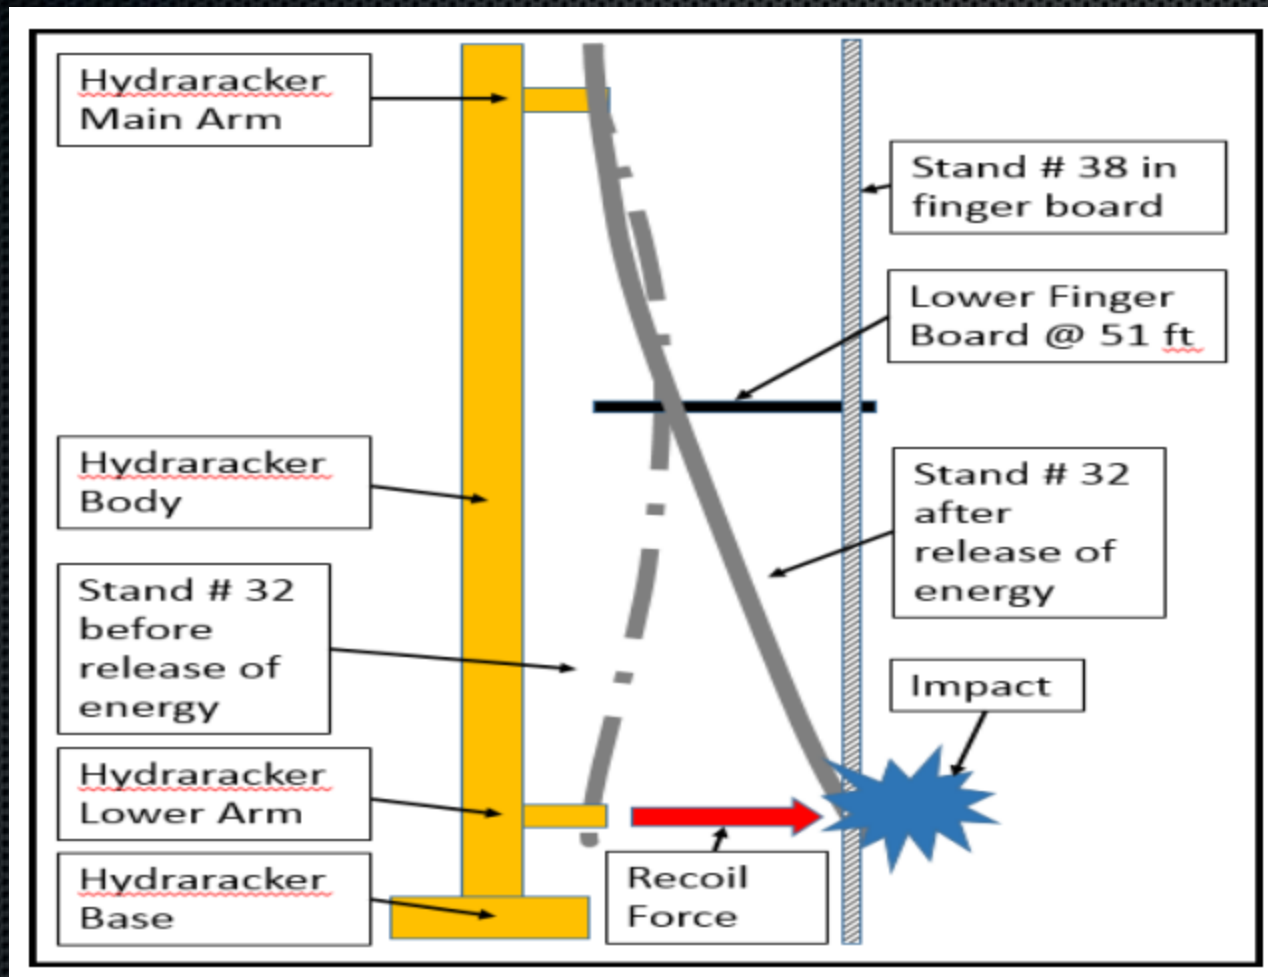
IADC Alert 15-10 Fatality on Drill Floor

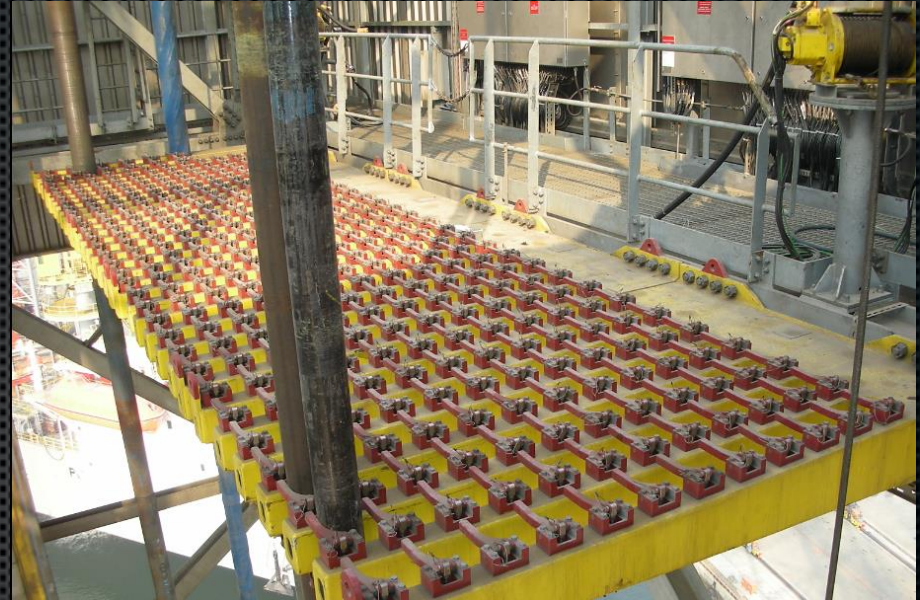
Each finger has mechanical locking latches which are:

- Closed by springs
- Opened by Pneumatic Pressure.

Pneumatic piping /hoses are connected from the Valve Cabinet to each pneumatic latch cylinder.

The latches are all of **failsafe** design. If air pressure is lost, each latch will lock down with the mechanical return spring.

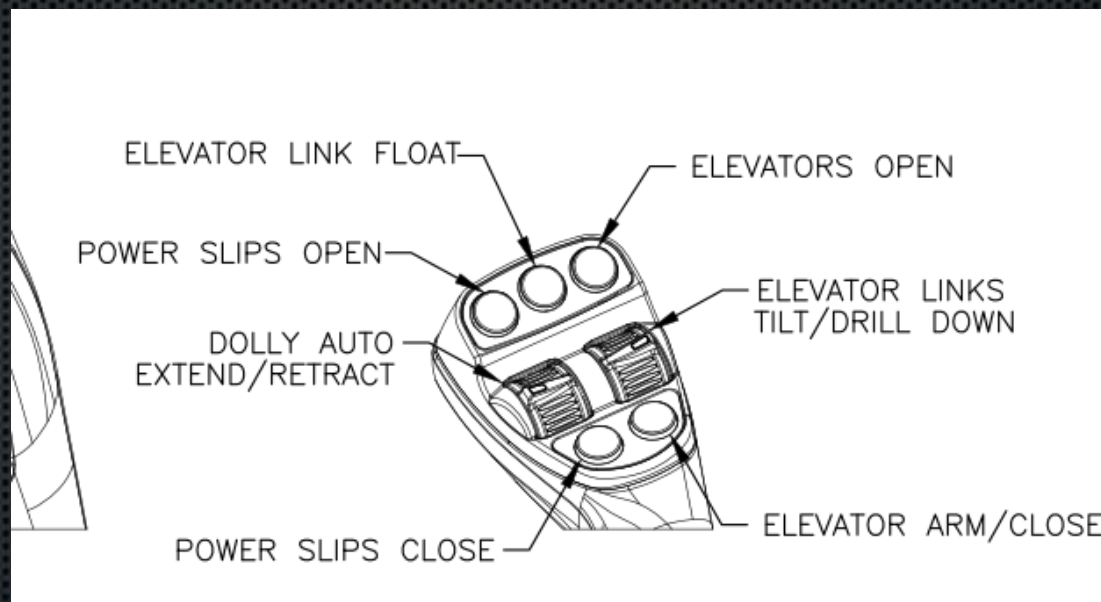
- Inadvertent dolly retraction could result in a bent drill pipe, damage to the rotary table and damage to the top drive.

Contrary to OEM documentation, ADC suggested that the dolly should only be operated in manual mode. Thus, if the button was inadvertently activated, the operator would be more likely to identify the movement and cease the operation before the dolly had moved any significant distance.
