Brent Bravo Dropped Barrel

**Incident:** Oil drum dropped during lifting operation.

**Location:** Brent Bravo

**Date:** 17/05/2010

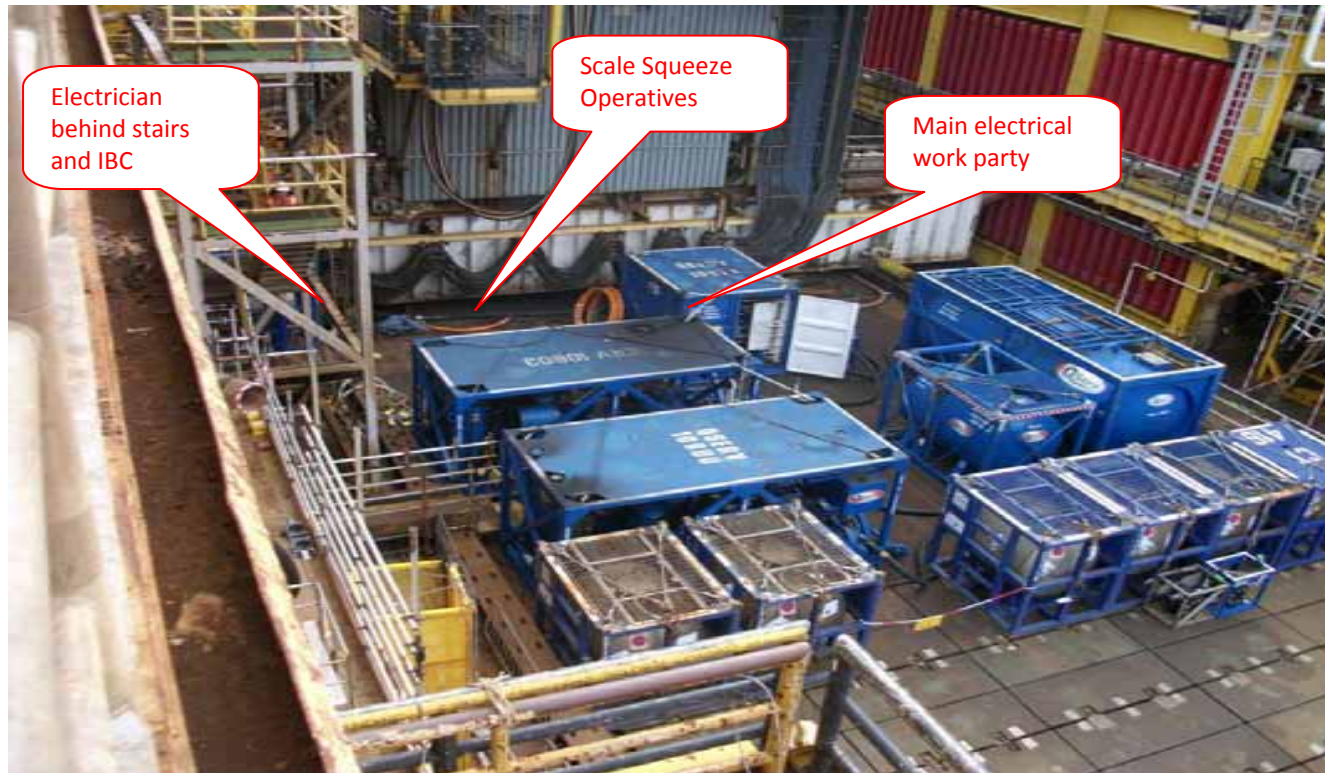
- On the day of the incident the drilling crew were reinstating the combined top drive unit and there was a scale squeeze crew on board (under operations control)
- There were three Electricians working on connecting the scale squeeze skid to the rig electrical mains circuits.

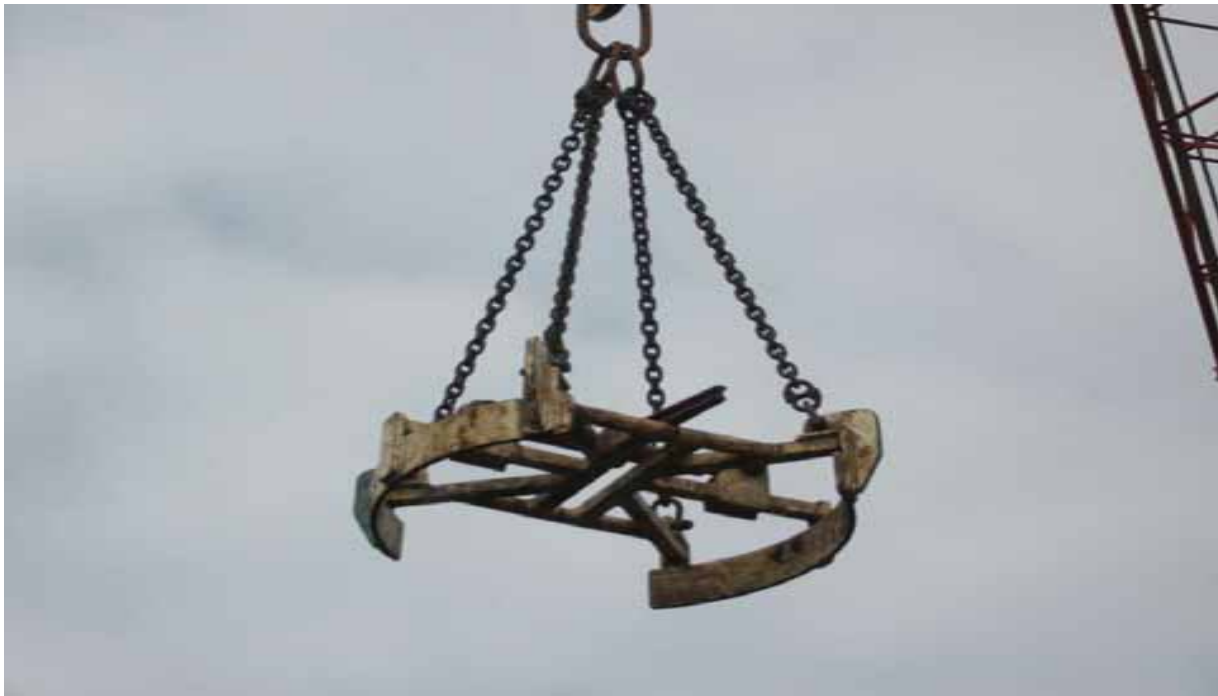
To do this they used the Vertical Barrel Clamp (VBC) owned by Sigma3  
The Drilling Deck Foreman (DDF) and Derrickman (DD) collected the key to the deck store on the pipe deck from the Platform Deck Foreman (PDF). He then collected the VBC and attached it to the crane

There was no mechanical failure of the VBC

- The VBC was also found to be in the fully closed position after the VBC was removed from the crane. This showed the VBC had been over tightened.
