Maersk Completer

DROPS – Incident sharing and
Awareness

Location: Maersk Completer Time: 13:25hrs 04/09/10 Title: Dropped Object

Incident: Dropped object – Metal sign dropped to Drill Floor
Synergi Case: 451625
Location: MAERSK COMPLETER, FADP-03, Brunei Darussalam
Date: 17th May 2010

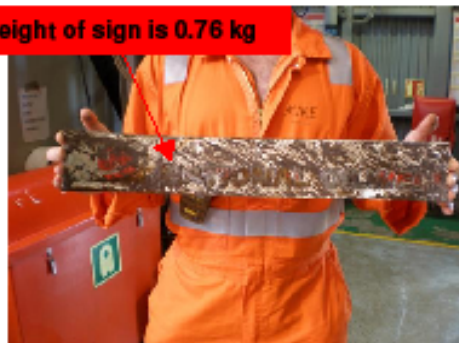
1. The energy created from the drops was 59.6 Joule.
2. The DROPS calculator classifies this as a "recordable case" – 2c
3. Sign sitting in a exposed position and likely to hit stands in aft setback area.
4. Sign had not been identified in Maersk Completer DROPS register as a potential dropped object
5. It has no functionality

Weight of sign is 0.76 kg

1. Check other Drill Floor equipment for similar signs and remove them.
2. Re-visit the need for 3rd Party review of DROPS manual on the Maersk Completer
