Gulf Offshore N.S. Ltd

DROPS Forum 28th Feb 2013

Potential Dropped Objects Summary

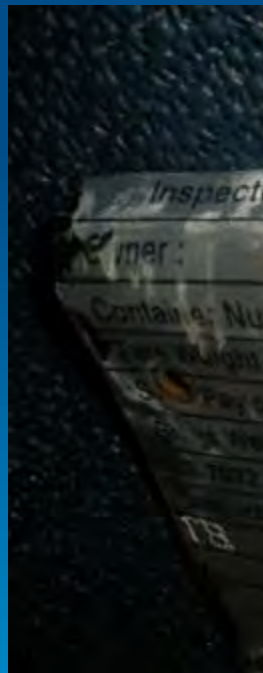
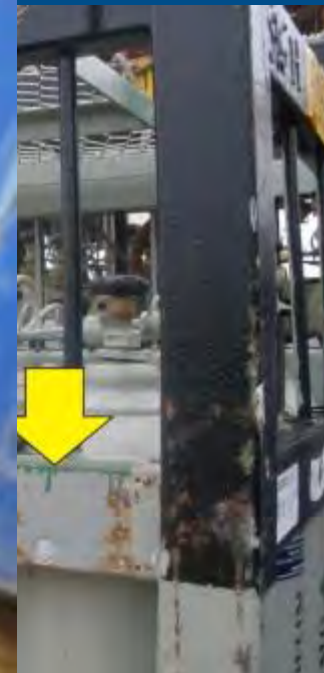
Metal identification plate

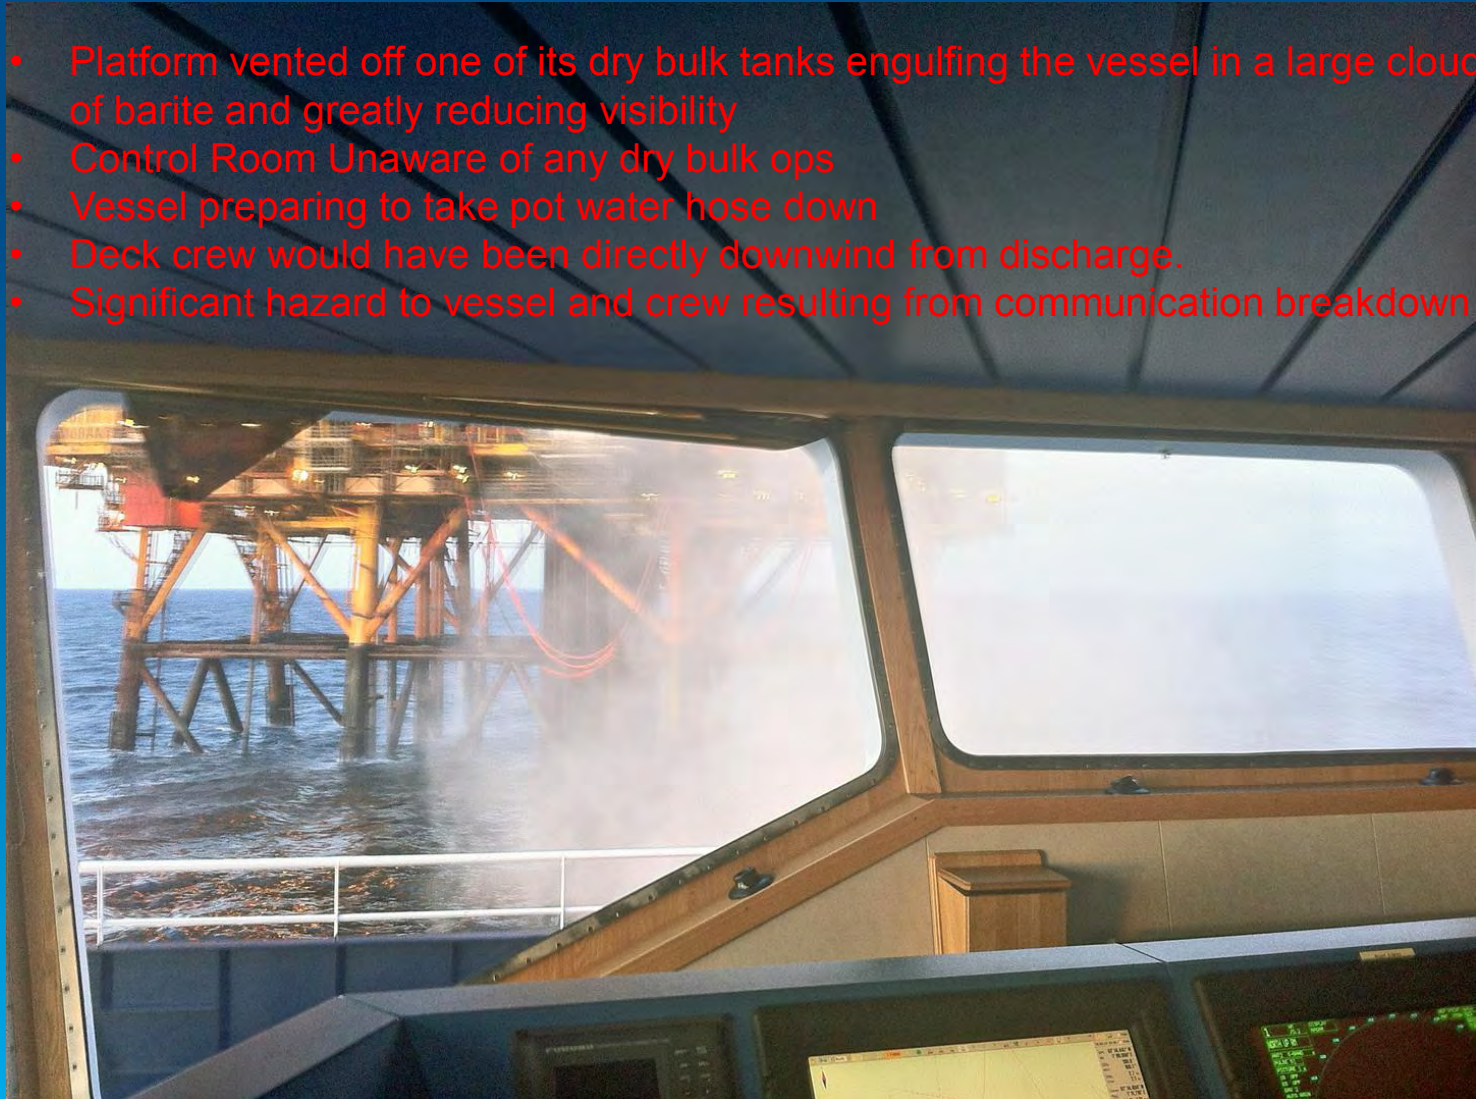
The Latest Overboard Discharge!

- Platform vented off one of its dry bulk tanks engulfing the vessel in a large cloud of barite and greatly reducing visibility
- Control Room Unaware of any dry bulk ops
- Vessel preparing to take pot water hose down
- Deck crew would have been directly downwind from discharge.
- Significant hazard to vessel and crew resulting from communication breakdown
