One Incident Many Lessons

Incident Overview

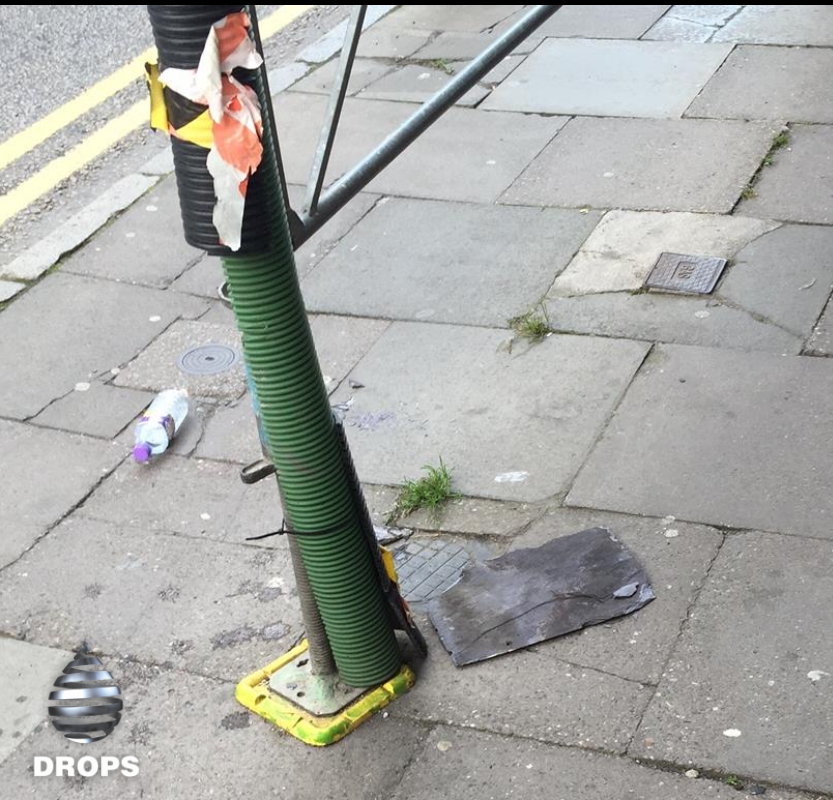
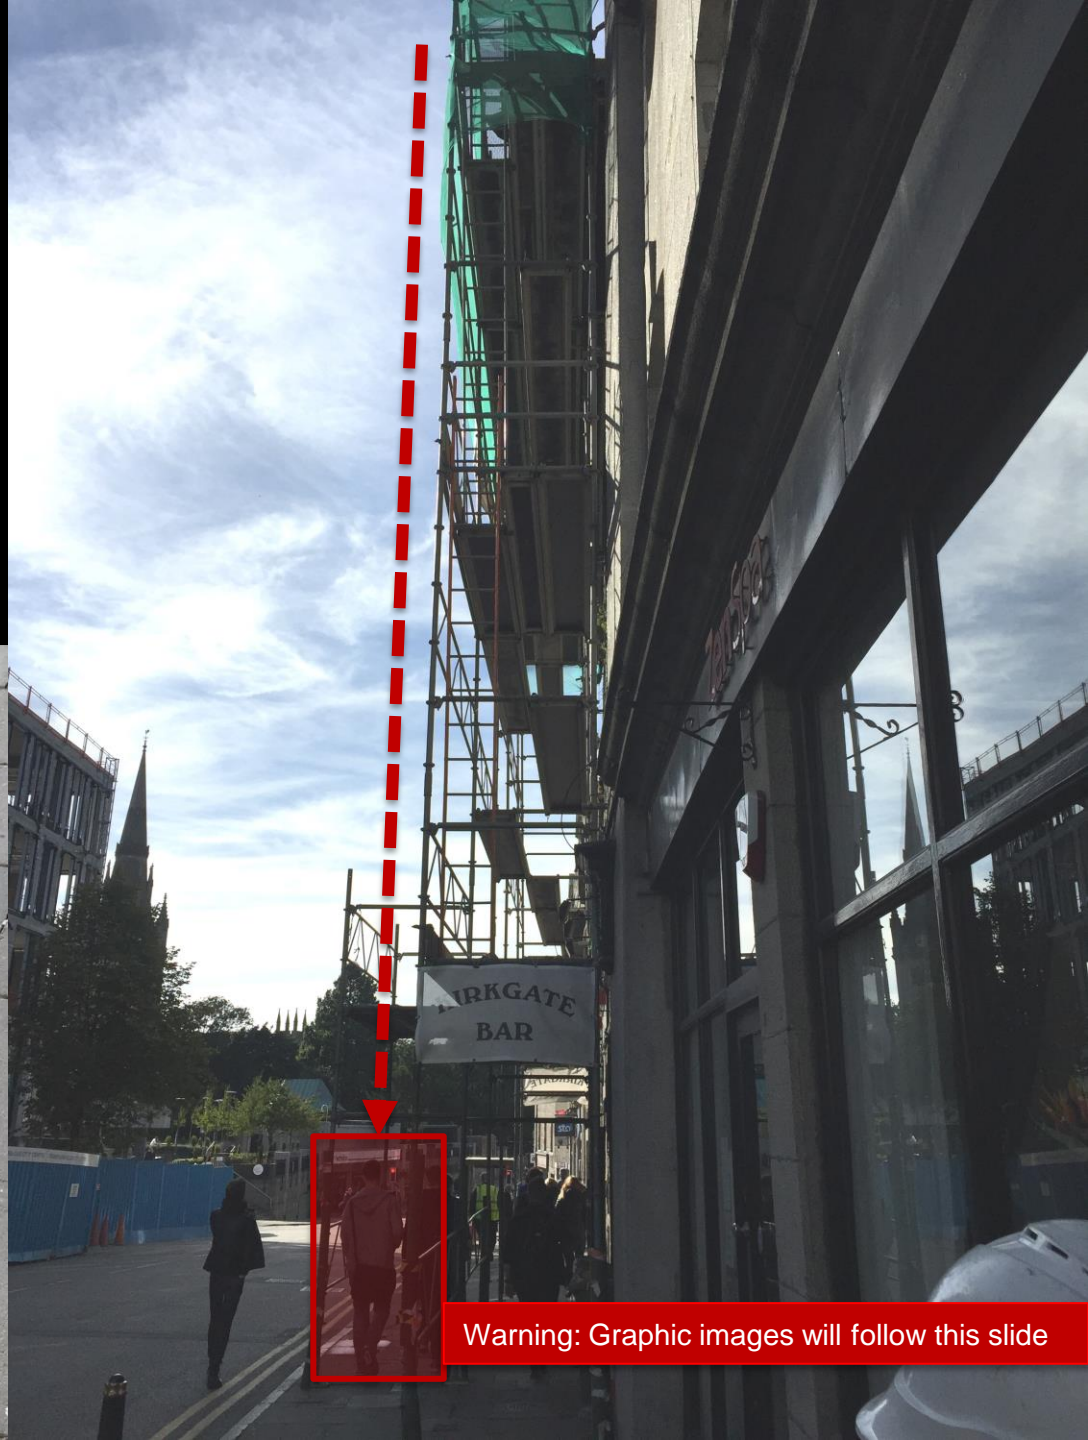
- Upperkirkgate, Aberdeen
- Monday 3rd October 2016, 13.00hrs
- 4 storey scaffolding erected for ongoing renovations
- IPs (2No.) walking under outer scaffold
- Roof slate dropped from top of scaffold

- Incorrect procedure (too many slates on scaffold boards)
- Incorrect layout of ladder hatches (in alignment instead of staggered)
- Inadequate, poorly installed netting around scaffold

- Roofing contractor requested to halt operations
- Police informed
- Incident reported to HSE
- Police cordoned off scaffold and provided pedestrian walkway on road
- HSE suspended all work on site pending investigation
