ABERDEEN DRILLING CONSULTANTS

DROPPED OBJECT STUDY

DRILLING CONTRACTOR YARD AND WAREHOUSE FACILITY

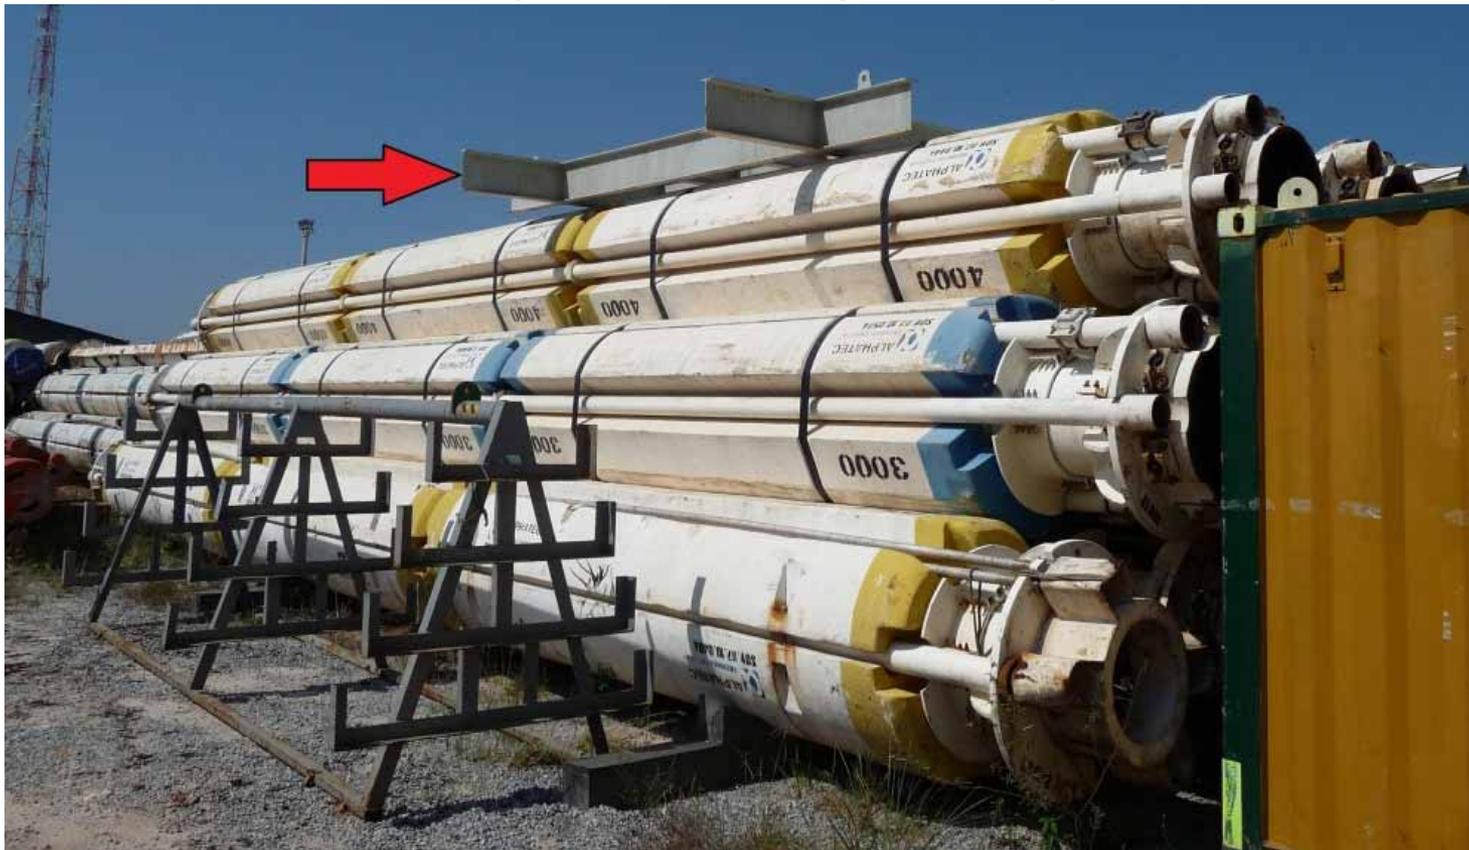
The supply chain manual supplied as being the governing document did not set out how yard operations onshore should be managed and what was or was not acceptable practice, such as maximum heights for stacking, securing and quarantine areas etc.

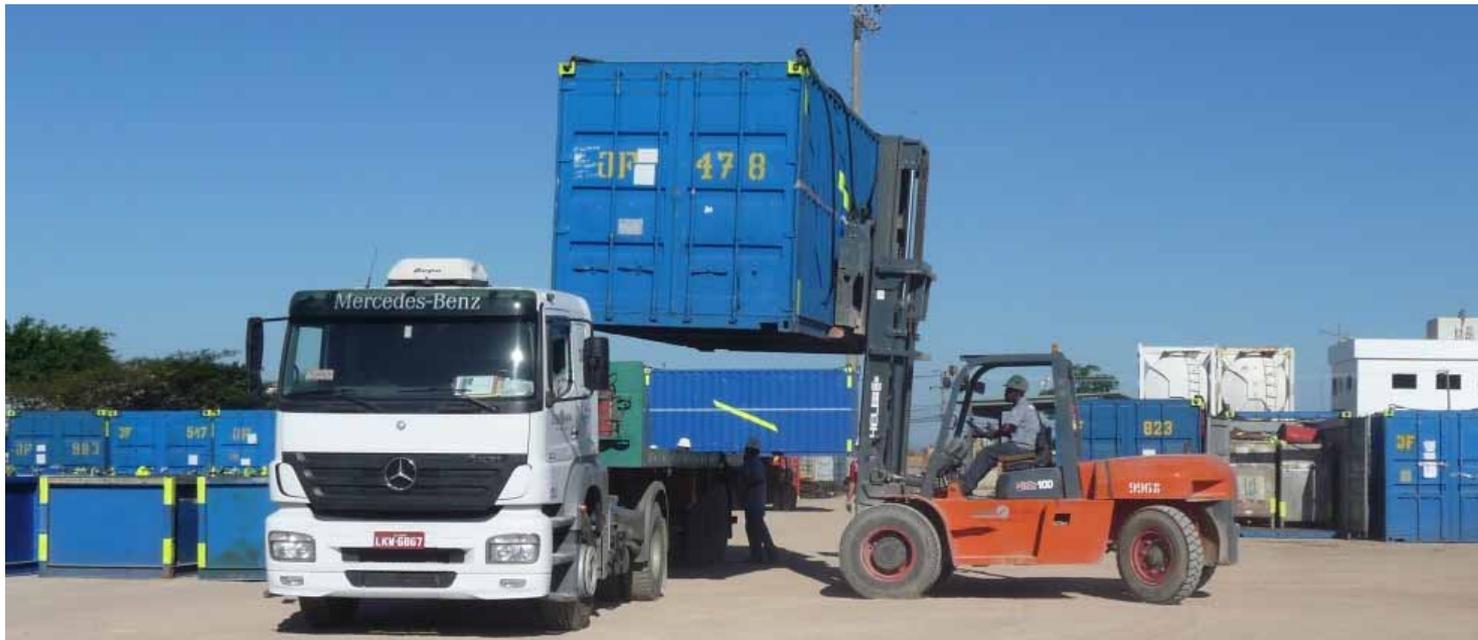
All containers and equipment being dispatched to one operators contracted rigs were being inspected thoroughly and “signed off” by an independent third party contractor. The remainder were subject to similar drilling contractor controls in house.

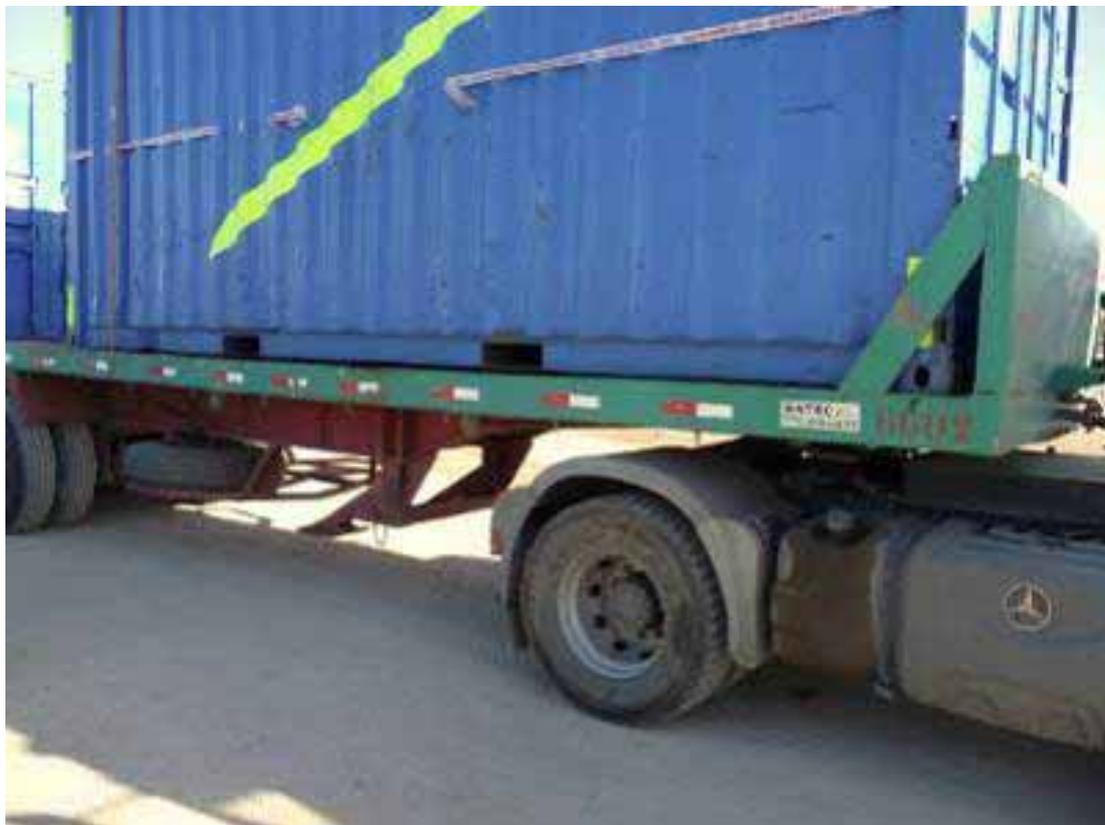
Having observed the preparation and loading of one particular lorry from start to finish including the various standard checks required by the drilling contractor - ADC inspected the lorry and load prior to it departing the yard,
