# High Potential SID March 2012

**SID  
4781**

## **UK 108 – Potential Dropped Object**

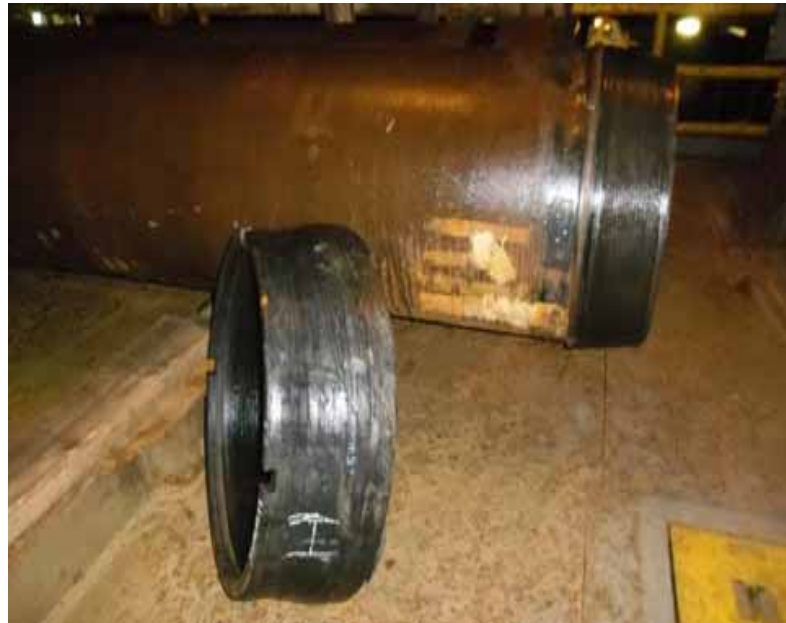
**PHD Base** - During hoisting of a 30" conductor pipe by the SEDCO 711 starboard crane, the protection collar of the conductor pipe fell off onto the deck of the vessel. Height was approximately 1 foot from the deck. Crane notified regards near miss and potential dropped object. Crew instructed to ensure security of all remaining protection collars, also request that protection collar security is checked prior to loading on board the vessel.

The protectors are checked to ensure they are against the end of the pipe and that no thread is showing. This is done for all sizes of pipe but no physical tightening done as a mandatory check.

This would be difficult when checking the smaller diameter bundles as some ends do not protrude far enough out for this to be done. The checks done are the count, any number identity, slinging and the protectors.

Some reasons for this falling off could be it hit something as they are made off hard rubber and would not need much of a knock to slacken them or it was not torqued tight and could slacken in transit eg vibrations or water hitting the protectors. These comments were pertaining to ANY part of the operation loading at vendor, transport to the base and loading or unloading the vessel.

Other factors could be it was against the headboard of the truck and looked tight. The incident details will be passed to the vendors supplying these larger pipe diameter and requesting the need for extra vigilance on securing these protectors.

The gantry team have been advised to give a visual check to protectors that are accessible and practical to see.

Any slackness observed should be reported to the relevant Focal Point/Client Rep.

This incident and actions will be rolled out to the base, charge hands and checkers safety meetings.
