# What:

Dropped Object (Section of 4 Core Electrical Cable weighing app: 1kg)

RGV / Elgin Wellhead Platform

21.04.2009 @ 08:30am

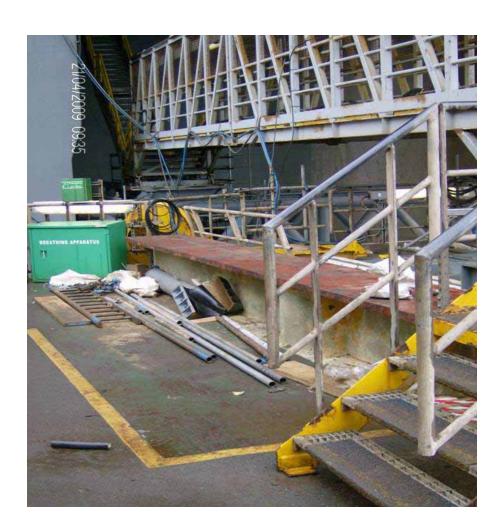
The piece of cable was observed to fall onto the EWHP Weather Deck.
It landed on the walkway to The PUQ Bridge on the NW Corner (Port Aft of RGV)

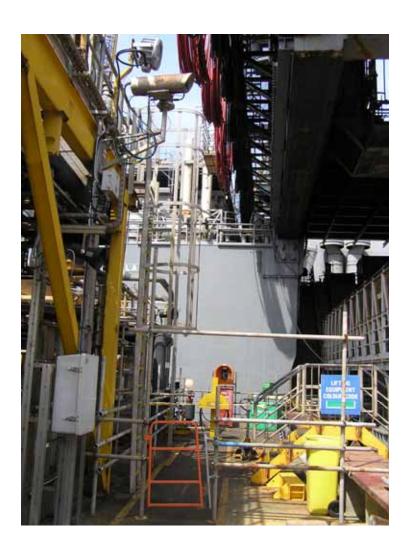
It is believed that the cable dropped from somewhere in this cable run, as the area above is protected by wire fencing.

Visual Sweep of area – Complete
Abseilers to remove any loose items – Complete
Extend restricted access area – Complete
Consider covered access walkway – Complete
DROPS Awareness Training – Ongoing
Consider netting around cables – Ongoing

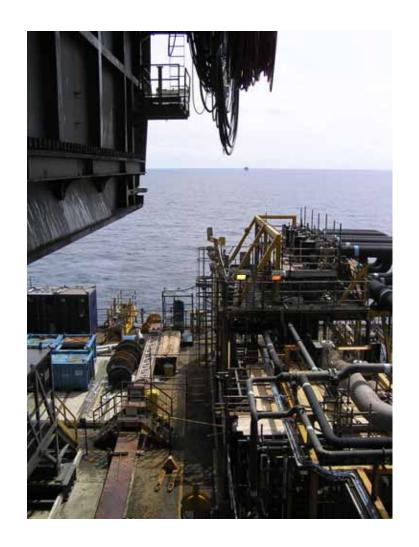
The age of the cable is evident from the corrosion to the conductors and from the bleaching of the insulation colours.

Experienced personnel believe that this was used as packing when ratchet straps were used to secure the cable runs.

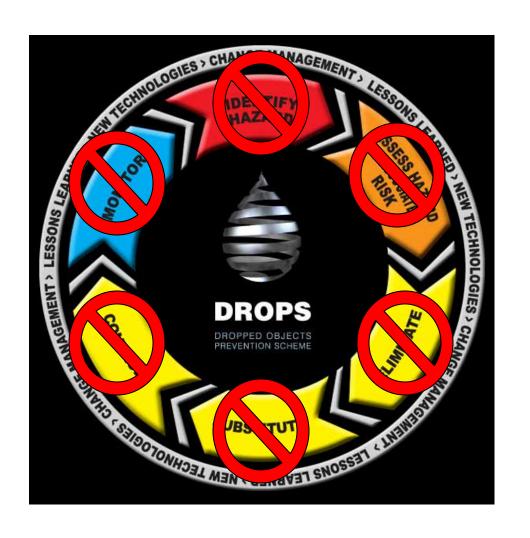
# HAZARD NOT IDENTIFIED AS NO ONE "KNEW" IT WAS THERE
