Worker's Leg Amputated by Parted Sand Line

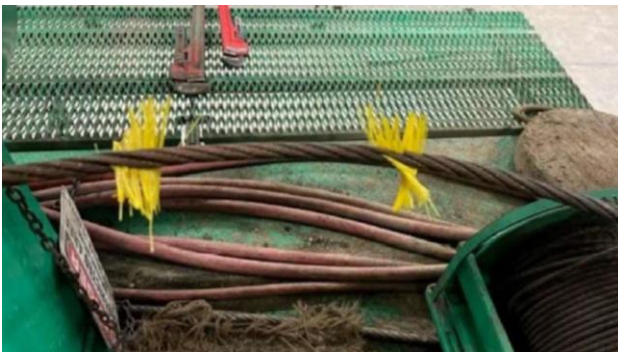
- Several sets of flags, 3-2-1, in use and visible on the second swab were no longer visible on the third swab of this horizontal well.
- Personnel did not recognize how close the swab assembly was to the surface (at the top of the lubricator) because of sun in their eyes, multitasking and other distractions.
- The throttle control configuration on this rig operates in the opposite direction of the typical driller's draw works controls. During this high stress moment, the driller activated the throttle control in the wrong direction.

Example of sand line flags installed before use

- Ensure flags are designed to withstand the conditions of the well they are being used for.
- Investigate the use of fail-safe measures so the swabbing assembly is not pulled up too far, even if flags become worn/not visible or an error or mistake is made (i.e., ensure there is capacity to fail safely).
- Review control configurations to ensure they are consistent.
- Review the incident and job safety analysis (JSA) with all operations personnel prior to swabbing.
- Prior to conducting swabbing operations, the rig manager must get approval from the field superintendent to ensure safeguards are in place and everyone understands their roles and responsibilities.

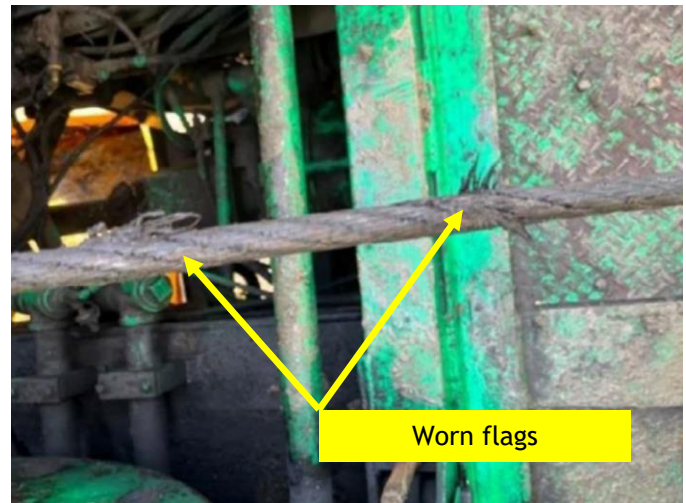
Worn flags on sand line after use
